**COMPREHENSIVE ANALYSIS OF ENHANCEMENTS AND IMPACTS  
ASSOCIATED WITH DISCHARGE OF TREATED EFFLUENT FROM THE  
VENTURA WATER RECLAMATION FACILITY  
TO THE SANTA CLARA RIVER ESTUARY**

**TOXICOLOGY, ECOLOGY, AND HYDROLOGY**

**FINAL REPORT**

Prepared for:  
City of San Buenaventura  
Ventura Water Reclamation Facility

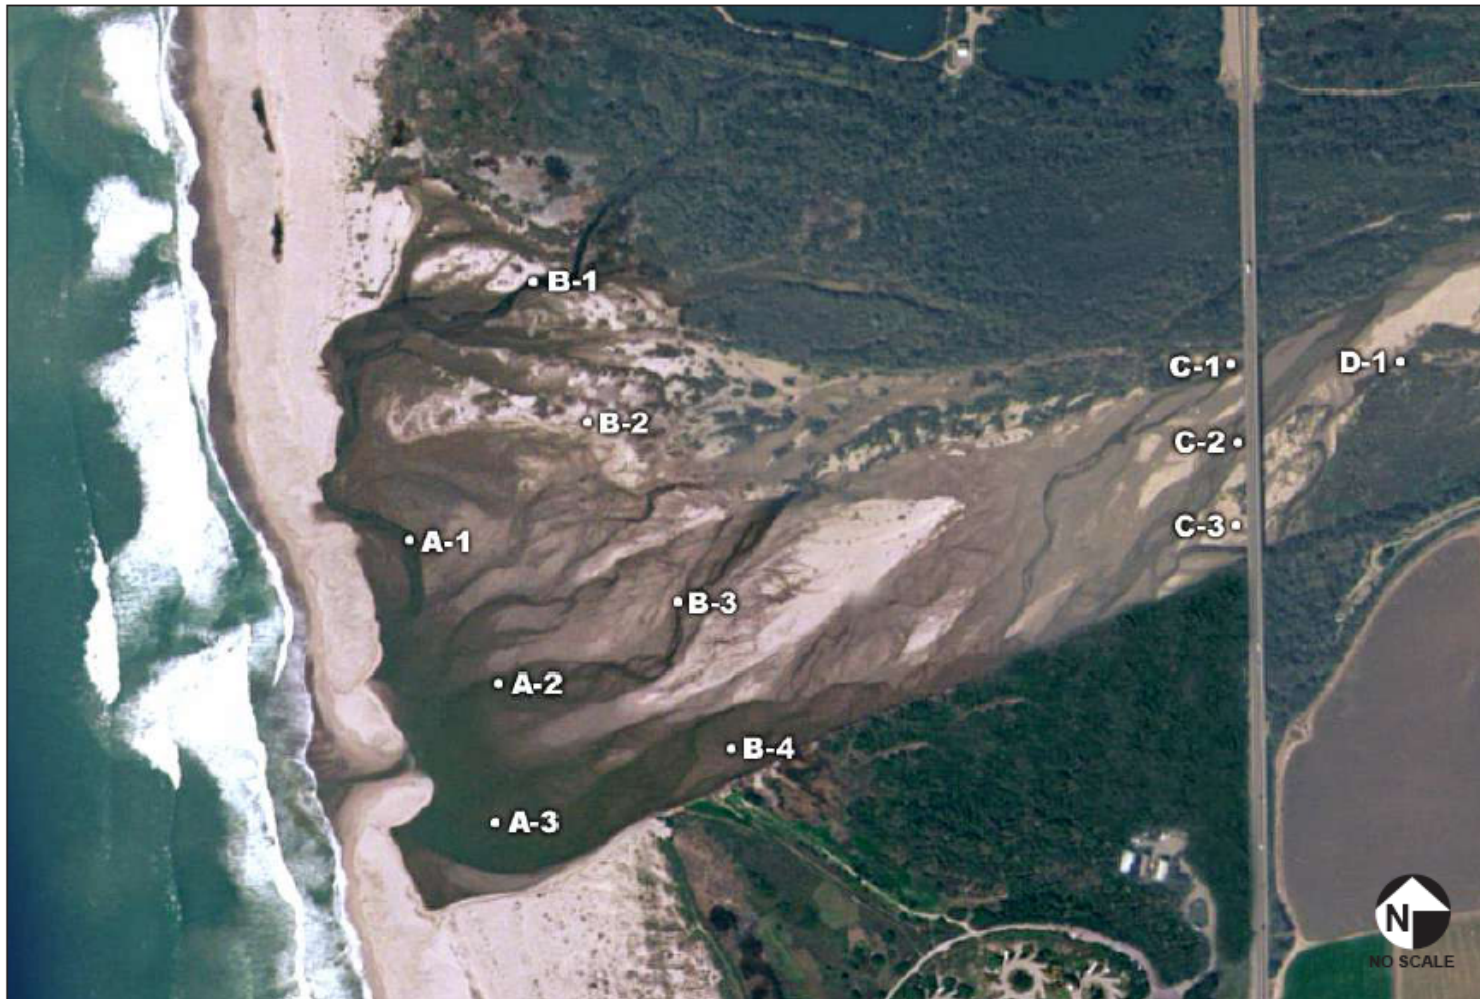
Graphics2/3164/Santa Clara River/SantaClaraSedSampLocs.th8

Sediment Sampling Locations  
Santa Clara River Estuary, City of San Buenaventura  
(Collected 17 October 2003, Photo Taken 1 June 2002)

All of the sediment samples were analyzed by Cal-Science Environmental Laboratories (Garden Grove, CA) for copper, nickel, zinc, and selenium concentrations by ICP-MS (USEPA Method 3050B/6020), and total organic carbon (TOC) (USEPA Method 9060). These results were reported on a dry-weight basis. Grain size was determined at AMEC/Nautilus (San Diego, CA). Concentrations of the trace elements were compared with commonly applied threshold values for evaluating sediment quality (Long et al. 1995). With the exception of the sample collected from upstream of the bridge (D-1), the samples were also tested for toxicity using the 10-day amphipod test (survival) and the 48-hour larval bivalve test (survival and shell development). The toxicity tests were performed according to methods presented in USEPA (1994a) and PSEP (1995) for the amphipod and mussel tests, respectively.

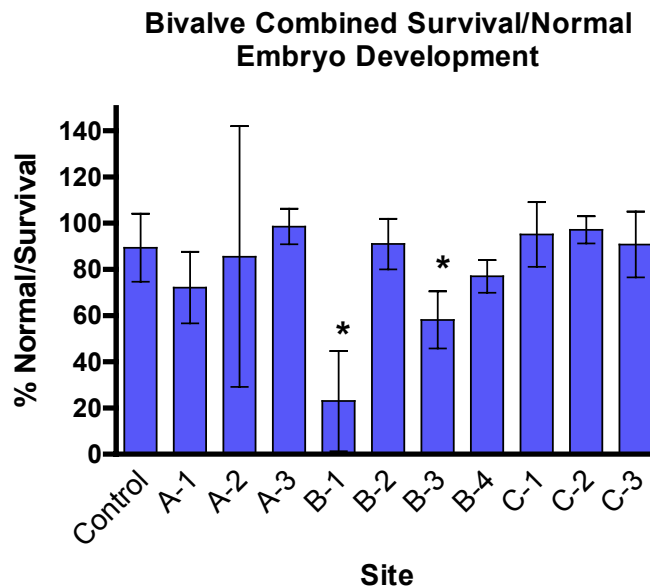
**Figure 2-6. Summary of sediment toxicity test results for bivalve embryo development. Santa Clara River Estuary samples were collected 17 October 2003. Mean ( $\pm 1$  SD) are displayed. A significant reduction in survival/normal embryo development was observed for samples B-1 and B-3.**

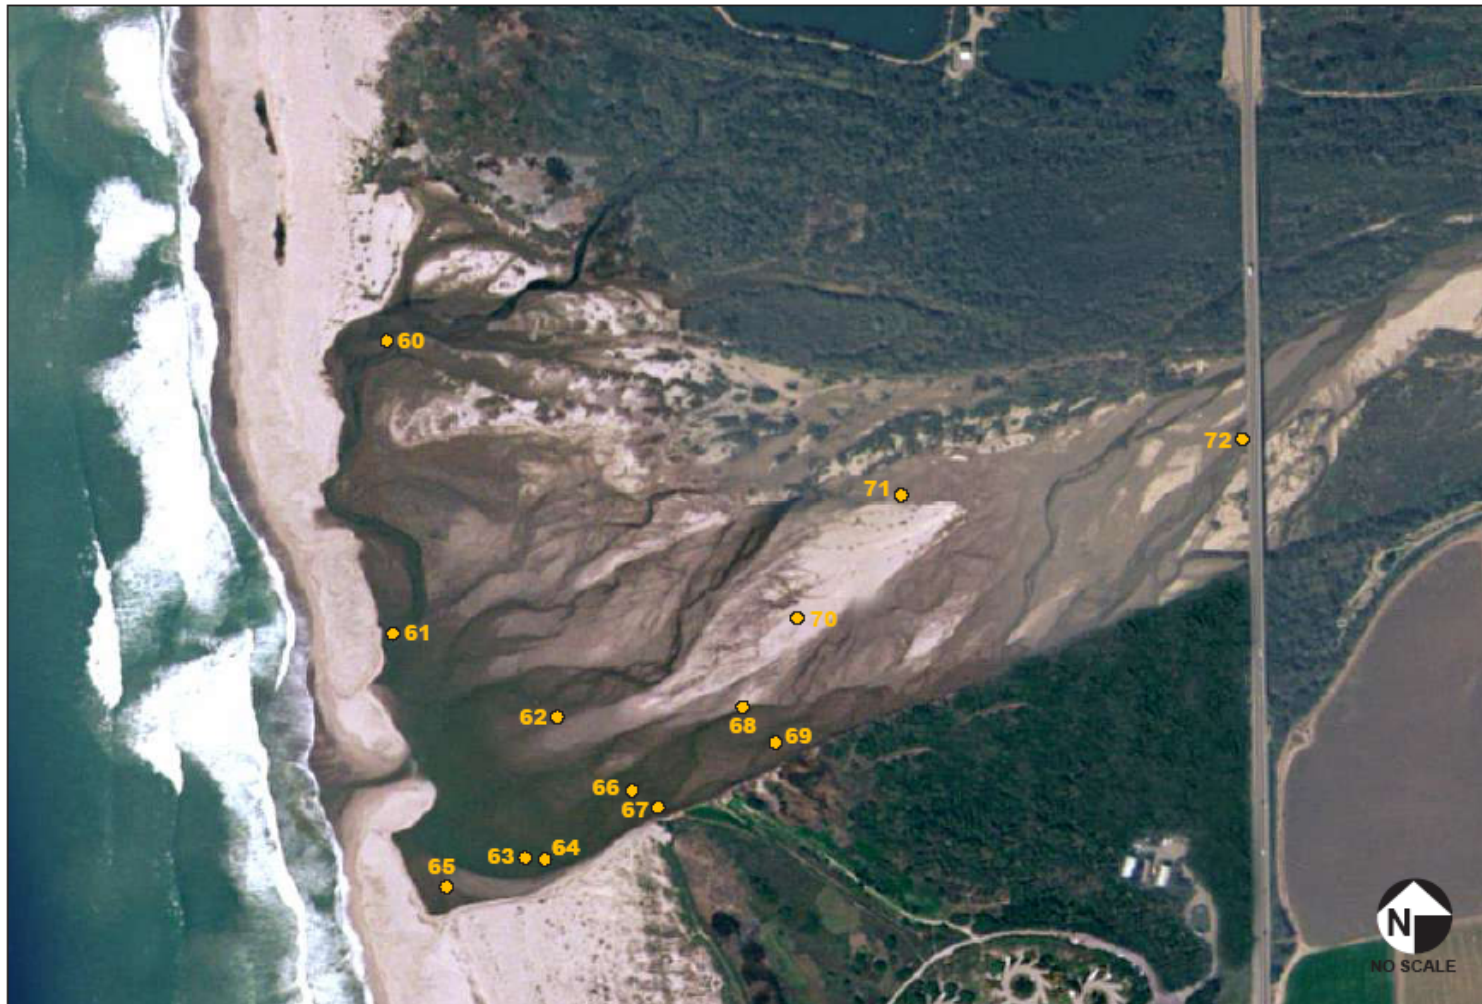
Graphics2/3164/Santa Clara River/SantaClaraSedSampLocs\_wet.m8

Sediment Sampling Locations  
Santa Clara River Estuary, City of San Buenaventura  
(Collected 06 November 2003, Photo Taken 1 June 2002)  
Wet Weather

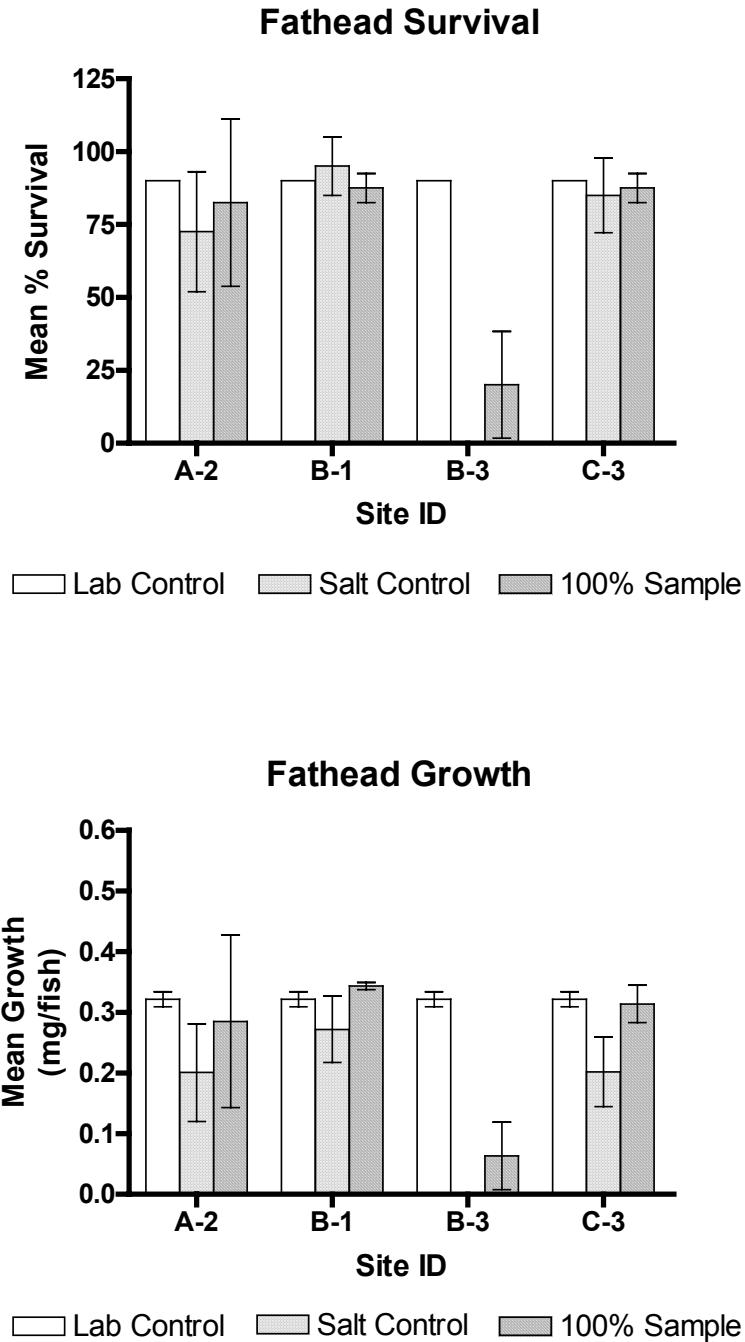
**Figure 2-10. Summary of toxicity test results (March 2004) for fathead minnow 7-day survival and growth. Mean ( $\pm 1SD$ ) values in 100-percent sample are displayed. No statistically significant decreases were observed compared to concurrent salinity controls.**

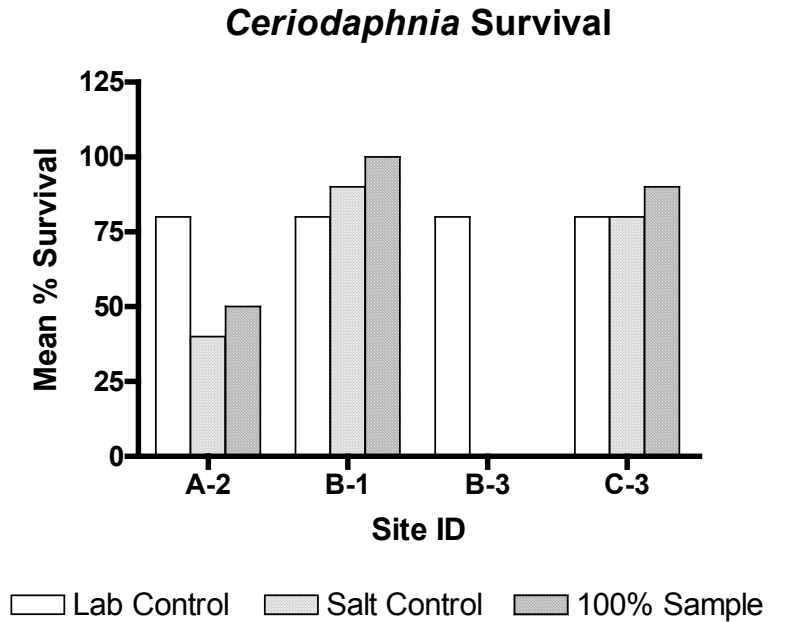
**Figure 2-11. Summary of toxicity test results (March 2004) for water flea 7-day survival and reproduction. Mean ( $\pm 1SD$ ) values in 100-percent sample are displayed. No statistically significant decreases were observed compared to concurrent salinity controls.**

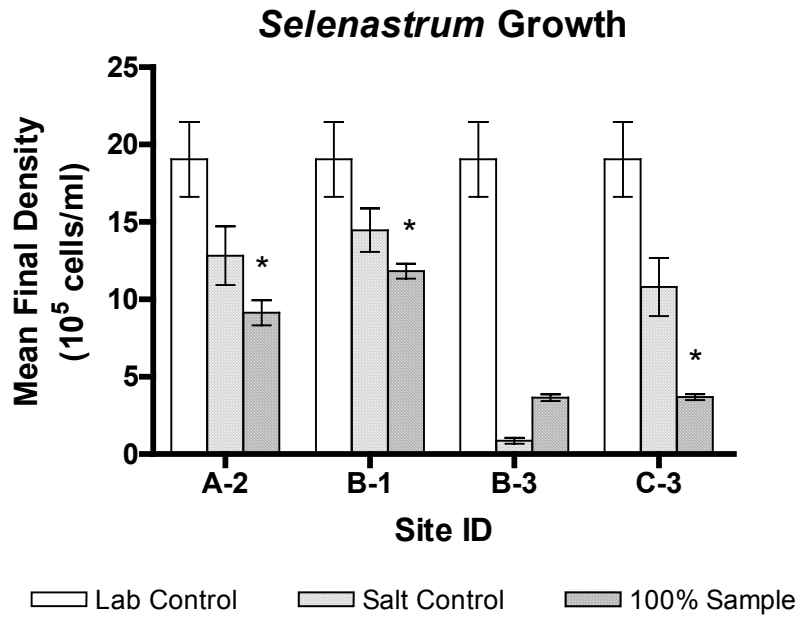
**Figure 2-12. Summary of toxicity test results (March 2004) for algal growth inhibition. Mean ( $\pm 1SD$ ) values in 100-percent sample are displayed. A significant reduction in growth was observed for samples A-2, B-1, and C-3, relative to the salt control.**

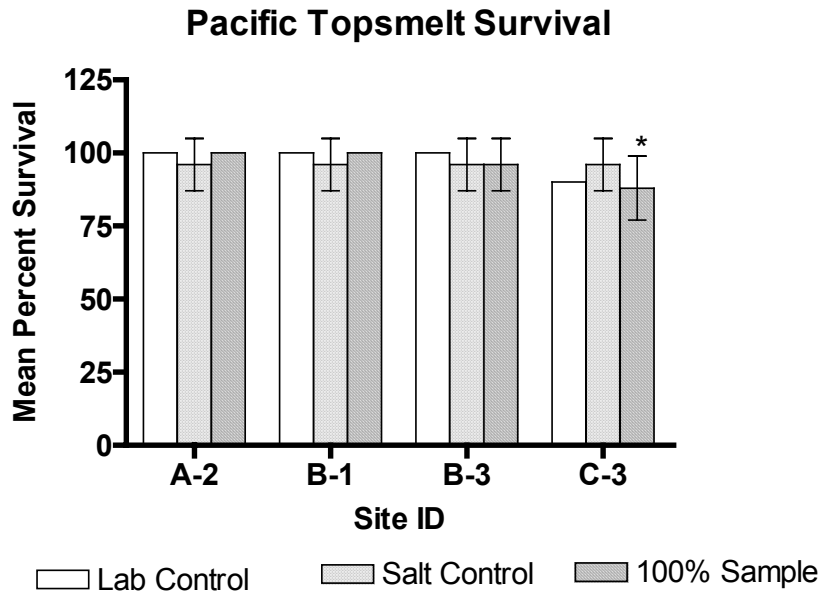
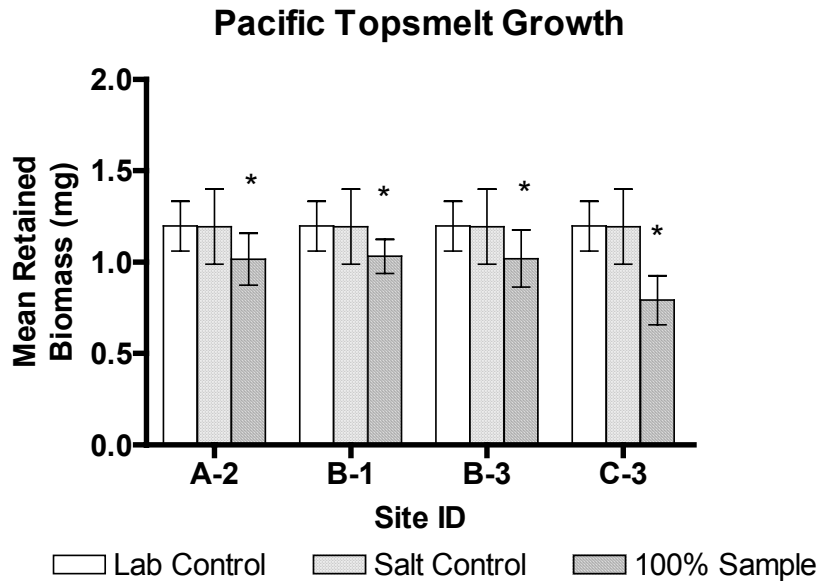
**Figure 2-13. Summary of toxicity test results (March 2004) for Pacific topsmelt 7-day survival and growth. Mean ( $\pm 1SD$ ) values in 100-percent sample are displayed. A significant reduction in survival was observed for sample C-3, and a significant decrease in growth was observed for samples A-2, B-1, B-3, and C-3, relative to the salt control.**

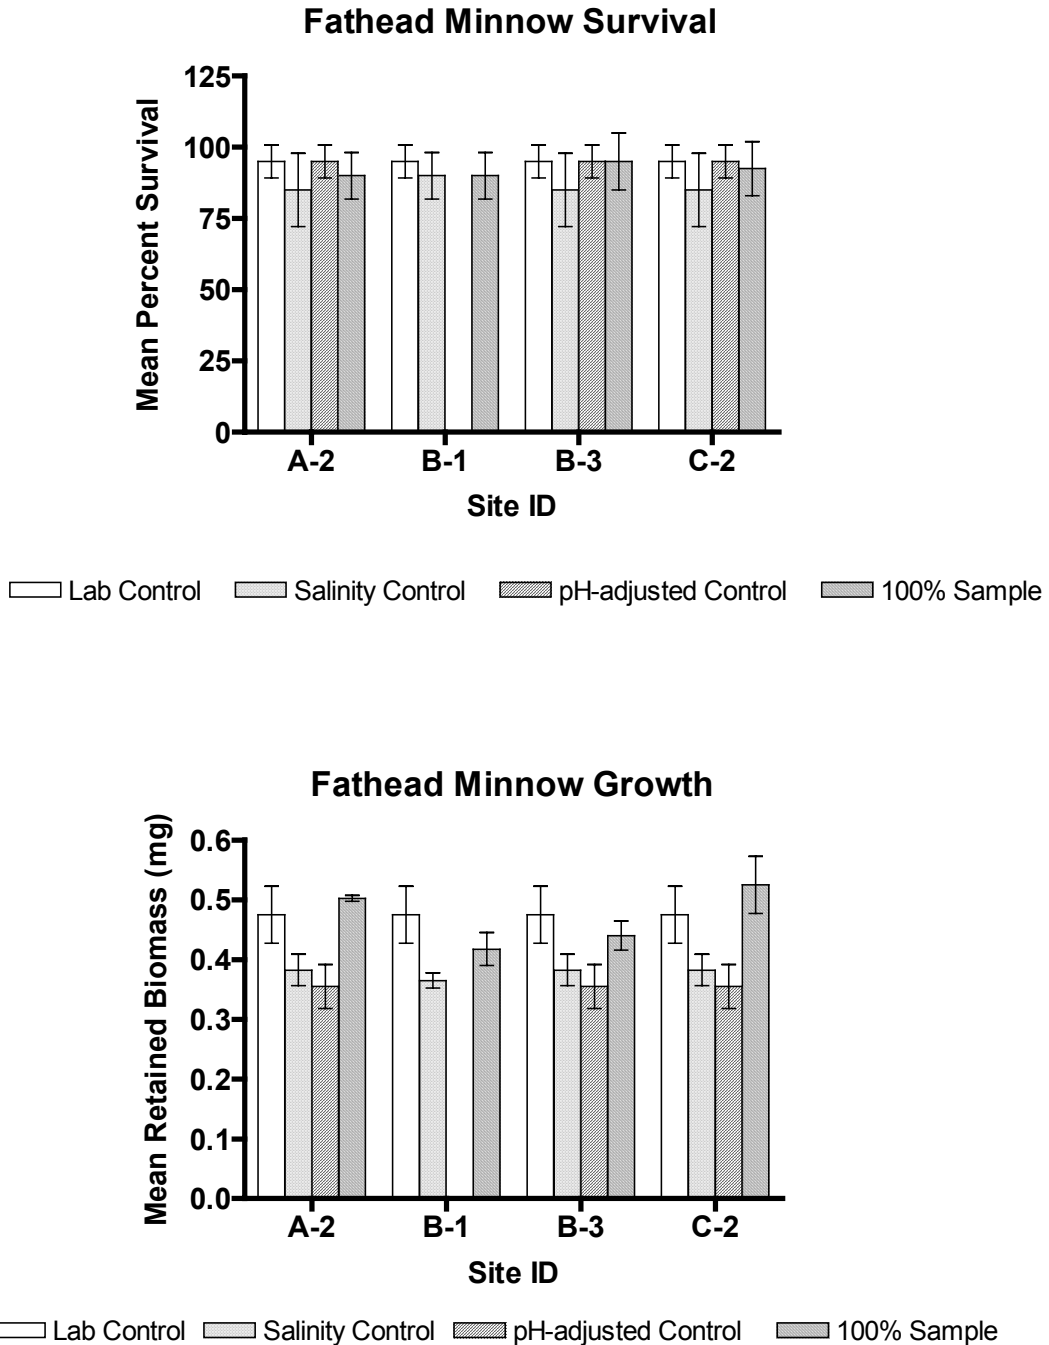
**Figure 2-17. Summary of toxicity test results (July 2004) for fathead minnow 7-day survival and growth. Mean ( $\pm 1SD$ ) values in 100-percent sample are displayed. No statistically significant decreases were observed compared to concurrent salinity control (Site B-1) and pH control (Sites A-2, B-3, and C-2).**

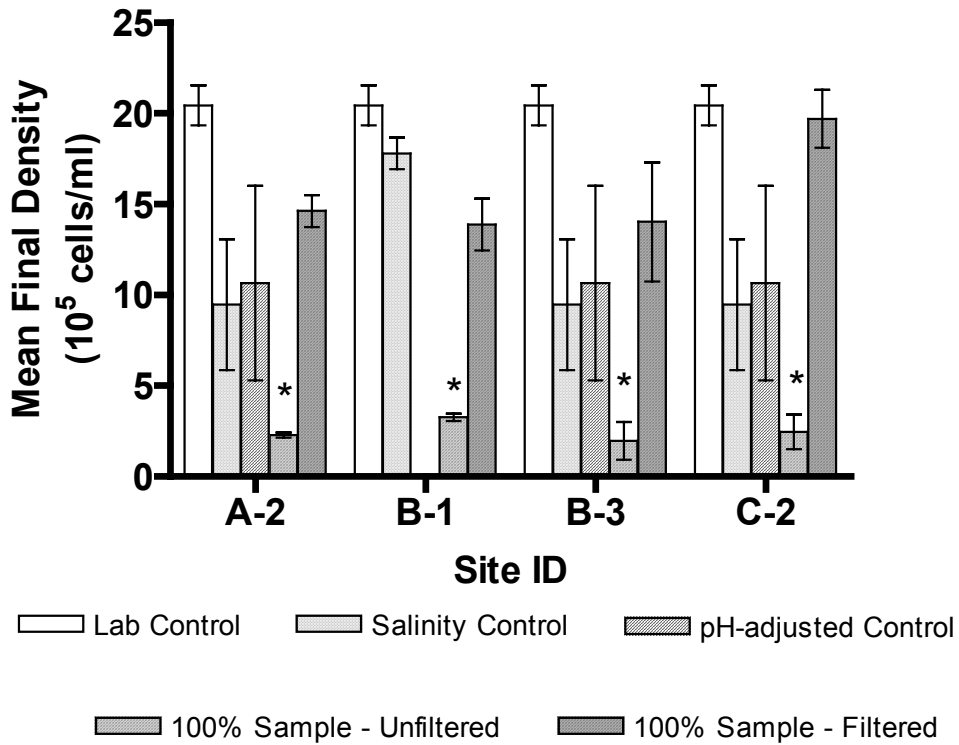
**Figure 2-19. Summary of toxicity test results (July 2004) for algal growth inhibition. Mean ( $\pm 1$ SD) values in 100-percent sample are displayed. All unfiltered samples showed a significant decrease relative to the salinity control (t-test,  $p < 0.05$ ,  $n=4$ ).**

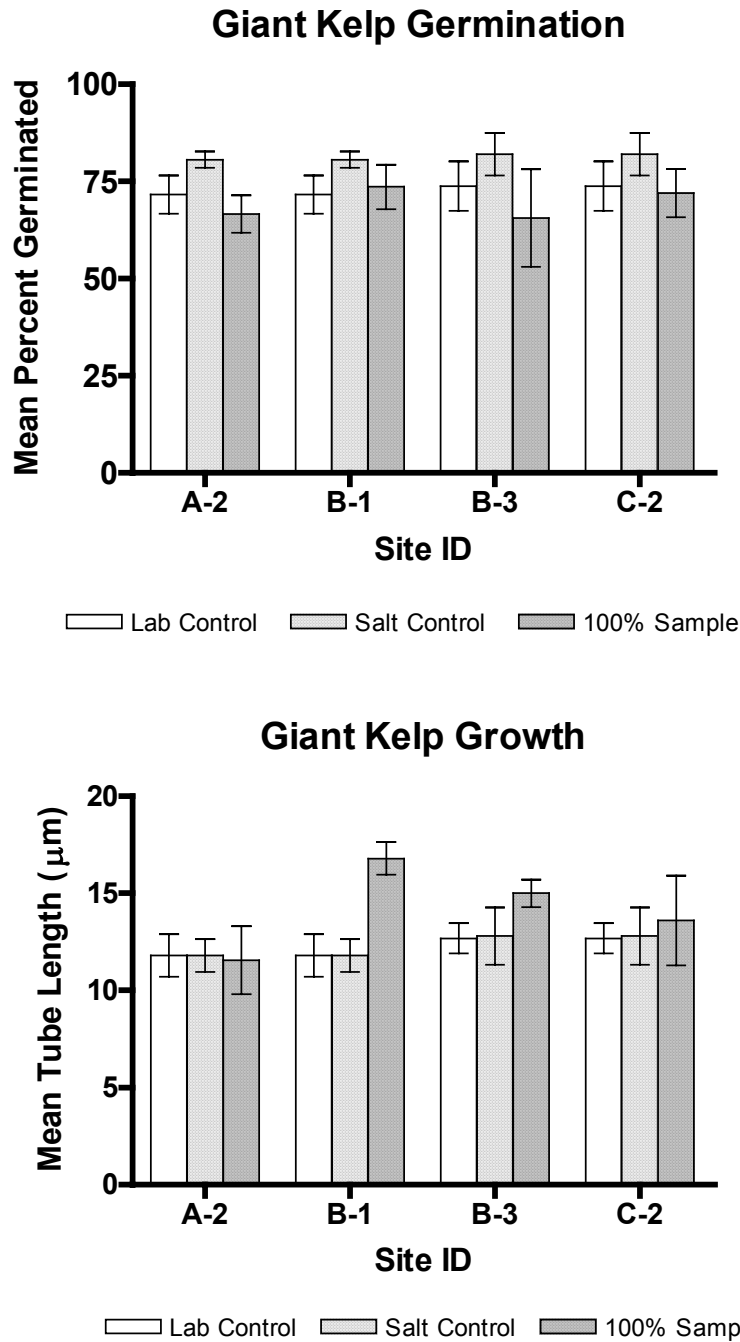
**Figure 2-23. Summary of toxicity test results (July 2004) for kelp spore germination and growth. Mean ( $\pm 1SD$ ) values in 100% sample for each site are displayed. No statistically significant decreases were observed compared with the concurrent artificial salt controls.**

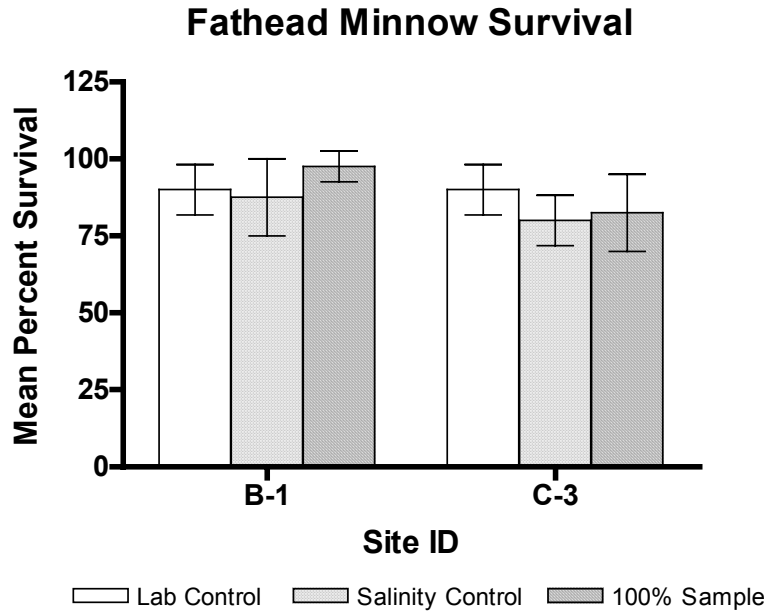
**Figure 2-24. Summary of toxicity test results (September 2004) for fathead minnow 7-day survival and growth. Mean ( $\pm 1SD$ ) values in 100-percent sample are displayed. No statistically significant decreases were observed compared to concurrent salinity controls.**

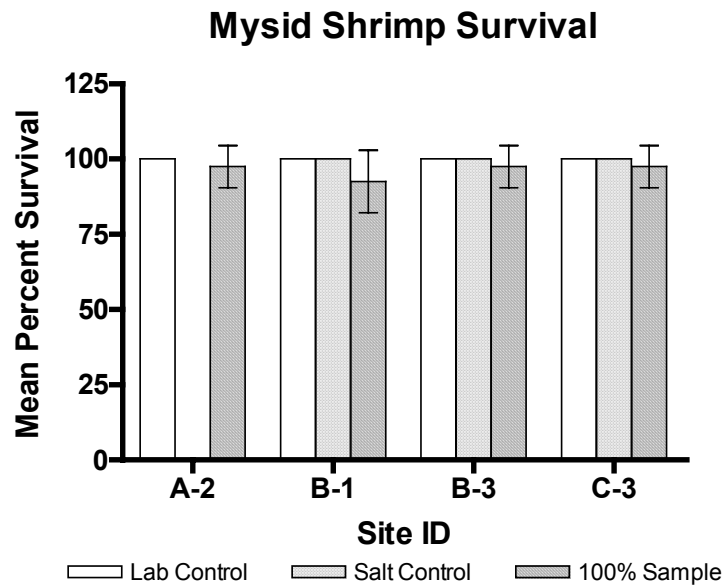
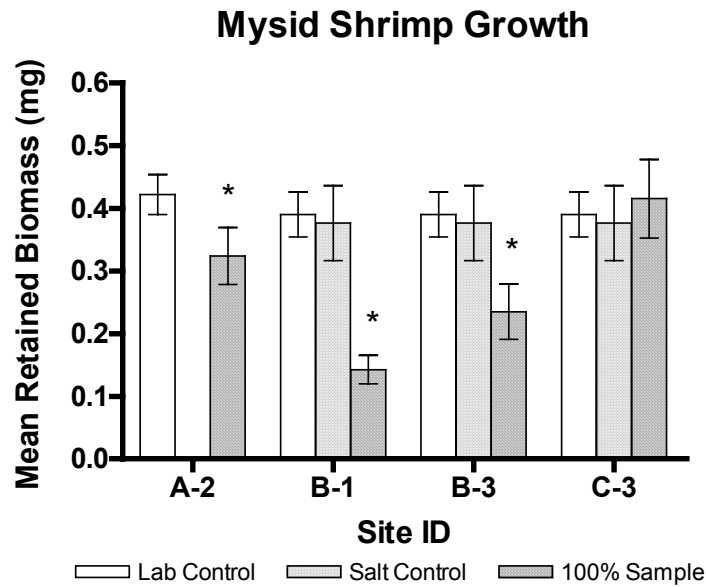
**Figure 2-28. Summary of toxicity test results (September 2004) for opossum shrimp 7-day survival and growth. Mean ( $\pm 1SD$ ) values in 100-percent sample are displayed. Significant decreases in growth were observed for samples A-2, B-1, and B-3 (t-test,  $p < 0.05$ ,  $n=8$ ).**

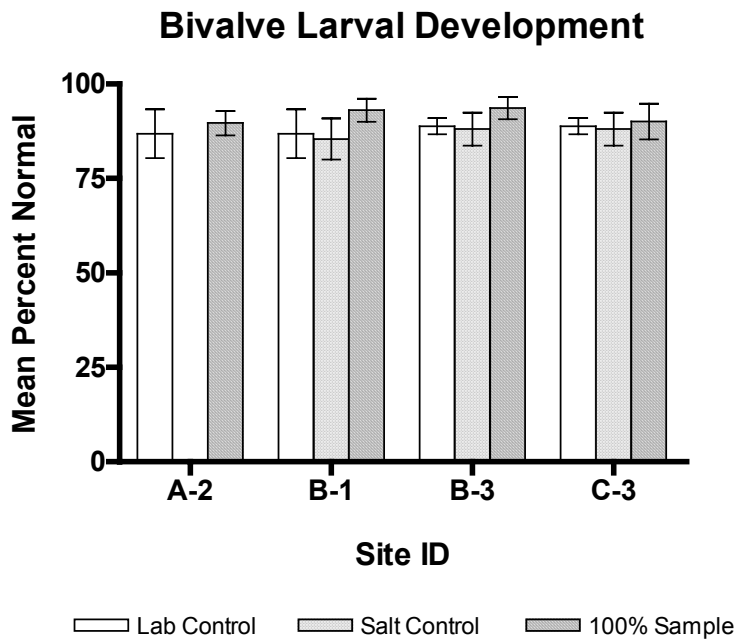
**Figure 2-29. Summary of toxicity test results (September 2004) for bivalve 48-hour embryo development using *Mytilus galloprovincialis*. Mean ( $\pm 1SD$ ) values in the 100-percent sample are displayed. No statistically significant decreases were observed compared to the appropriate concurrent controls.**

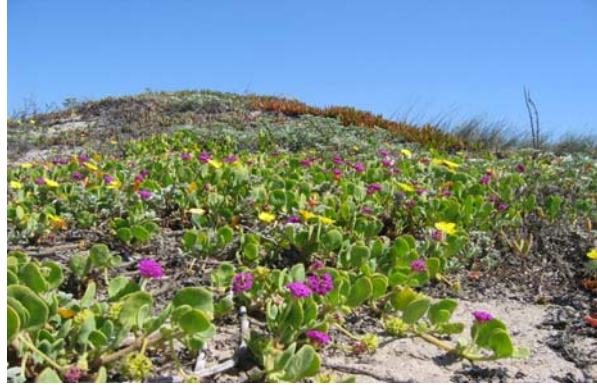
Sand verbena and beach evening primrose are shown in the foreground growing on a semi-stabilized dune. The invasive Hottentot fig (*Carpobrotus edulis*) and Veldt grass (*Ehrharta calycina*) are seen growing in the background.

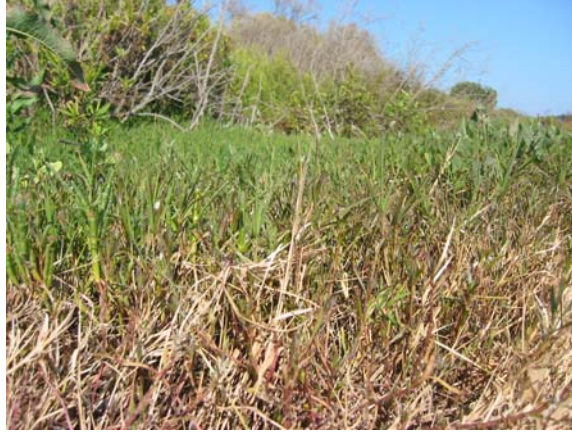
Photograph illustrating dominant saltmarsh vegetation (foreground): Salt grass (*Distichlis spicata*) and pickleweed (*Salicornia* sp.).

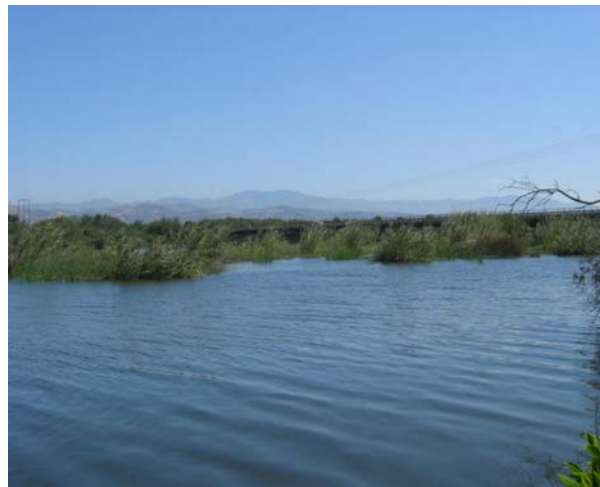
Photograph shows vegetation establishing on sandbars within the main channel (note giant reed in center).

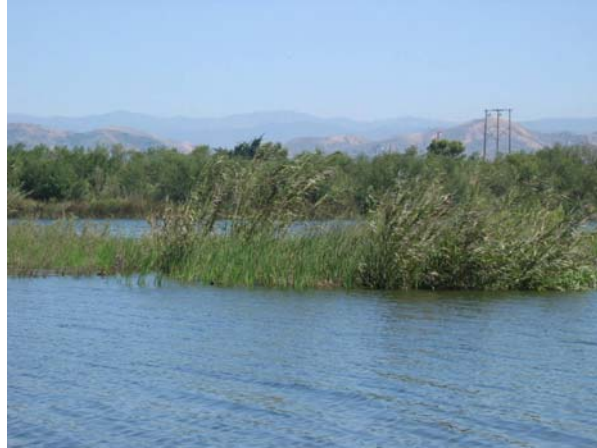
Freshwater marsh dominated by cattails (*Typha latifolia*) and bulrushes (*Scirpus* sp.) is shown here with the invasive giant reed to the right.

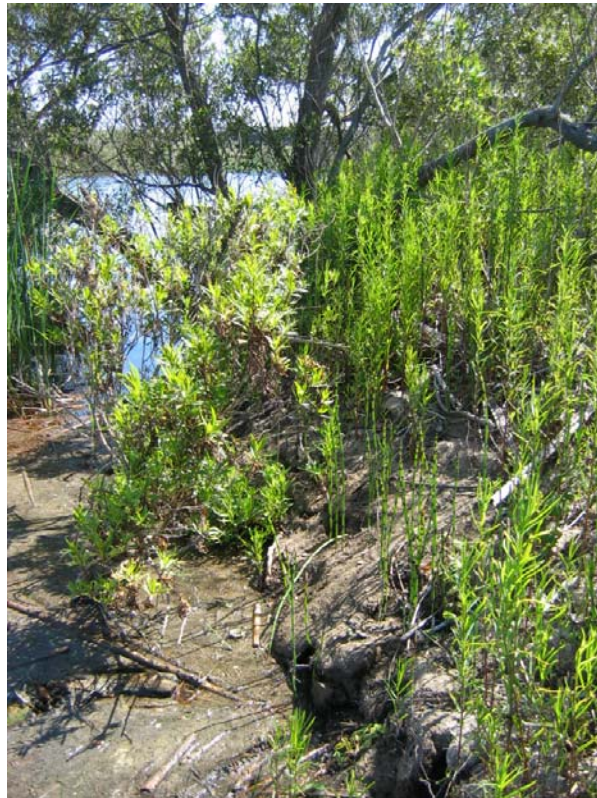
Shown here are willow riparian woodland and an understory comprised of horsetails (*Equisetum* spp.), willow (*Salix* sp), and other herbaceous species.

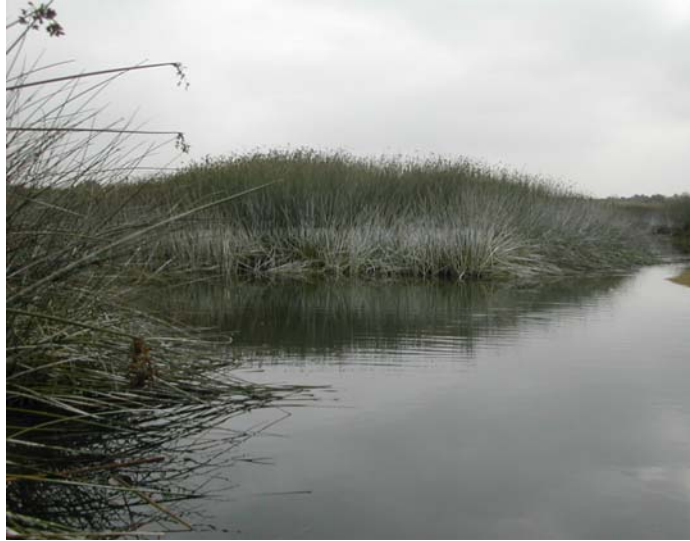
**VWRF discharge channel prior to storm events (photograph taken 28 September 2004).**

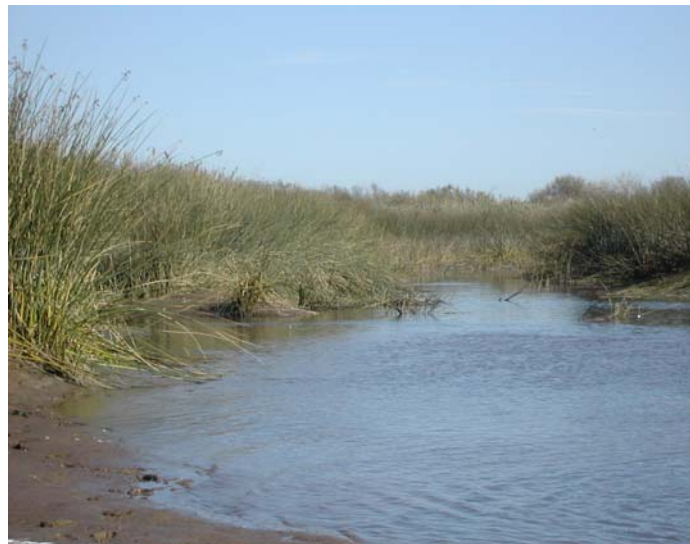
**Figure 3-8. Comparison of VWRF discharge channel before and after the January 2005 storm events.**

**VWRF discharge channel after the storm events (photograph taken 31 January 2005).**

The lagoon remains the most conspicuous habitat component of the estuary. From the perspective of tidewater goby populations, key habitat includes the area of the lagoon, which limits population size; water quality, which needs to remain within ranges (e.g., temperature, DO, salinity) that do not limit survival or place physiological stress on the organisms; substrate suitable for spawning and incubating eggs; sufficient cover to provide protection from predators; and side-channel habitat that provides refugia from high stormwater outflows during flood events. Notably, the most stable side-channel freshwater marsh habitat is associated with the VWRP outflow channel. Photographs (Figure 3-8) taken of the discharge channel before and after a major storm event (50- to 100-year flood event) in early January 2005 demonstrate the stability of this habitat, as the vegetation adjacent to the discharge channel remained intact after the event.

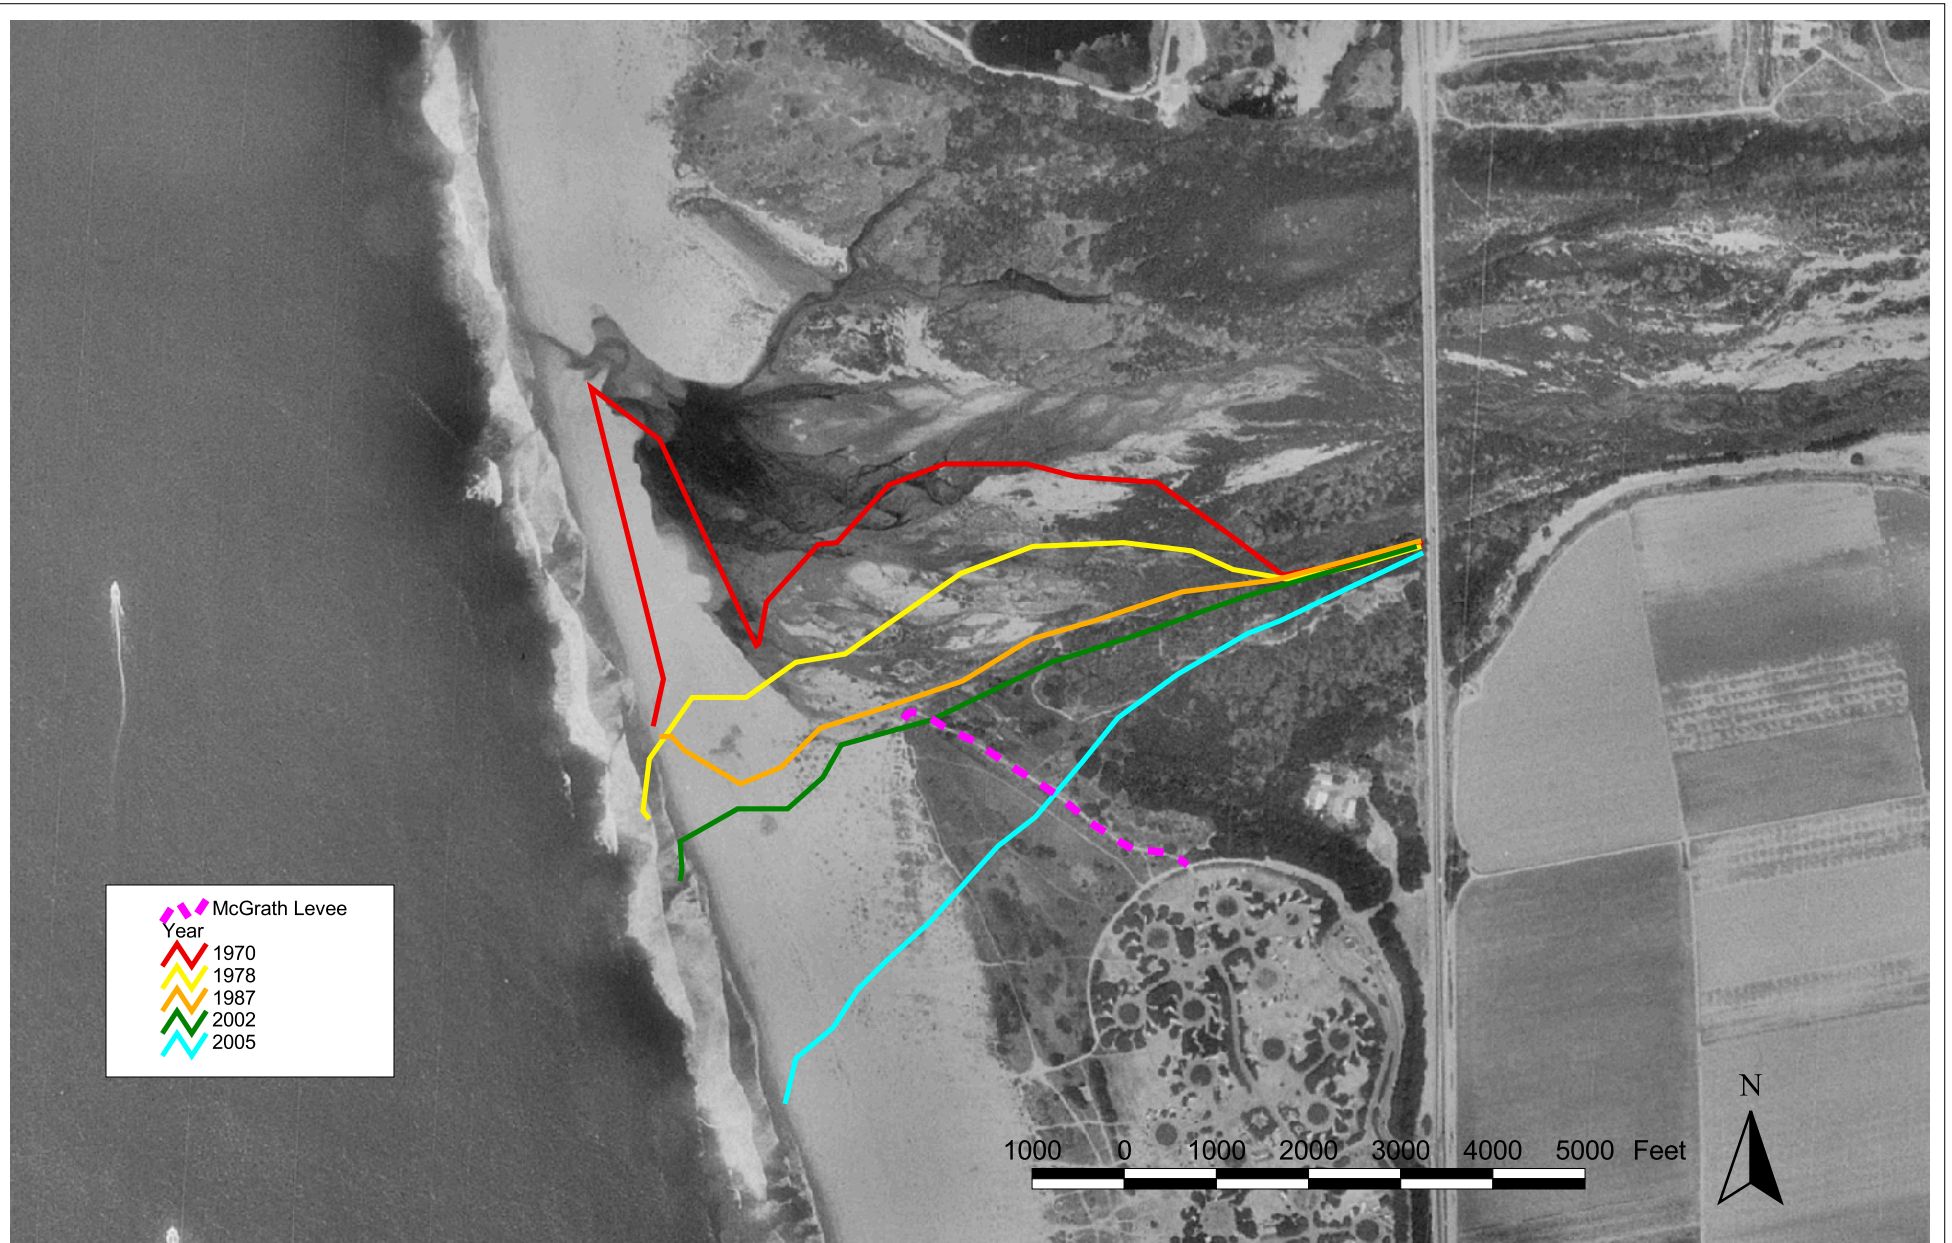
Recent Migration of Lagoon South Bank  
ENVIRONMENTAL STUDY OF THE SANTA CLARA RIVER ESTUARY  
HYDROLOGY AND COASTAL LAGOON ASSESSMENTS
