Santa Clara River Parkway
Floodplain Restoration
Feasibility Study

**Assessment of Geomorphic Processes for the
Santa Clara River Watershed,
Ventura and Los Angeles counties,
California**

FINAL REPORT
August 2007

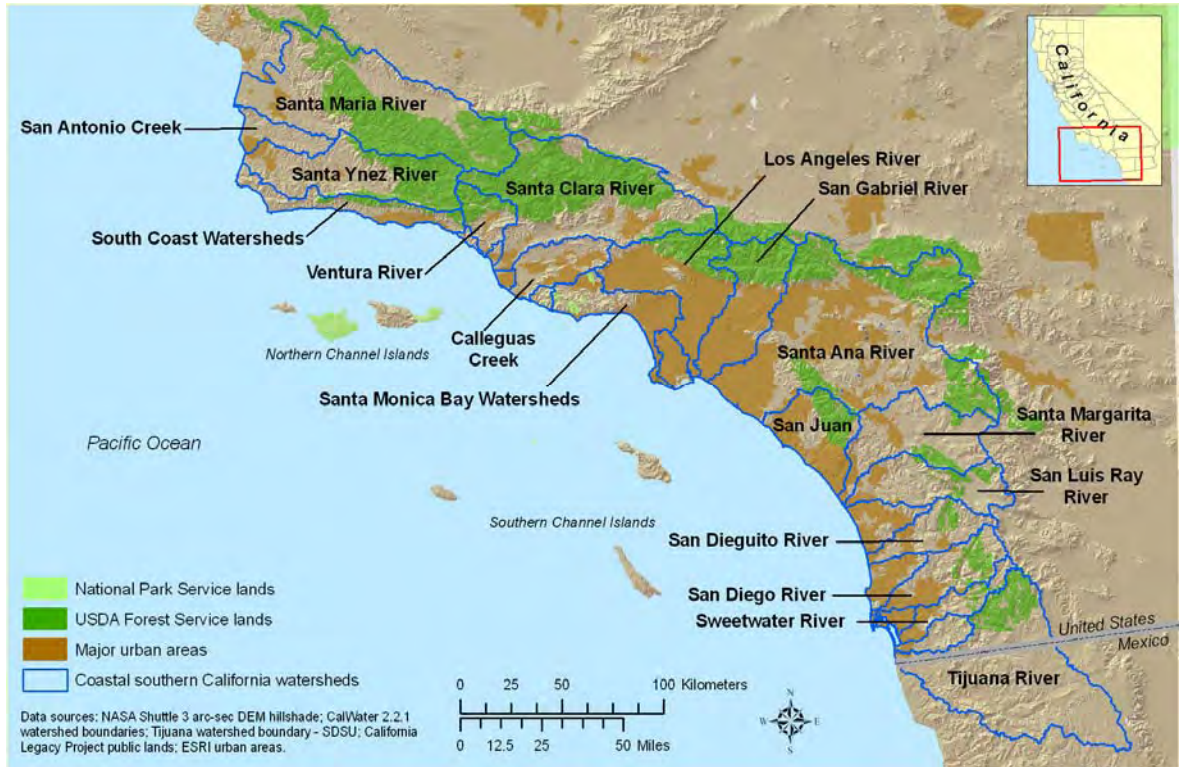
Figure 2-3. Major coastal southern California watersheds.

Flowing 186 km (116 mi) from the northwestern San Gabriel Mountains to the coast, the Santa Clara River drains approximately 4,212 km² (1,626 mi²)—one of the largest watersheds on the southern California coast (Figure 2-3). Elevations range from sea level to 2,692 m (8,832 ft) in the watershed (Figure 2-2). The Santa Clara River is relatively pristine in comparison with other large, coastal southern California rivers. For example, on the Los Angeles, Santa Ana, and San Gabriel rivers, flood protection and urban development modifications have been so extensive that natural physical processes have become largely ineffective at maintaining aquatic and riparian habitat.

The Santa Clara River watershed remains relatively undeveloped when compared with many of the coastal watersheds to the south (Figure 2-3). Large expanses of the mountainous northern portions of the watershed are part of the Angeles and Los Padres National Forest (see Figure 2-1). Land cover in upland areas of the Santa Clara River watershed is dominated by scrub/shrub (chaparral) vegetation; grasslands and mixed, deciduous, and evergreen woodlands comprise the remainder of upland land cover. Along floodplain and valley bottom areas of the Santa Clara River Valley, orchard and row crop agriculture is the dominant land use, with significant urban areas in the upper (Santa Clarita) and lower (Ventura, Santa Paula, Fillmore, Oxnard) valley areas (Figure 2-7). In the lower Santa Clara River, below the confluence with Sespe Creek, agricultural and urban use account for 22% and 9% of land cover respectively (Warrick, 2002).

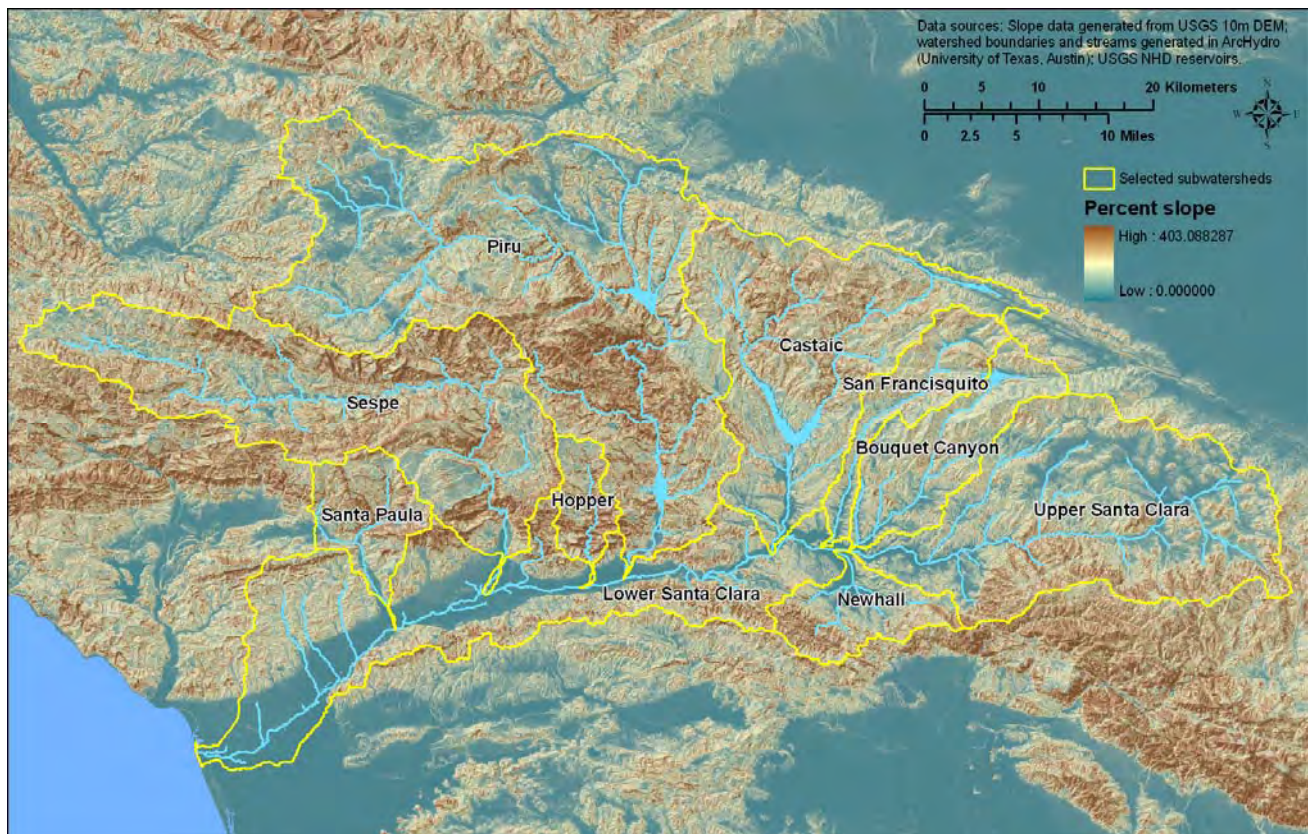
Figure 4-1. Slope distribution in the Santa Clara River watershed.

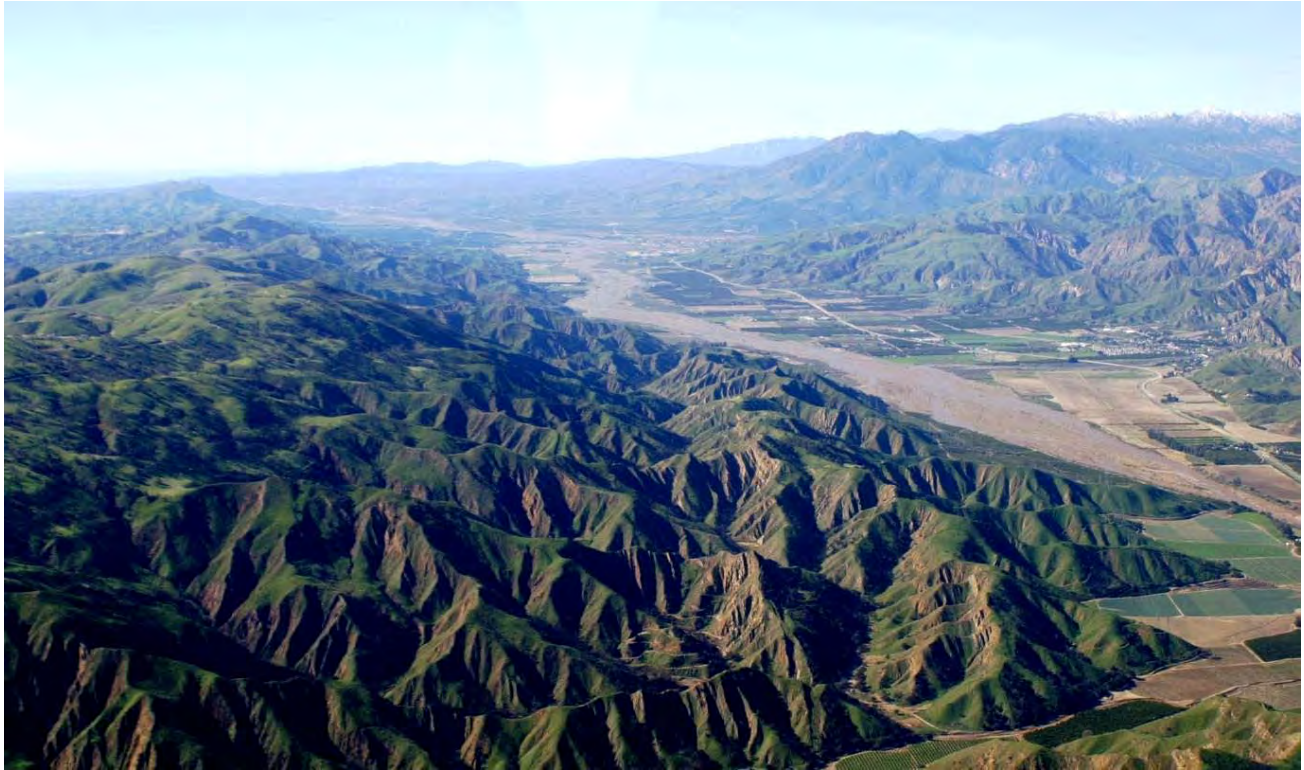
Figure 4-2. January 2005 view of the Santa Susana Mountains (left and foreground) and Santa Clara River near the confluence of Piru Creek (downstream, westward view). Slopes in the watershed exhibit numerous landslide scars, including many that span entire hillslope lengths, from ridgetops to channel bottoms. Note snow capped peaks at upper right. (Photo courtesy of the California Coastal Conservancy)

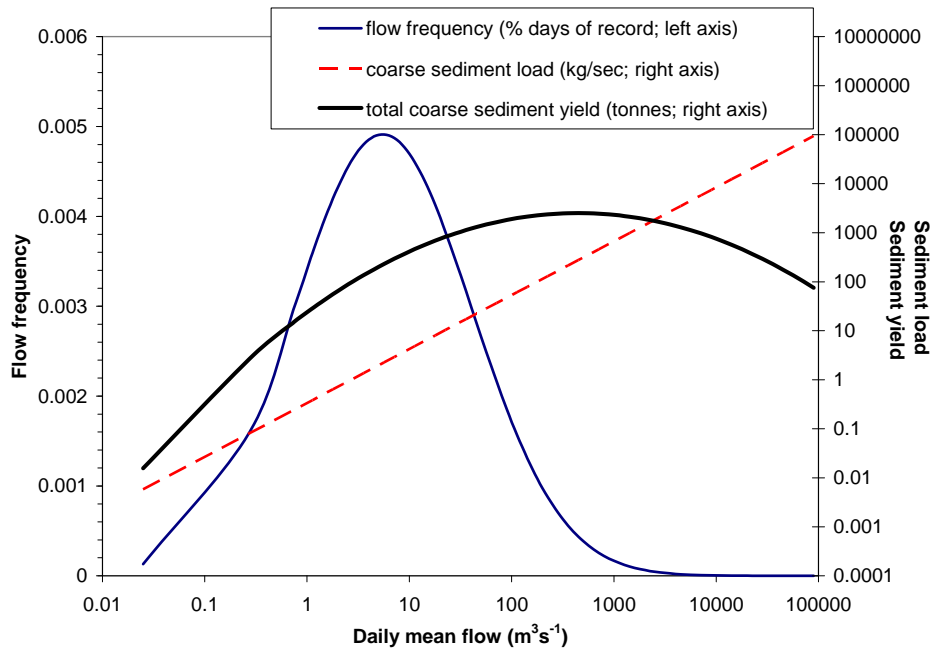
Figure 5-1. Flow frequency (left axis, scaled to 1) and sediment load (right axis) plotted against flow, showing conceptual, dominant discharge model of Wolman and Miller (1960). Blue line tracks flow frequency (for mean daily flow), red line tracks sediment transport rate (in tons/day) and black line tracks total sediment load (in tons). Sediment load increases to a maximum at an intermediate flow.

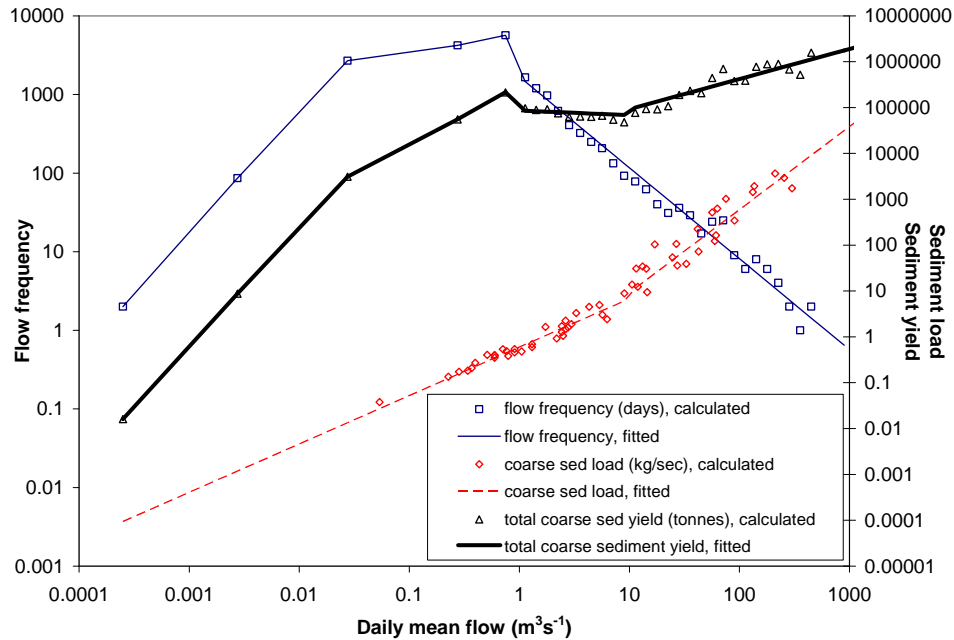
Figure 5-3. Flow frequency and coarse sediment load (right axis) as functions of daily mean flow for the Santa Clara River at the Los Angeles/Ventura County line (USGS11108500).

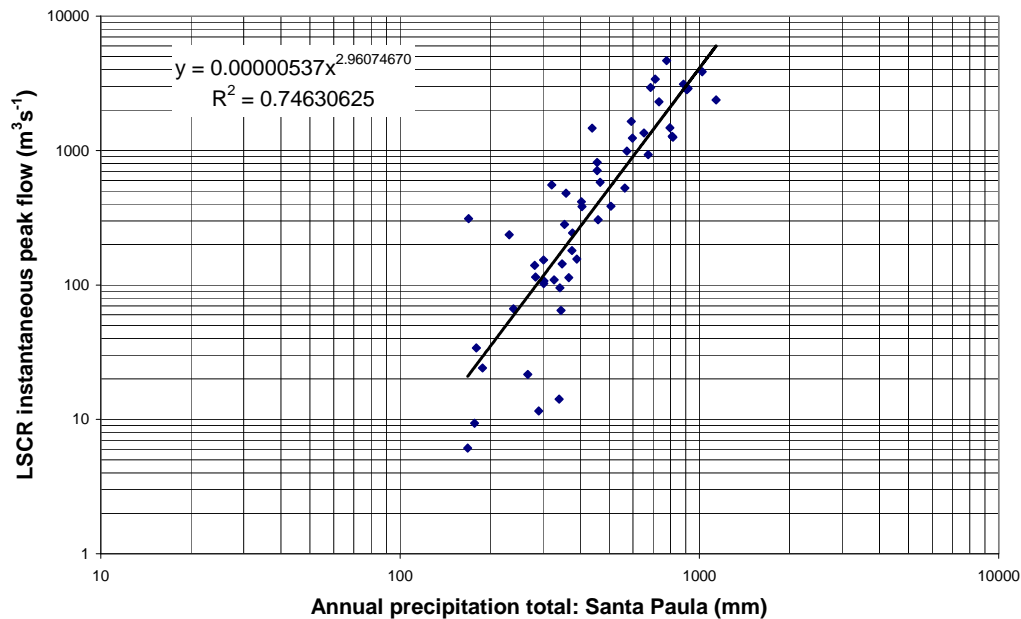
Figure 5-6. Relationship between annual precipitation totals in Santa Paula (VCWPD11113500) and annual maximum instantaneous flood peaks recorded in the lower Santa Clara River at Montalvo (USGS11114000).

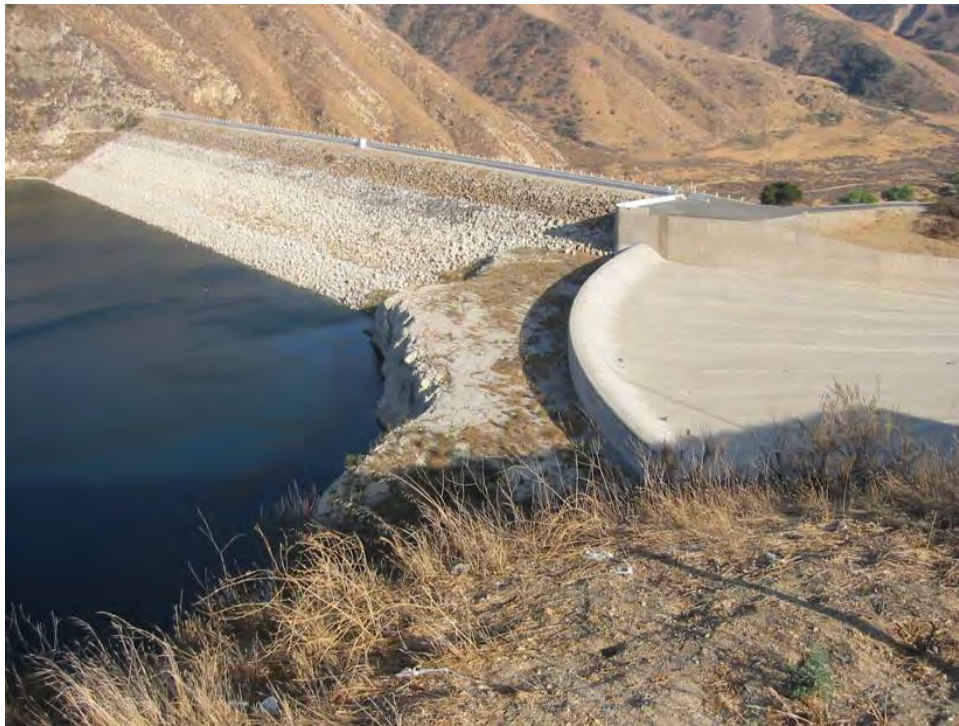
Figure 5-7. Santa Felicia Dam, looking downstream. (Photo by Stillwater Sciences)

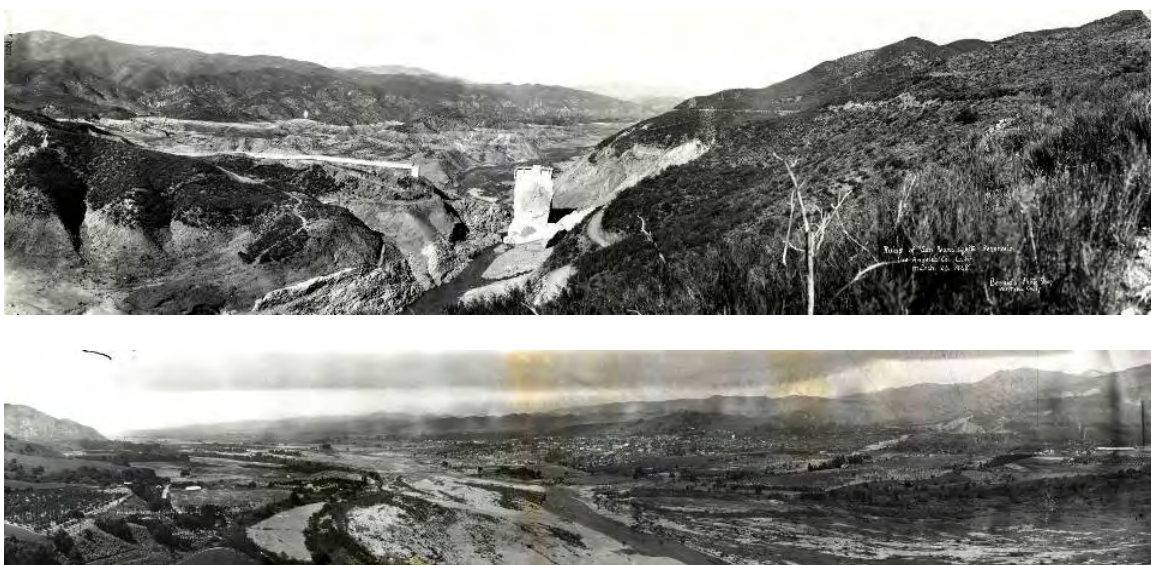
Figure 5-8. The remains of the Saint Francis Dam after collapsing just before midnight on March 12, 1928, in the San Francisquito subwatershed (above). Below, a downstream view of the mainstem Santa Clara River near Santa Paula Creek, the day after the Saint Francis Dam break flood. Photos courtesy of the Ventura County Watershed Protection District.

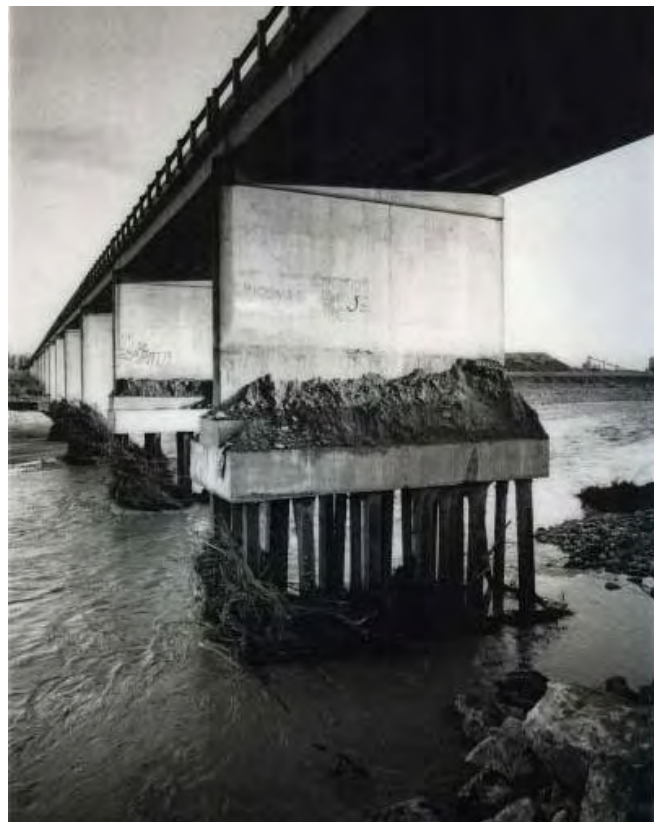
Figure 5-10. Undercutting of the Highway 118 bridge over the Santa Clara River as a result of incision following the 1969 floods. (Photo courtesy of the Ventura County Watershed Protection District)

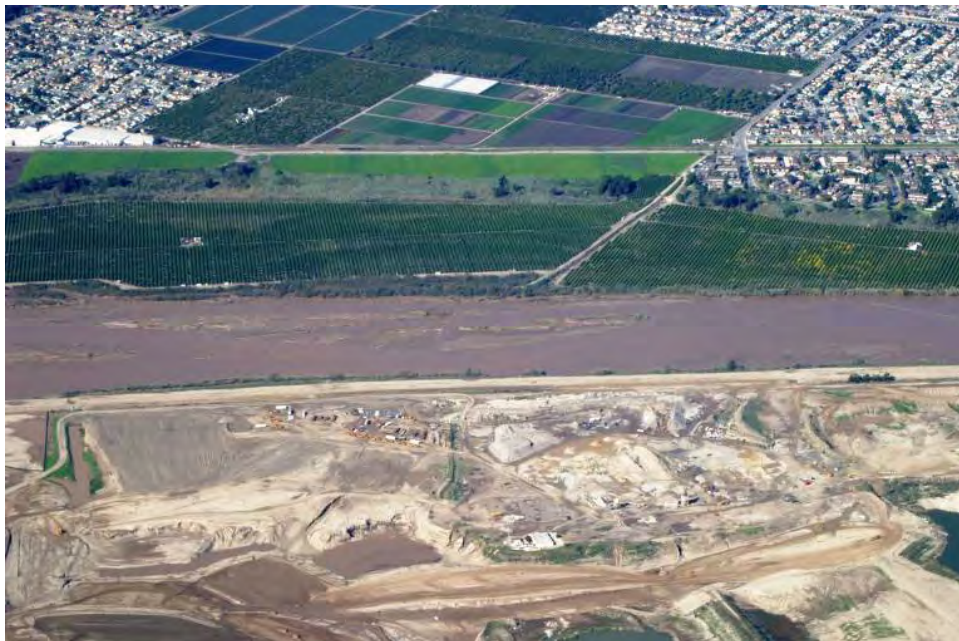
Figure 5-11. View across the Santa Clara River in Reach 2 (near Saticoy) on the lower Santa Clara River showing the 1961 Army Corps of Engineers levee (left bank) during the recession of the 2005 flood. Active floodplain aggregate mining in the foreground. (Photo courtesy of the California State Coastal Conservancy)

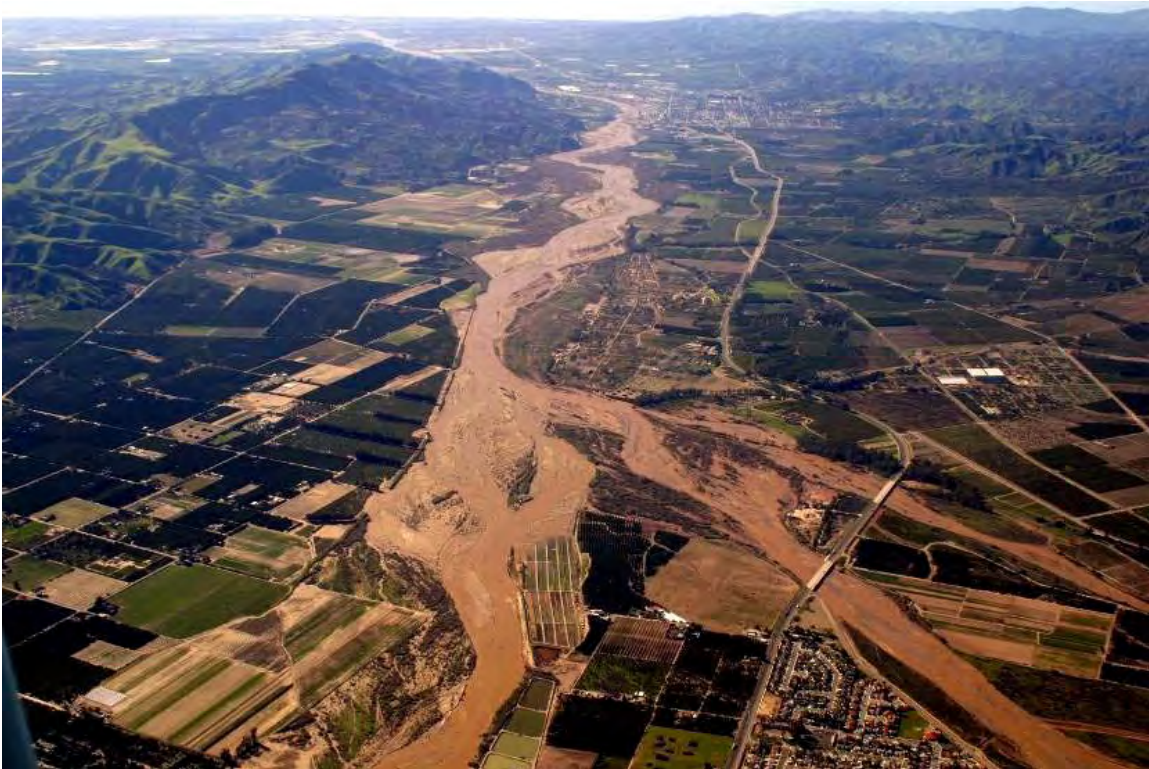
Figure 5-13. Westward, downstream view of the Sespe Creek confluence (two channels entering from right) following the January 2005 flood. South Mountain is in the upper left of photo. (Photo courtesy of the California Coastal Conservancy)

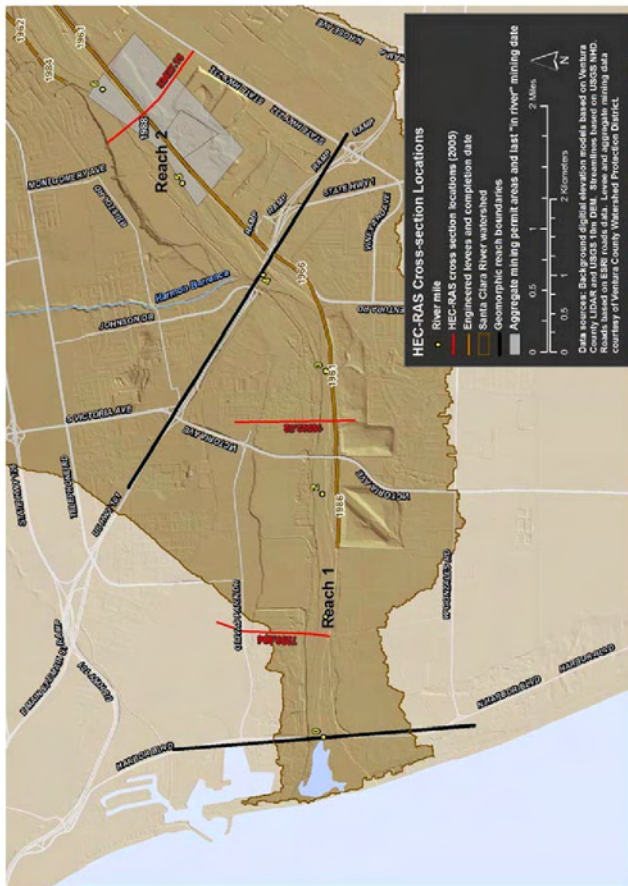
Figure 5-21. Planform, typical cross-sections and indicative photographs by reach. Cross-sections derived from HEC-RAS analysis (URS, 2006). Photographs taken January 12, 2005 during recession of January 10, 2005 flood (peak flow $3,850 \text{ m}^3 \text{ s}^{-1}$). (Photographs courtesy of California Coastal Conservancy)

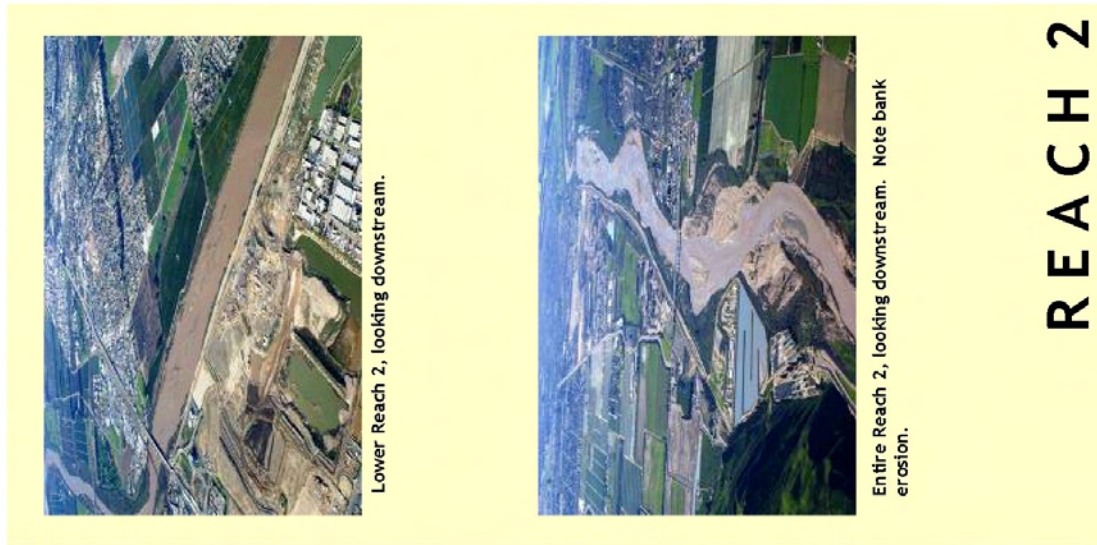
Figure 5-21. Planform, typical cross-sections and indicative photographs by reach. Cross-sections derived from HEC-RAS analysis (URS, 2006). Photographs taken January 12, 2005 during recession of January 10, 2005 flood (peak flow $3,850 \text{ m}^3 \text{ s}^{-1}$). (Photographs courtesy of California Coastal Conservancy)

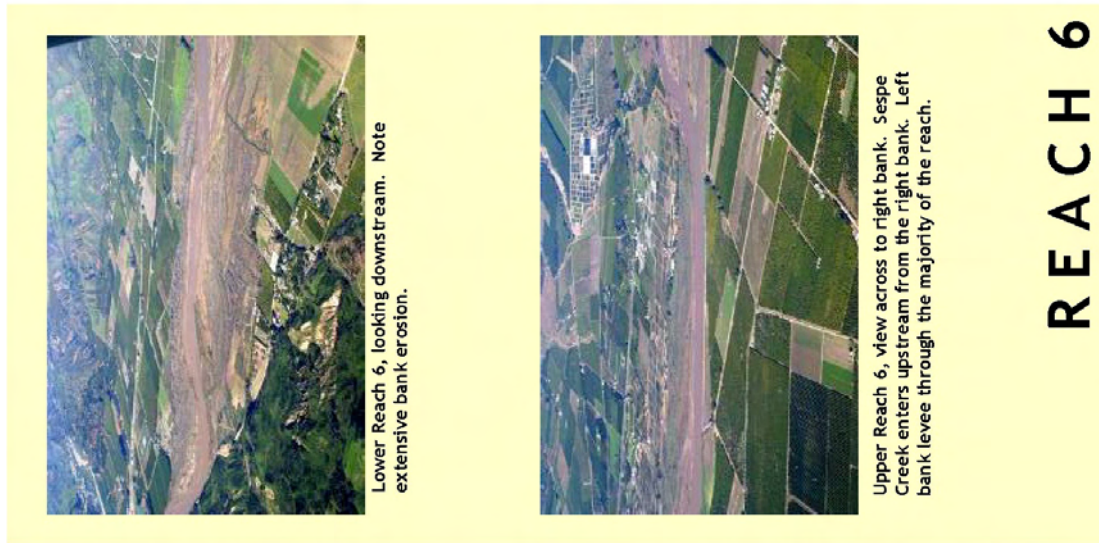
Figure 5-21. Planform, typical cross-sections and indicative photographs by reach. Cross-sections derived from HEC-RAS analysis (URS, 2006). Photographs taken January 12, 2005 during recession of January 10, 2005 flood (peak flow $3,850 \text{ m}^3 \text{ s}^{-1}$). (Photographs courtesy of California Coastal Conservancy)

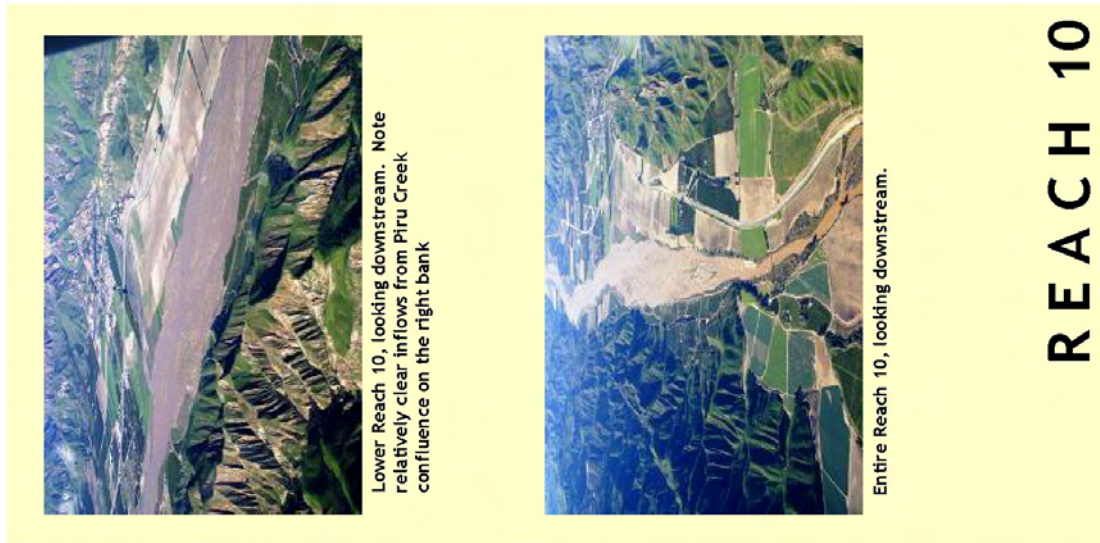
Figure 5-21. Planform, typical cross-sections and indicative photographs by reach. Cross-sections derived from HEC-RAS analysis (URS, 2006). Photographs taken January 12, 2005 during recession of January 10, 2005 flood (peak flow $3,850 \text{ m}^3 \text{ s}^{-1}$). (Photographs courtesy of California Coastal Conservancy)

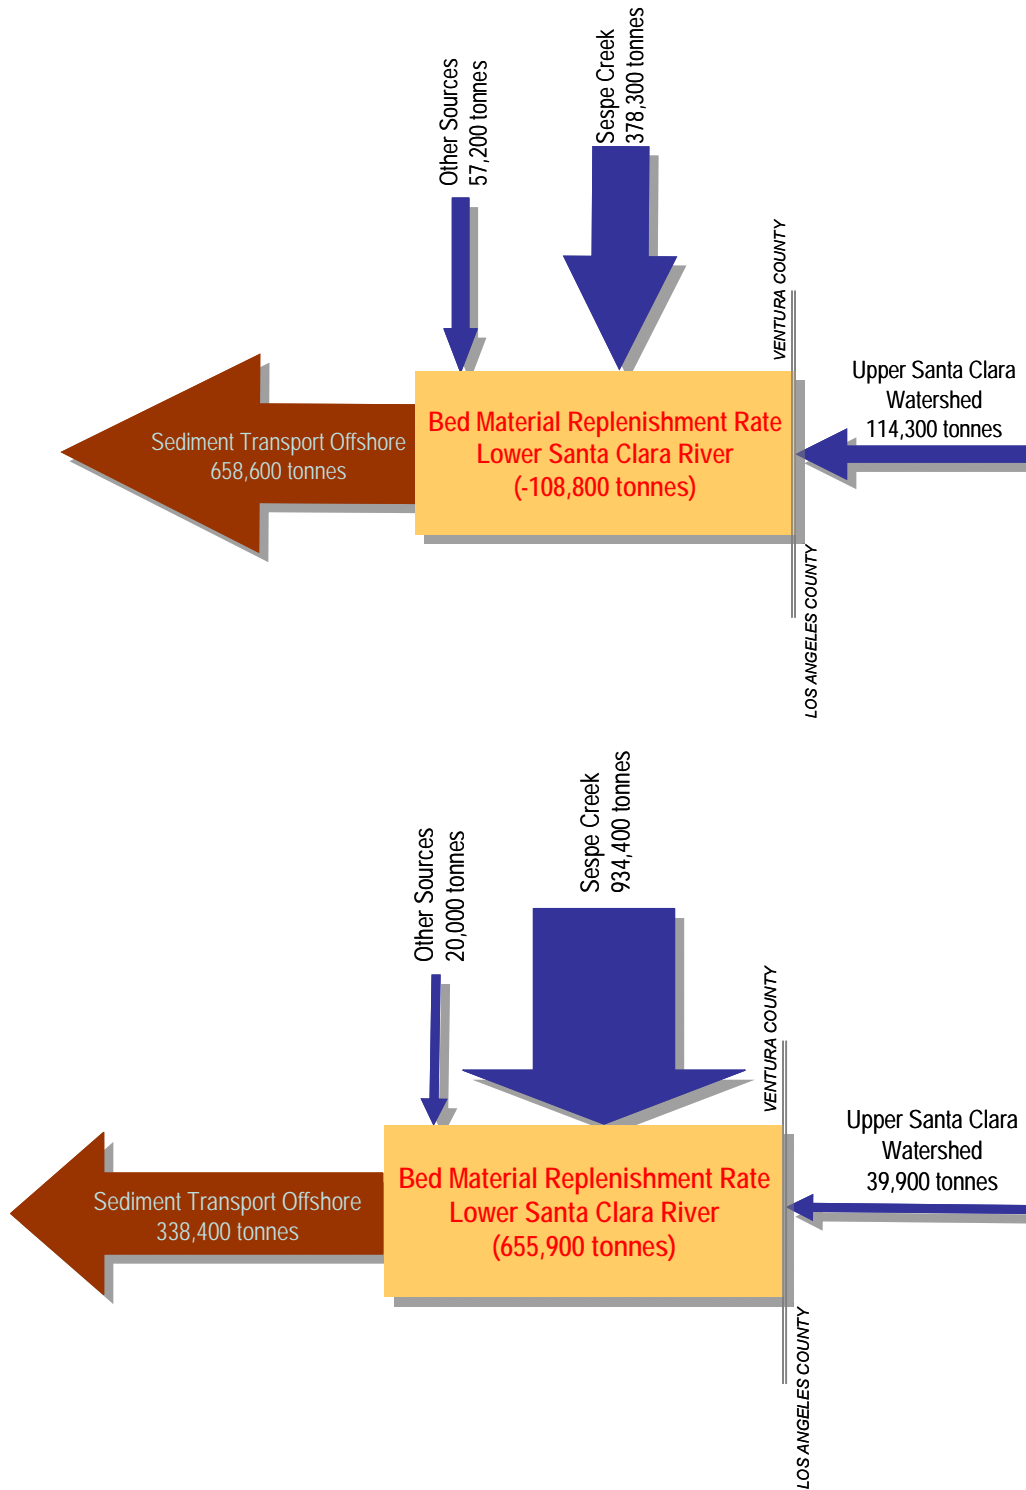
Figure 5-22. Illustration of the conceptual model of sediment transport dynamics within the lower Santa Clara River presented in Simons, Li & Associates (1983). Case A demonstrates a degradational (incision) event, based on the Simons, Li & Associates (1983) analysis of data from the January 25, 1969 flood. Case B shows an aggradational event based on their analysis of data from the February 10, 1978 flood.

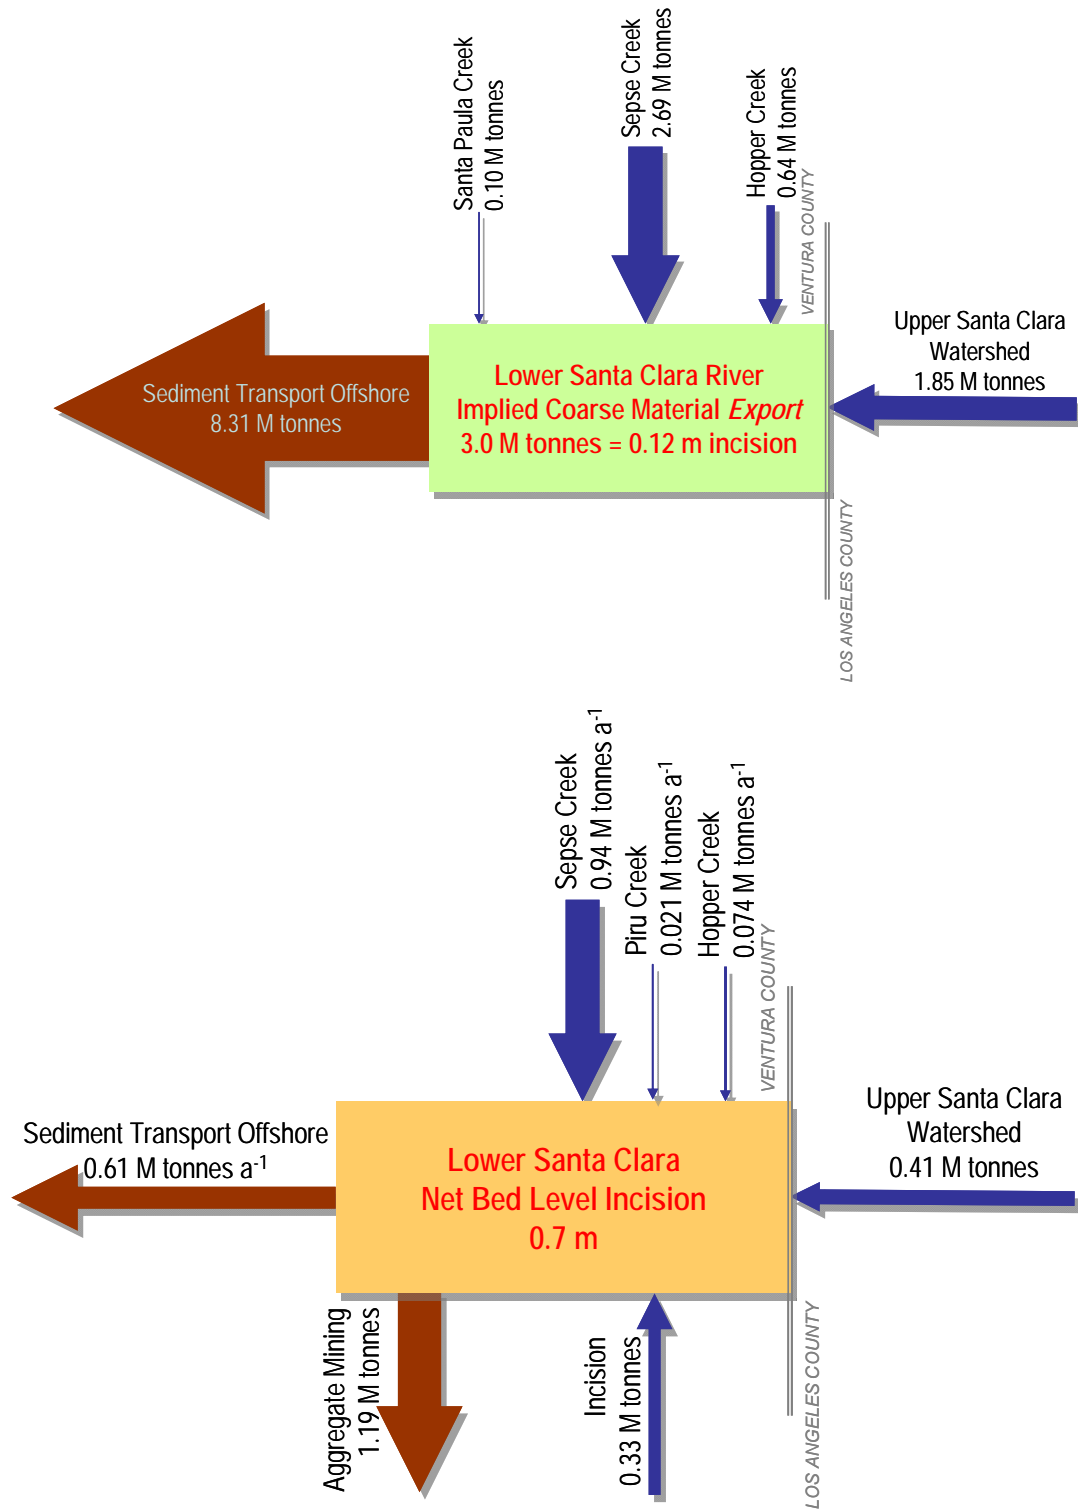
Figure 5-24. Case A: Integration of storm based sediment budgets based the largest recorded flood events only (data in Table 5-16). Net incision implied for the LSCR is 0.12 m whereas from bed elevation records, net incision is 0.7 m. Case B: Sediment including an estimate of sediment removed directly by aggregate mining (scenario A in Table 5-18) resulting in very close agreement between sediment inputs and outputs.

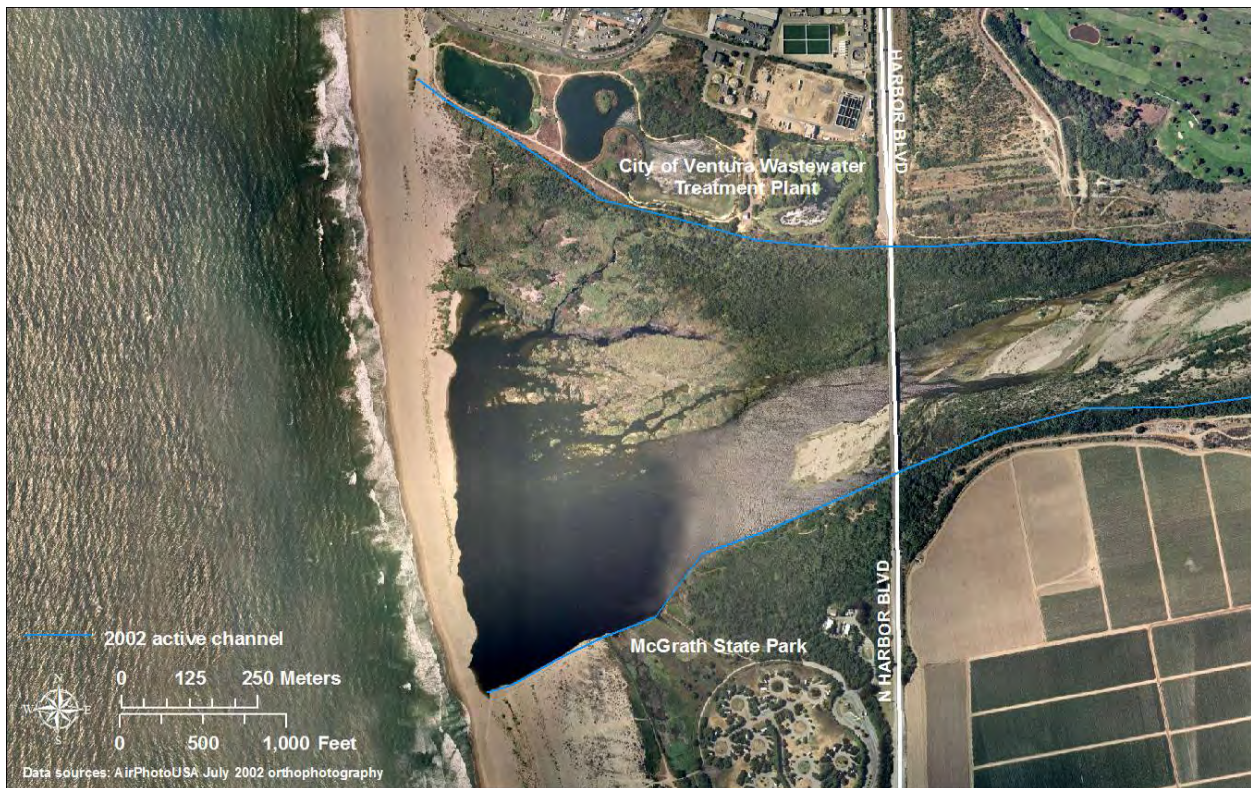
Figure 6-9. Approximate active channel extent in July 2002. (Photo courtesy of California Coastal Conservancy)

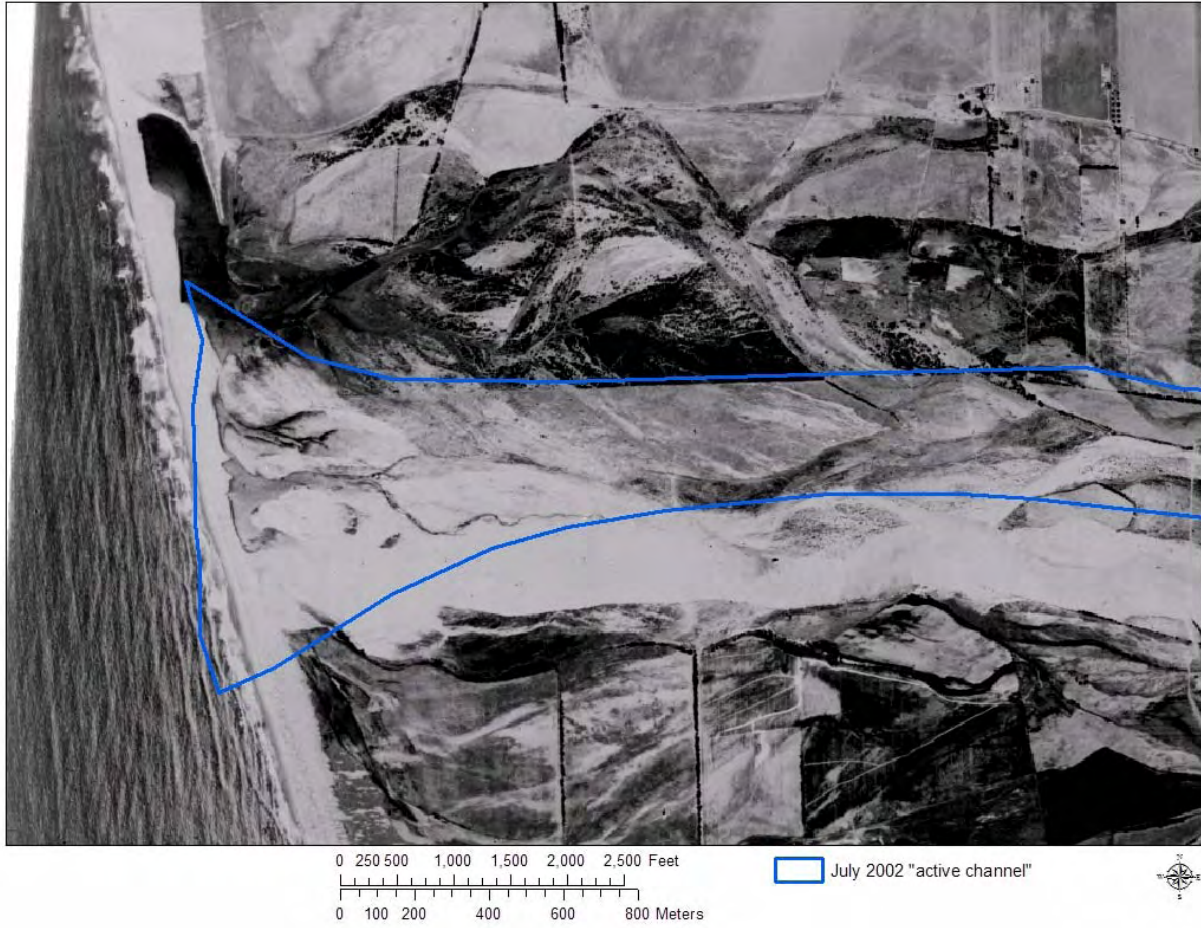
Figure G-2. Approximate 2002 active channel and estuary extent compared to 1927 conditions (Source: California Coastal Conservancy).
