SESPE CREEK HYDROLOGY, HYDRAULICS, AND  
SEDIMENTATION ANALYSIS:

## Watershed Assessment of Hillslope and River Geomorphic Processes

**FINAL REPORT**  
April 2010

*Prepared by*  
Stillwater Sciences  
2855 Telegraph Avenue, Suite 400  
Berkeley, CA 94705

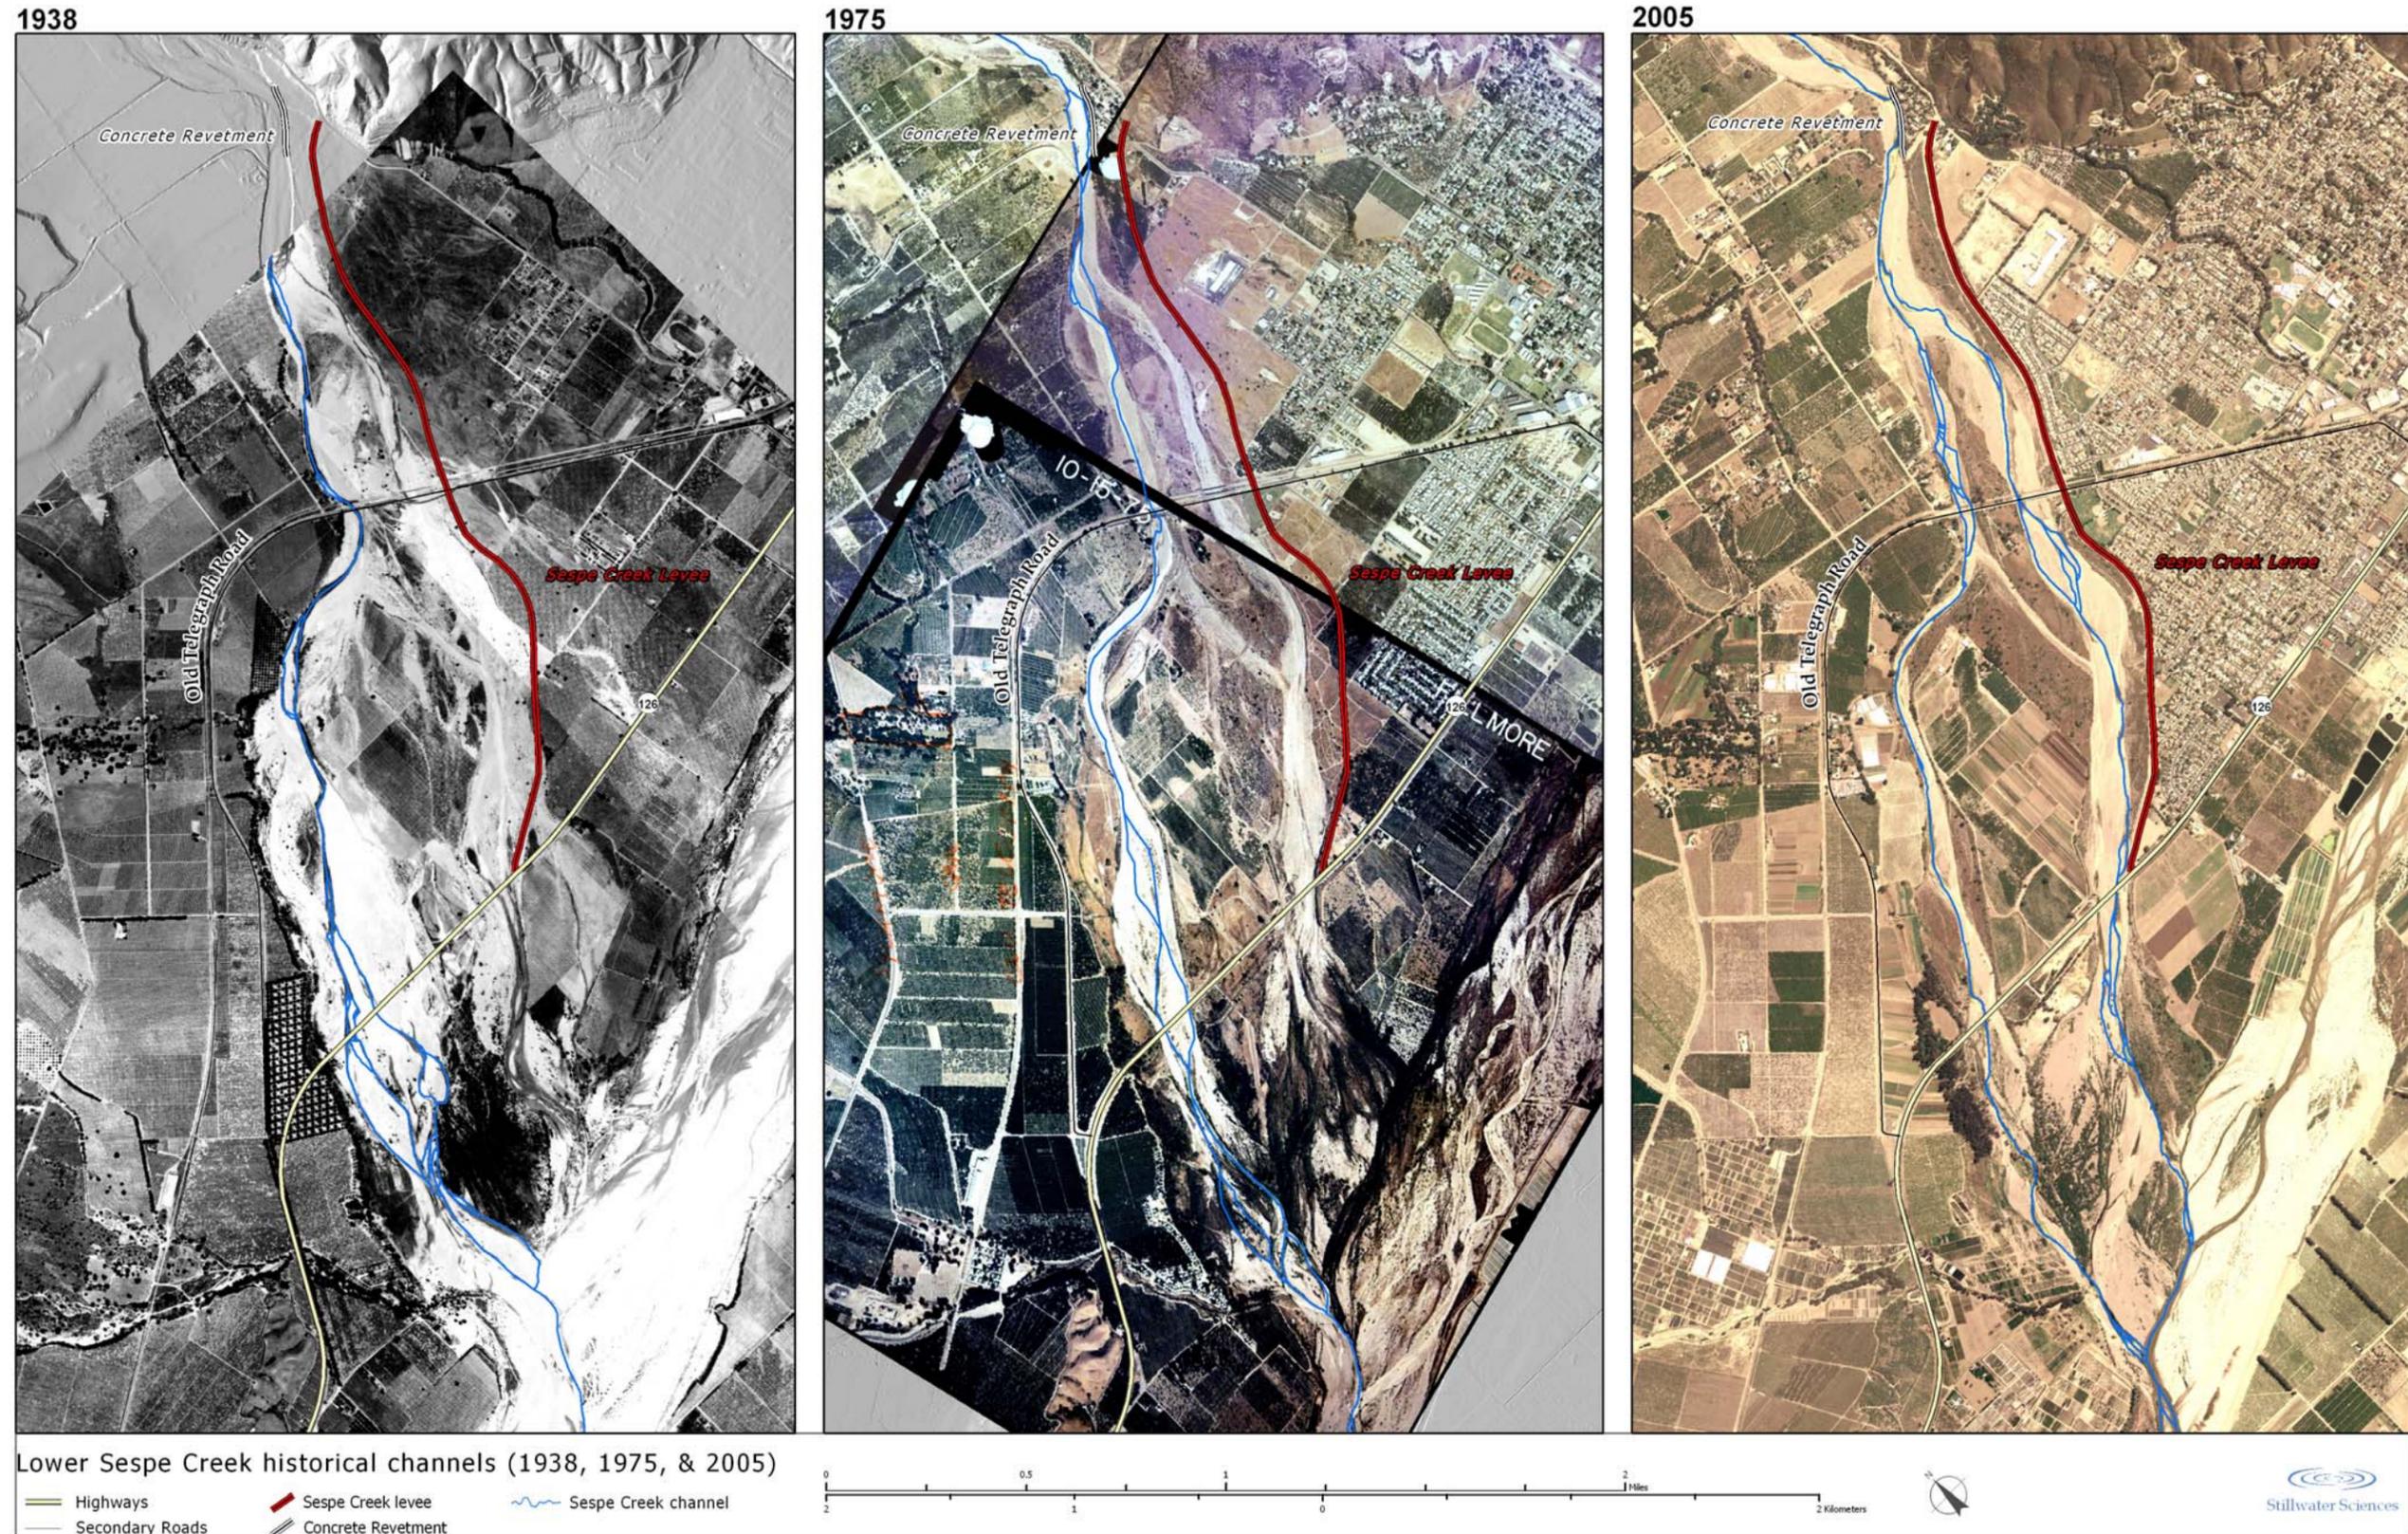
Figure 1-7. City of Fillmore and lower Sespe Creek in 1938, 1975, and 2005 showing the Sespe Creek Levee (constructed 1981), concrete revetment at Lookout Point, and terraces.

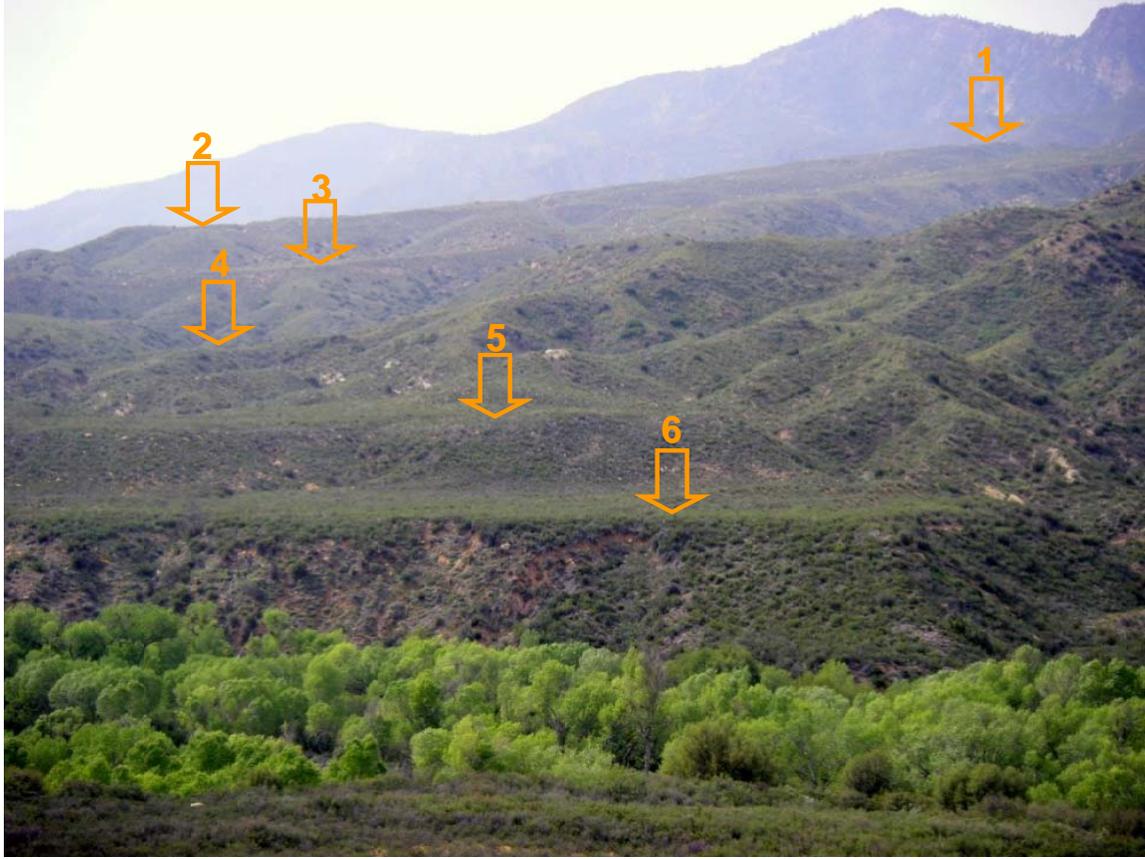
Figure 2-3. A flight of at least six uplifted terraces on the south side of Sespe Creek upstream of Piedra Blanca Creek. The lowest, youngest terrace (#6) is 40 m above the modern channel; the oldest (#1) is about 400 m above the channel and thus may be approximately 100,000 years old.

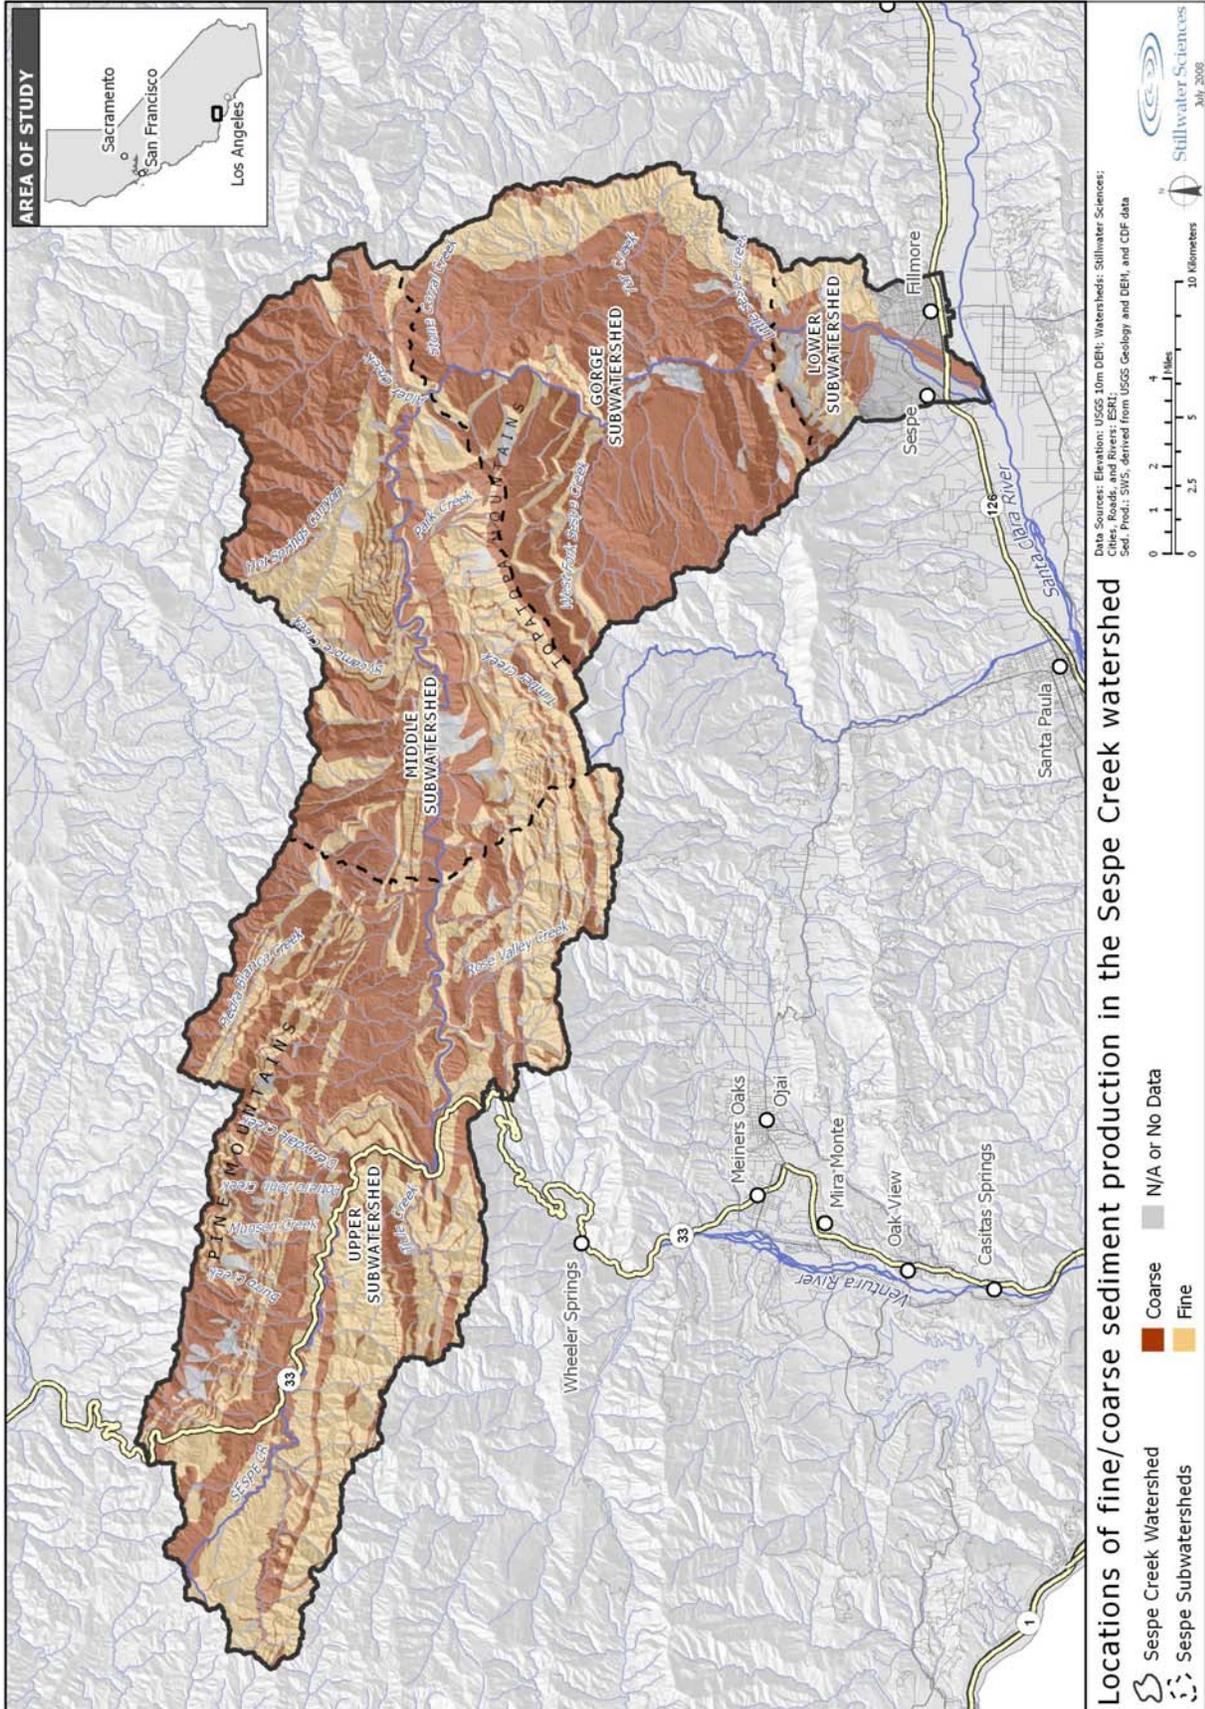
Figure 2-4. Generalized distribution of coarse-grained and fine-grained rocks across the Sespe Creek watershed.

Rock types were based on the 1:24,000-scale geologic maps of Dibblee (various; Figure 1-3). Following our approach for Santa Paula Creek, mapped units were grouped into categories of fine (shale) and coarse (sandstone and granite) (Figure 2-4), reflecting their likelihood of producing coarse sandstone blocks. Unconsolidated Quaternary deposits, exclusively modern river gravels (3.8% of the watershed area) and uplifted fluvial terraces (e.g., Figure 2-3; 3.6% by area), were considered “coarse” for purposes of this division, reflecting the observed abundance of cobbles and boulders in them. Qualitatively, the Miocene and Pliocene shaley rocks of the Pico, Caliente, Santa Margarita, Monterey, and Rincon Formations displayed greater erosivity than the older shales of the Cozy Dell and Juncal Formations, particularly on very steep slopes, but this distinction was not made across the watershed because the younger shales occupy only a few percent of the watershed as a whole.

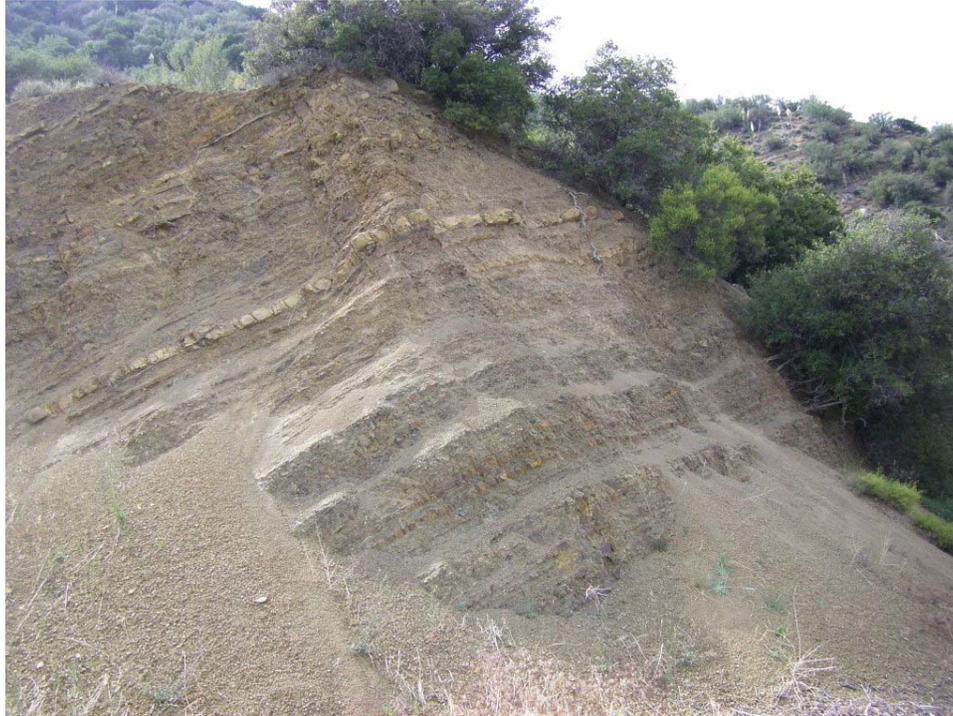
Figure 2-5. Typical exposure of thin-bedded shale of the Cozy Dell Formation.

Instead, the largest contributors of fine sediment in the Sespe Creek watershed comprise thin-bedded shaley rocks, particularly in the Juncal, Cozy Dell, and Rincon formations, which cover slightly more than one-third of the watershed area (Figure 2-5). Elsewhere in the watershed, the Eocene-age Cozy Dell Shale (about 42 million years old [Prothero 2001]) and slightly older fine-grained facies of the Matilija and Juncal formations crop out from elevations of about 330 m (1,100 ft) up to more than 1,800 m (6,000 ft). Although many millions of years older than the Saugus and Pico formations and originally deposited in deep marine waters, these rocks now lie atop these younger rocks due to thrusting along the San Cayetano fault (and its subsidiaries). These rocks have been warped into a broad east–west syncline (i.e., a trough), whose north and south limbs form the broad boundaries of the Upper and Middle subwatersheds. Although clearly incised by the drainage network, the intensity of hillslope erosion on these older and typically

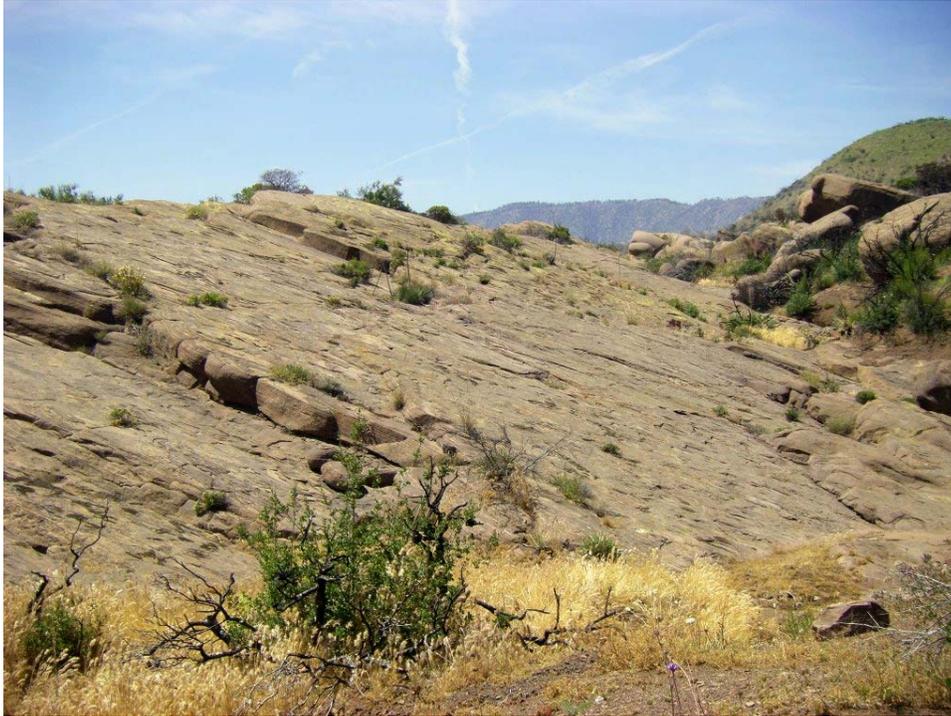
Figure 2-6. Sandstone bedding-plane surface of the Sespe Formation, east of the Sespe Creek gorge near the Dough Flat trailhead.

formations; Figure 2-6) but also locally present as interbeds in the shale-dominated deposits, are widespread throughout the watershed and underlie nearly one-half of its total area. Additional sources of coarse, durable rock include the granitic and gneissic rocks (6% of the watershed area), exposed in the northeast corner of the watershed, and both modern and old fluvial terraces largely composed of sandstone and granite cobbles and boulders (7% of the watershed area, of which about half is the modern river alluvium).

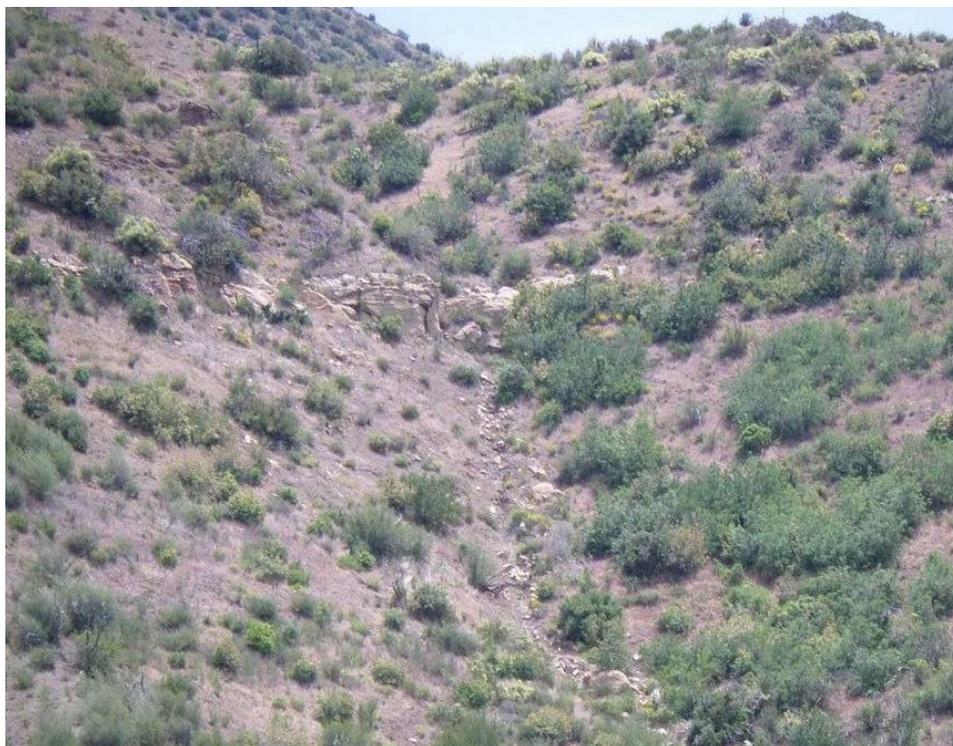
Figure 2-7. Example of the delivery of coarse sediment blocks into the channel network from the weathering of a single sandstone interbed.

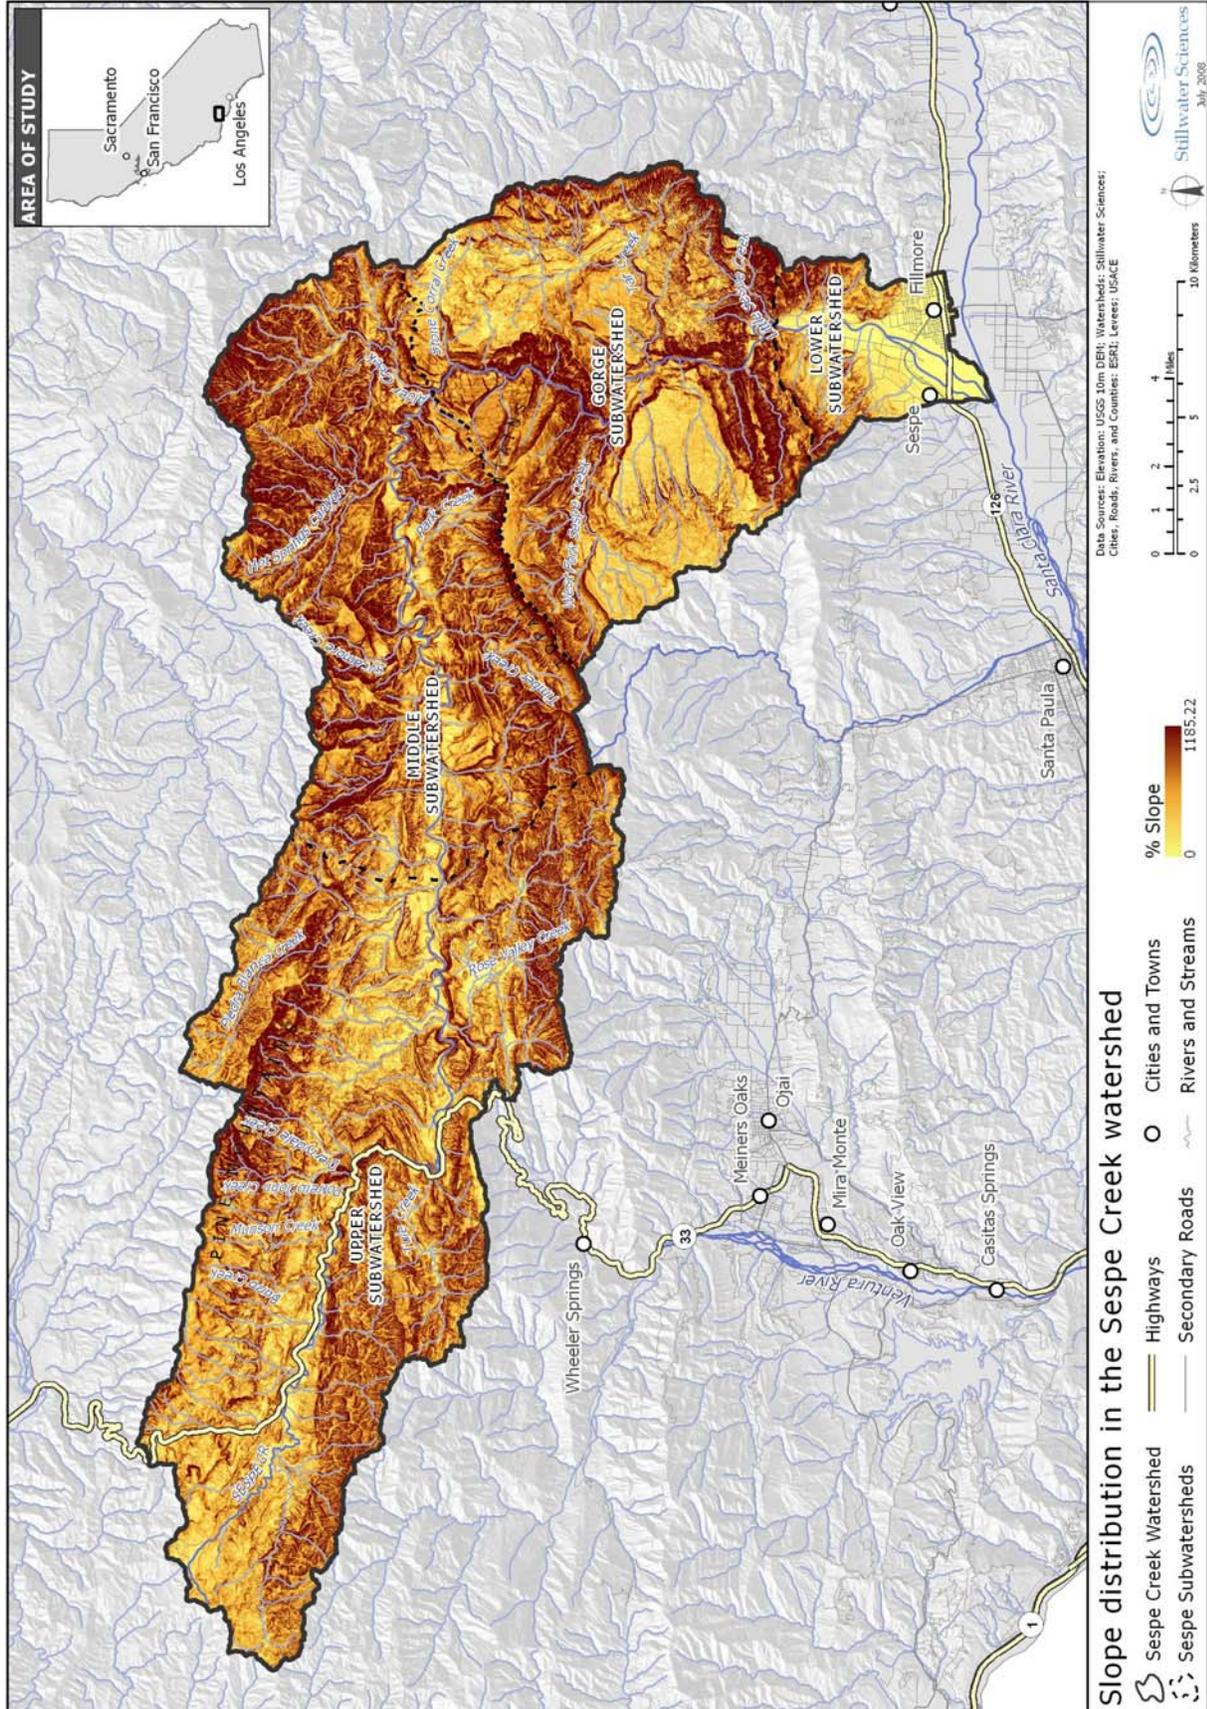
Figure 2-8. Hillslope gradient distribution in the Sespe Creek watershed.

Hillslope gradients were generated directly from the digital elevation model, which in turn was based on a USGS 10-m Digital Elevation Model (Figure 2-8). Based on observed ranges of relative erosion and slope instability, the continuous range of hillslope gradients was categorized into three groups: 0–20%, 20–60%, and steeper than 60%. These categories differed from those used in the Santa Paula Creek analysis (0–10%, 10–20%, >20%), because marked differences in erosion were not expressed on slopes as flat as 10%, and because over 84% of the Sespe Creek watershed is steeper than 20% and thus would provide little slope-based discrimination of sediment-production rates. The consequences of this change are very modest, as noted below.

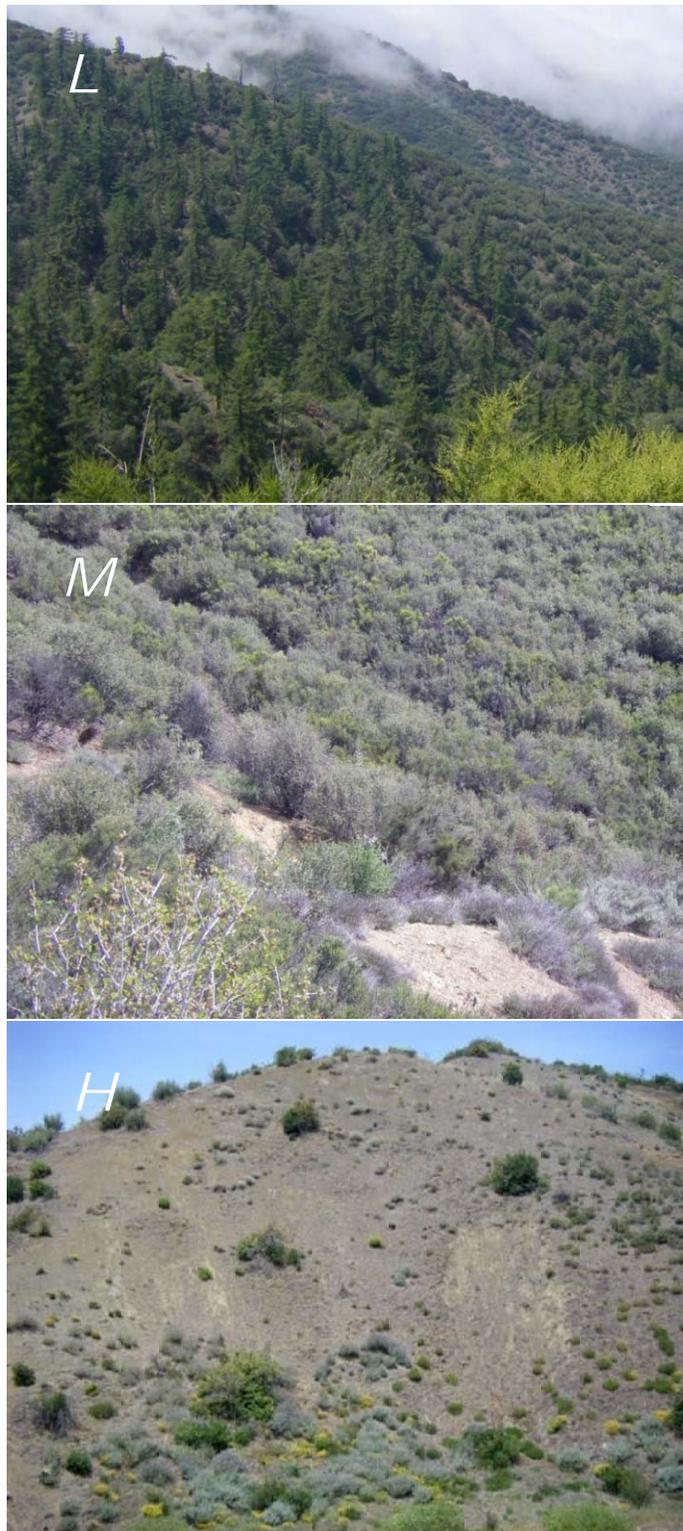
Figure 2-9. Examples of different geomorphic landscape units (GLUs) and their relative levels of sediment production. Top, sandstone forest 20-60%; middle, shale scrub 20-60%; bottom, shale ag/grass/bare >60%.

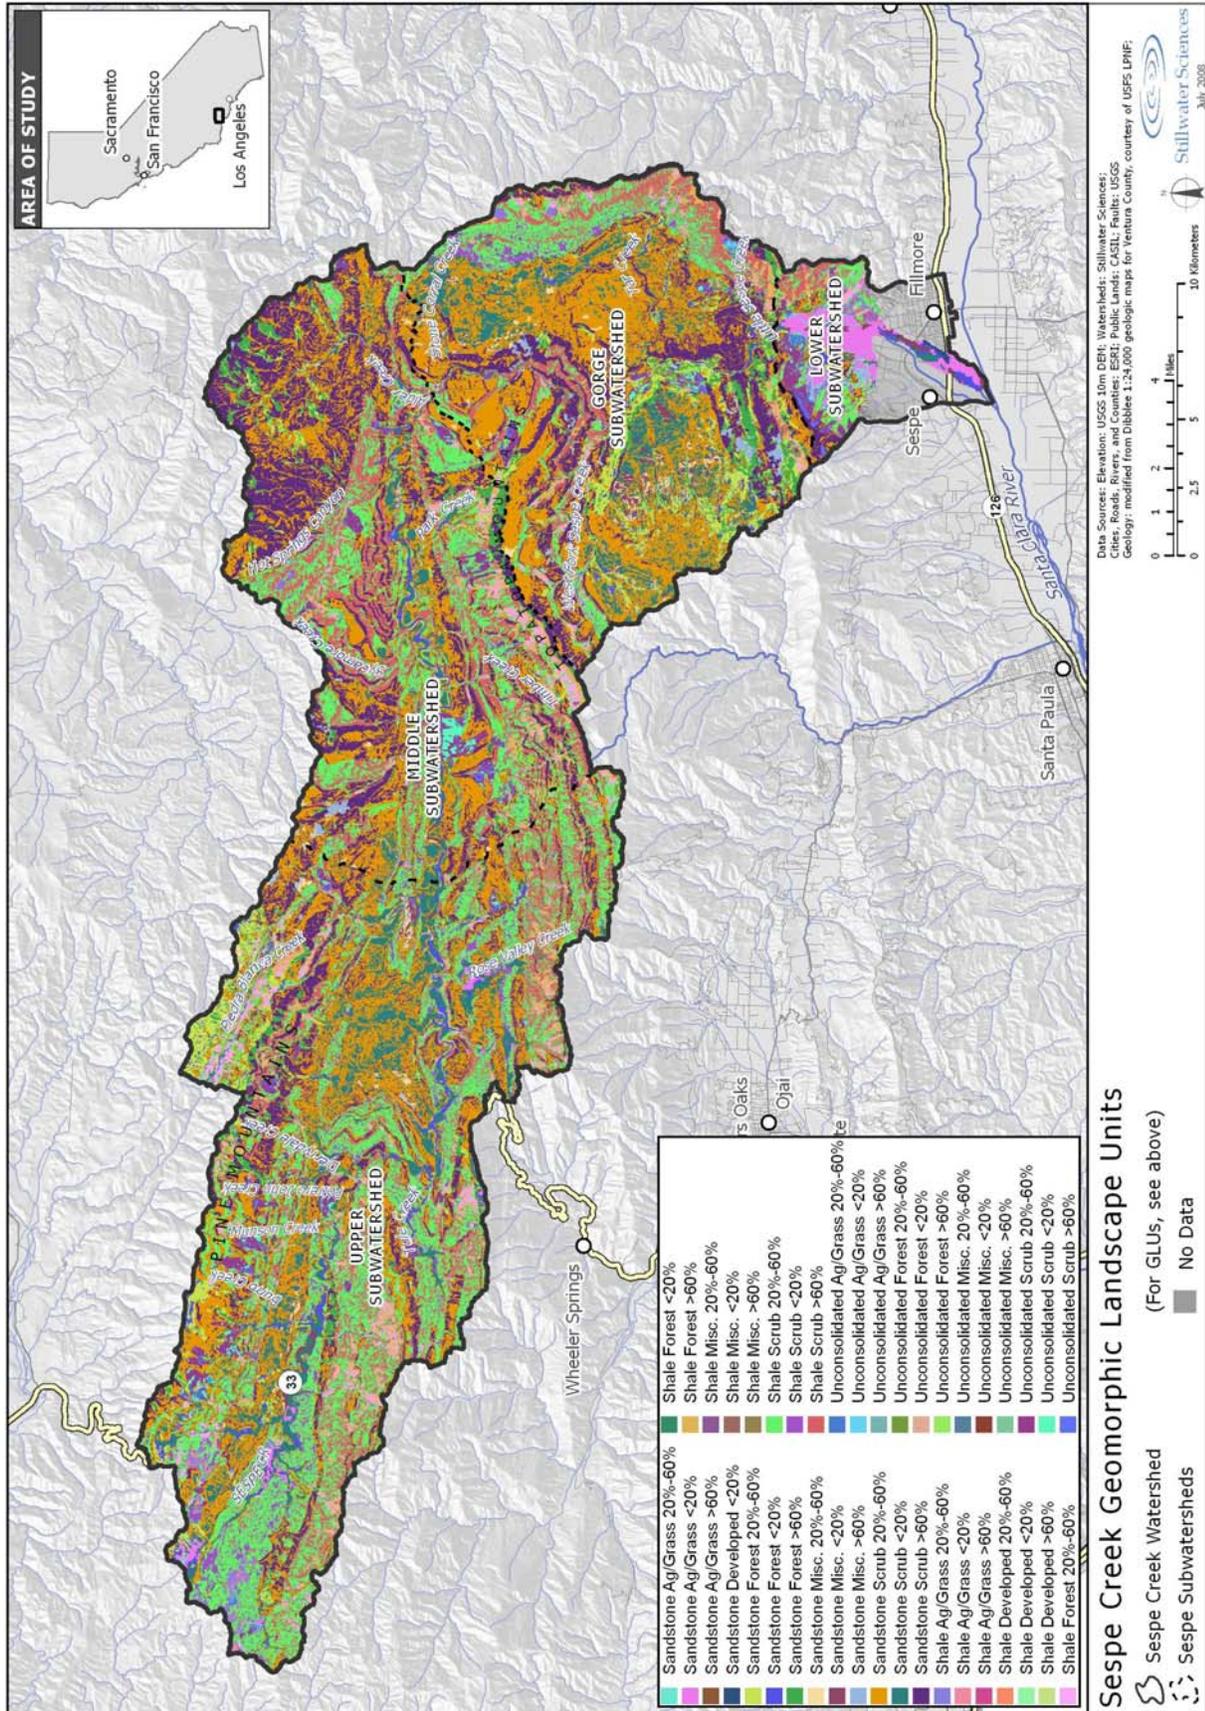
Figure 2-10. Geomorphic landscape units (GLUs) in the Sespe Creek watershed.

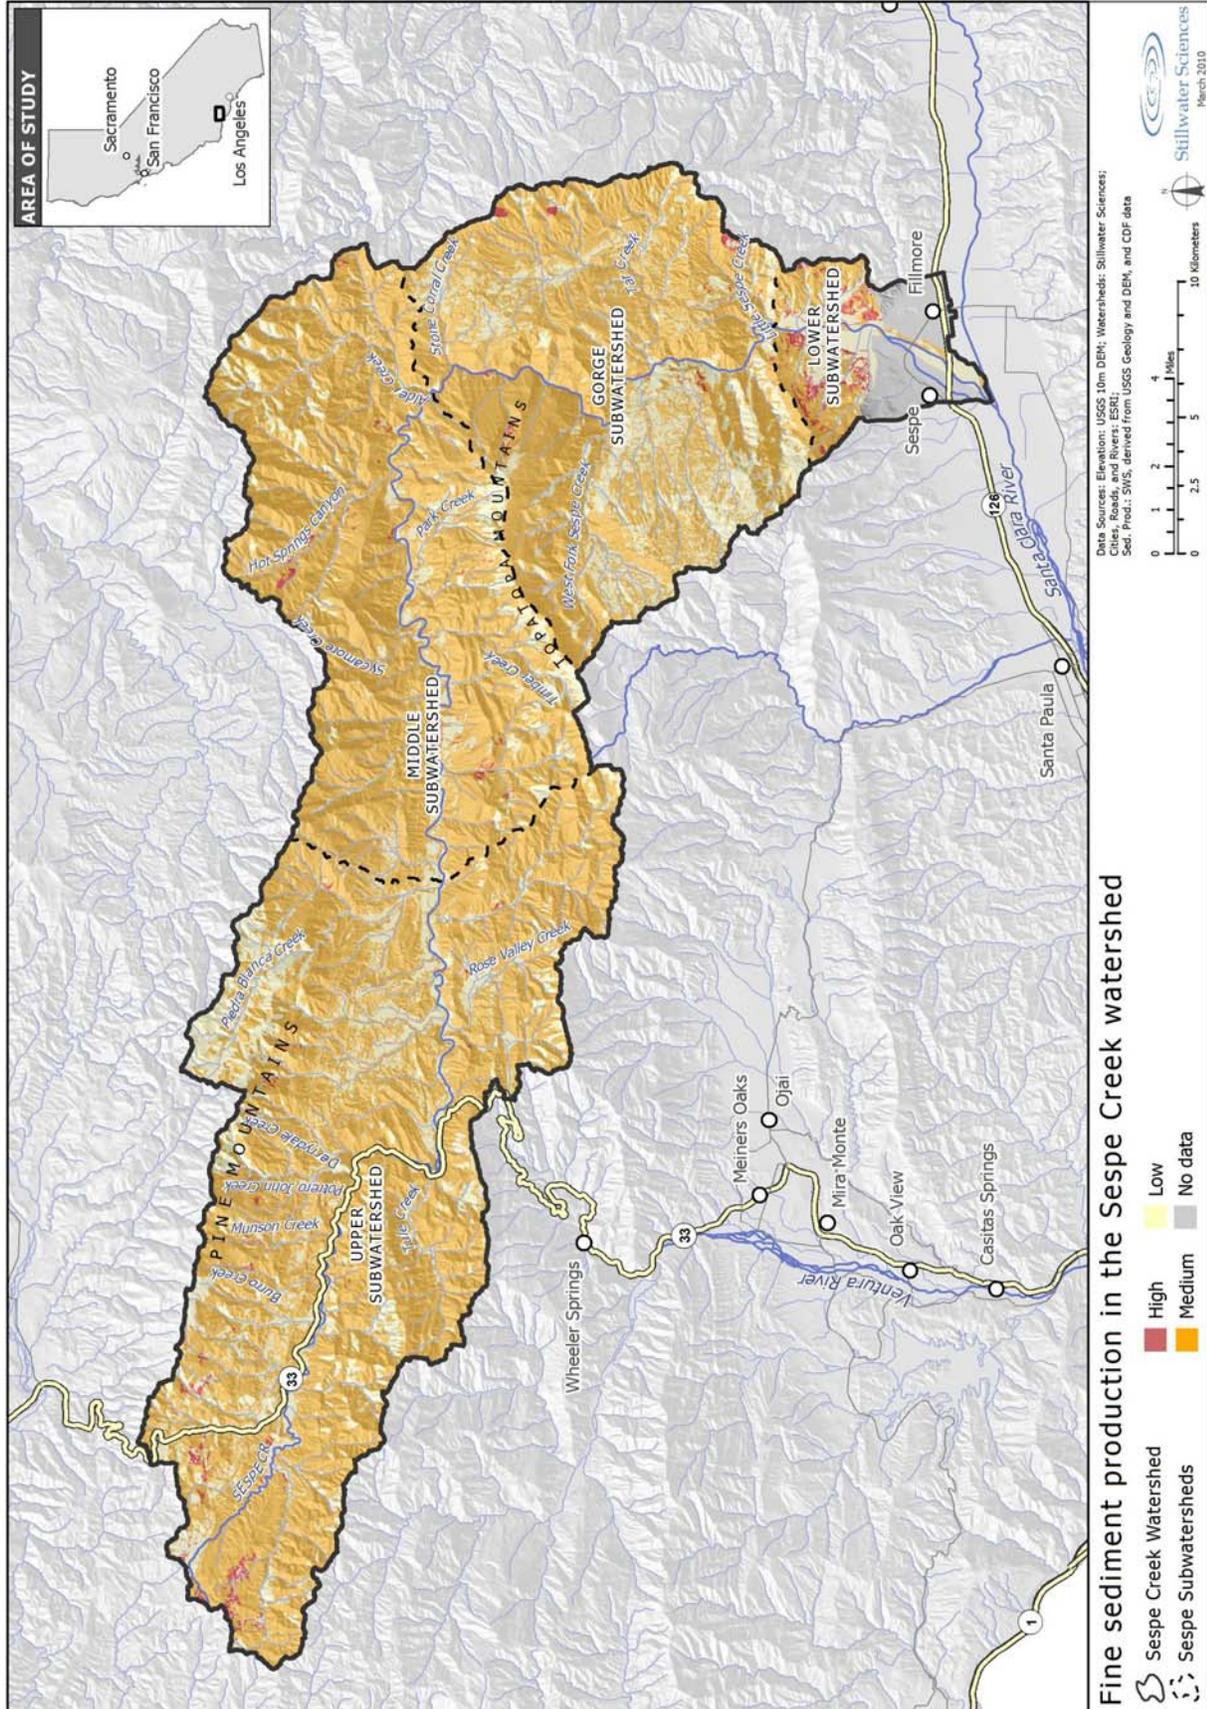
Figure 2-11. Predicted fine-sediment production in the Sespe Creek watershed.

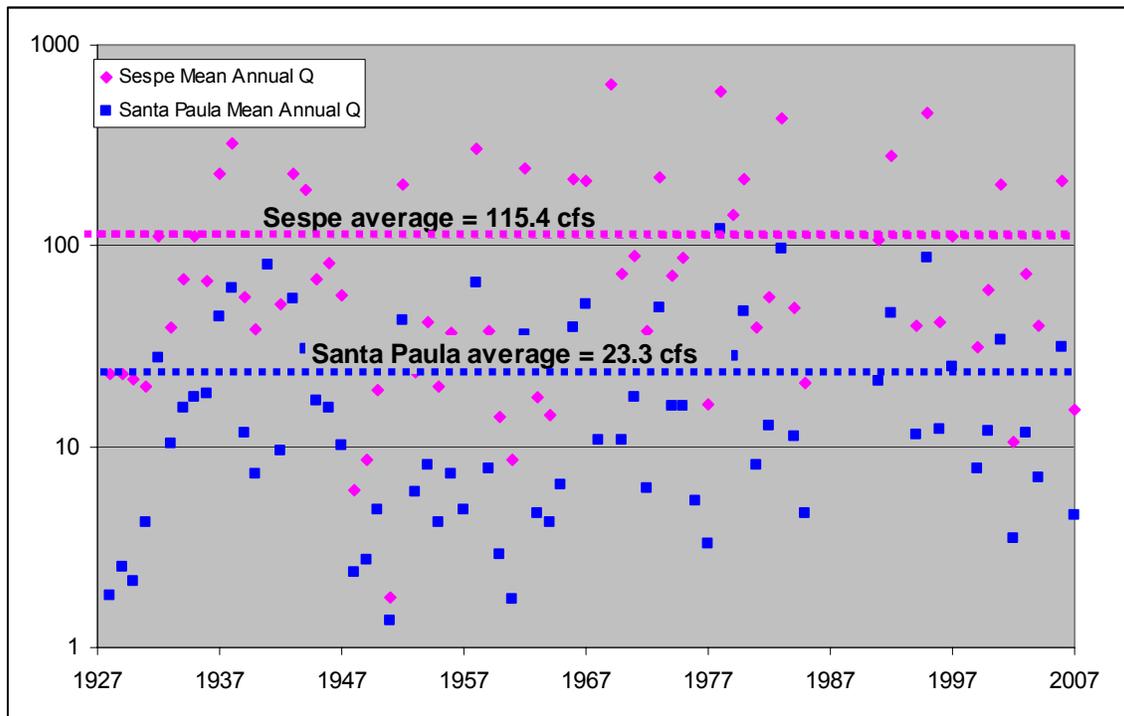
Figure 2-12. Mean average discharges for all years of coincident record at the USGS gages for Sespe Creek (11113000) and Santa Paula Creek (11113500). Although Sepse Creek drains 6.5 times the area of Santa Paula Creek, its discharge is only five times greater.

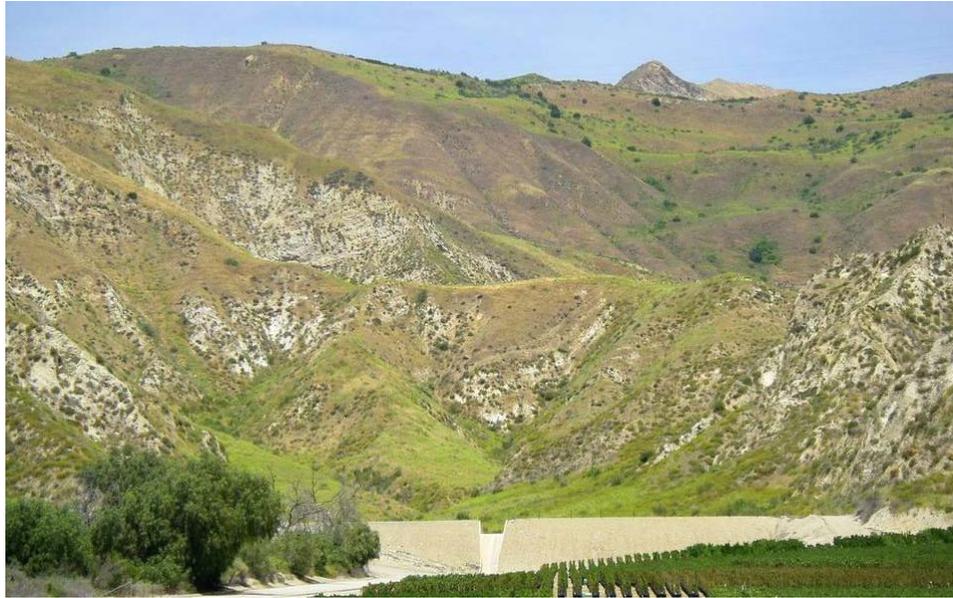
Figure 2-13. View of Real Wash debris basin located to the southeast of Hopper Creek watershed. This basin receives sediment from a steep, shrub-covered Miocene and Pliocene rock (GLU) terrain with an assigned sediment yield value of “High”.

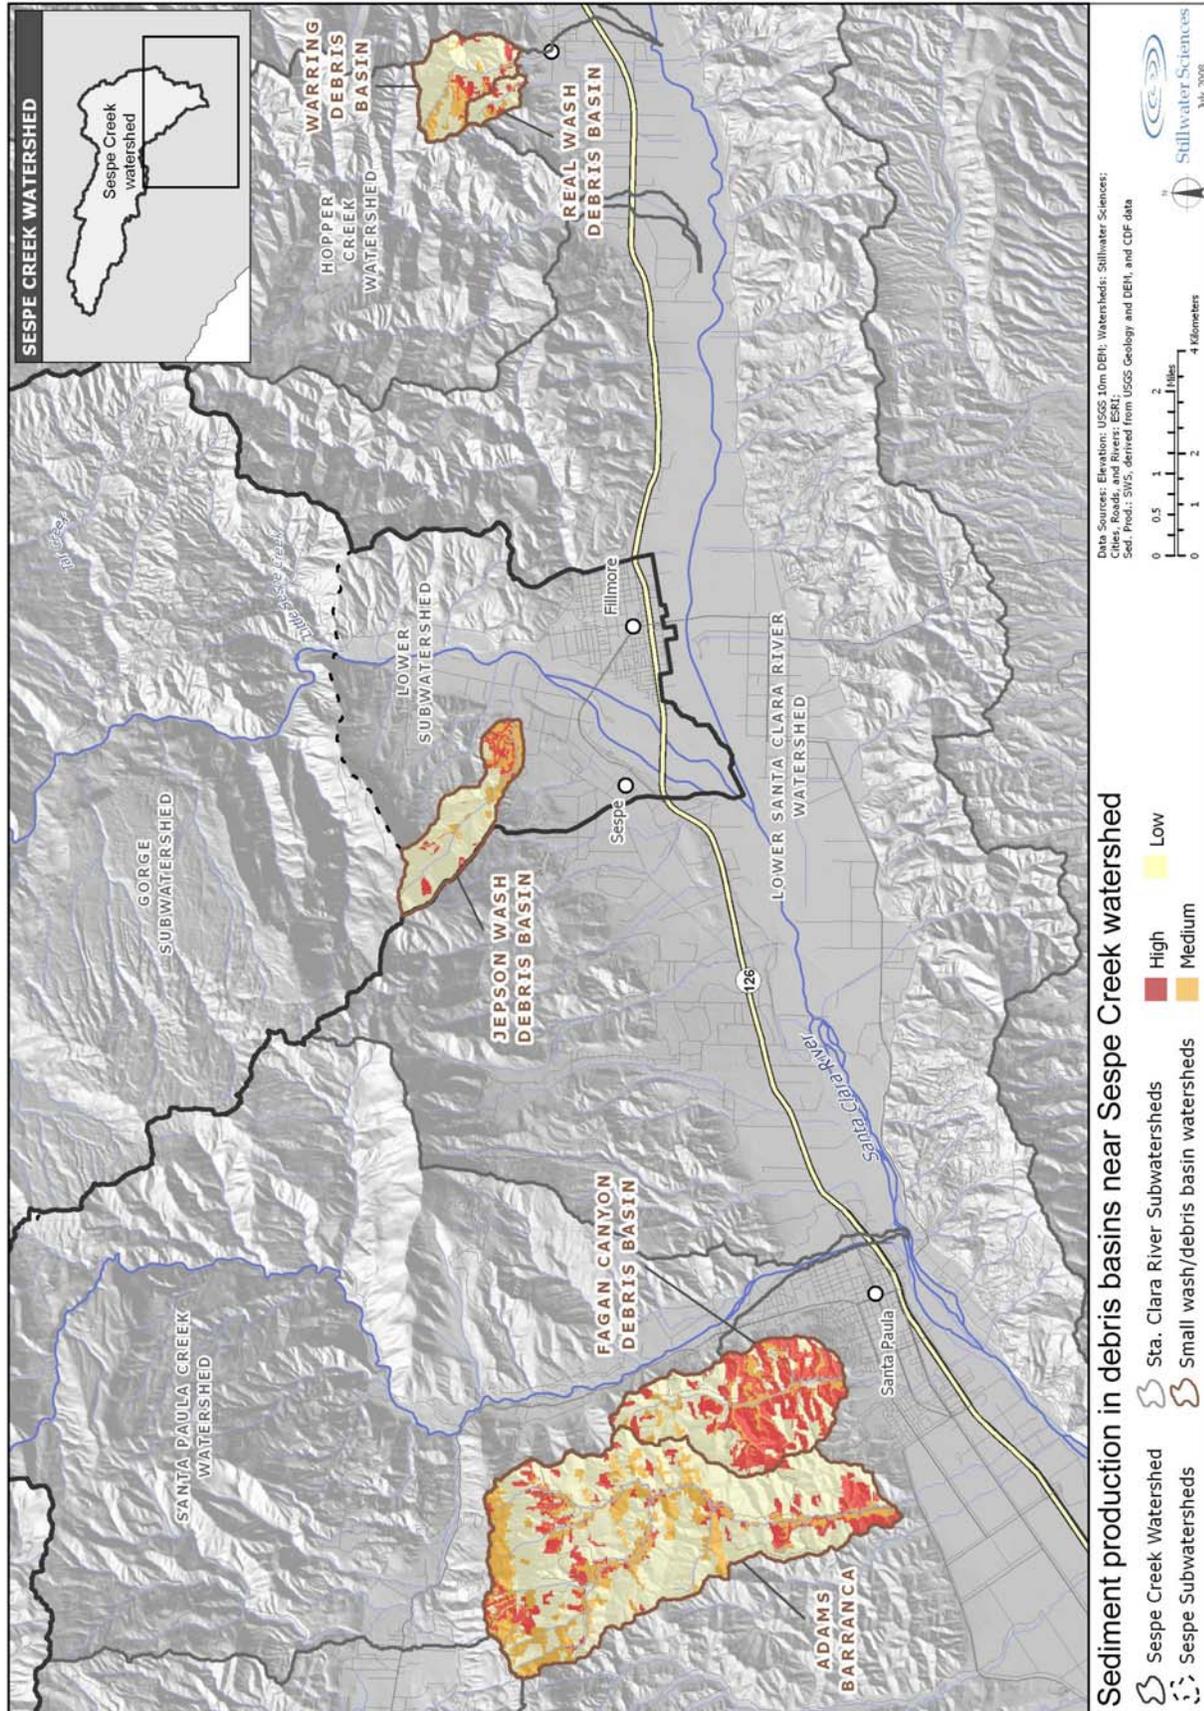
Figure 2-14. Geomorphic landscape units (GLUs), with assigned levels of sediment production, across the five nearby watersheds draining into debris basins with records of sediment removal.

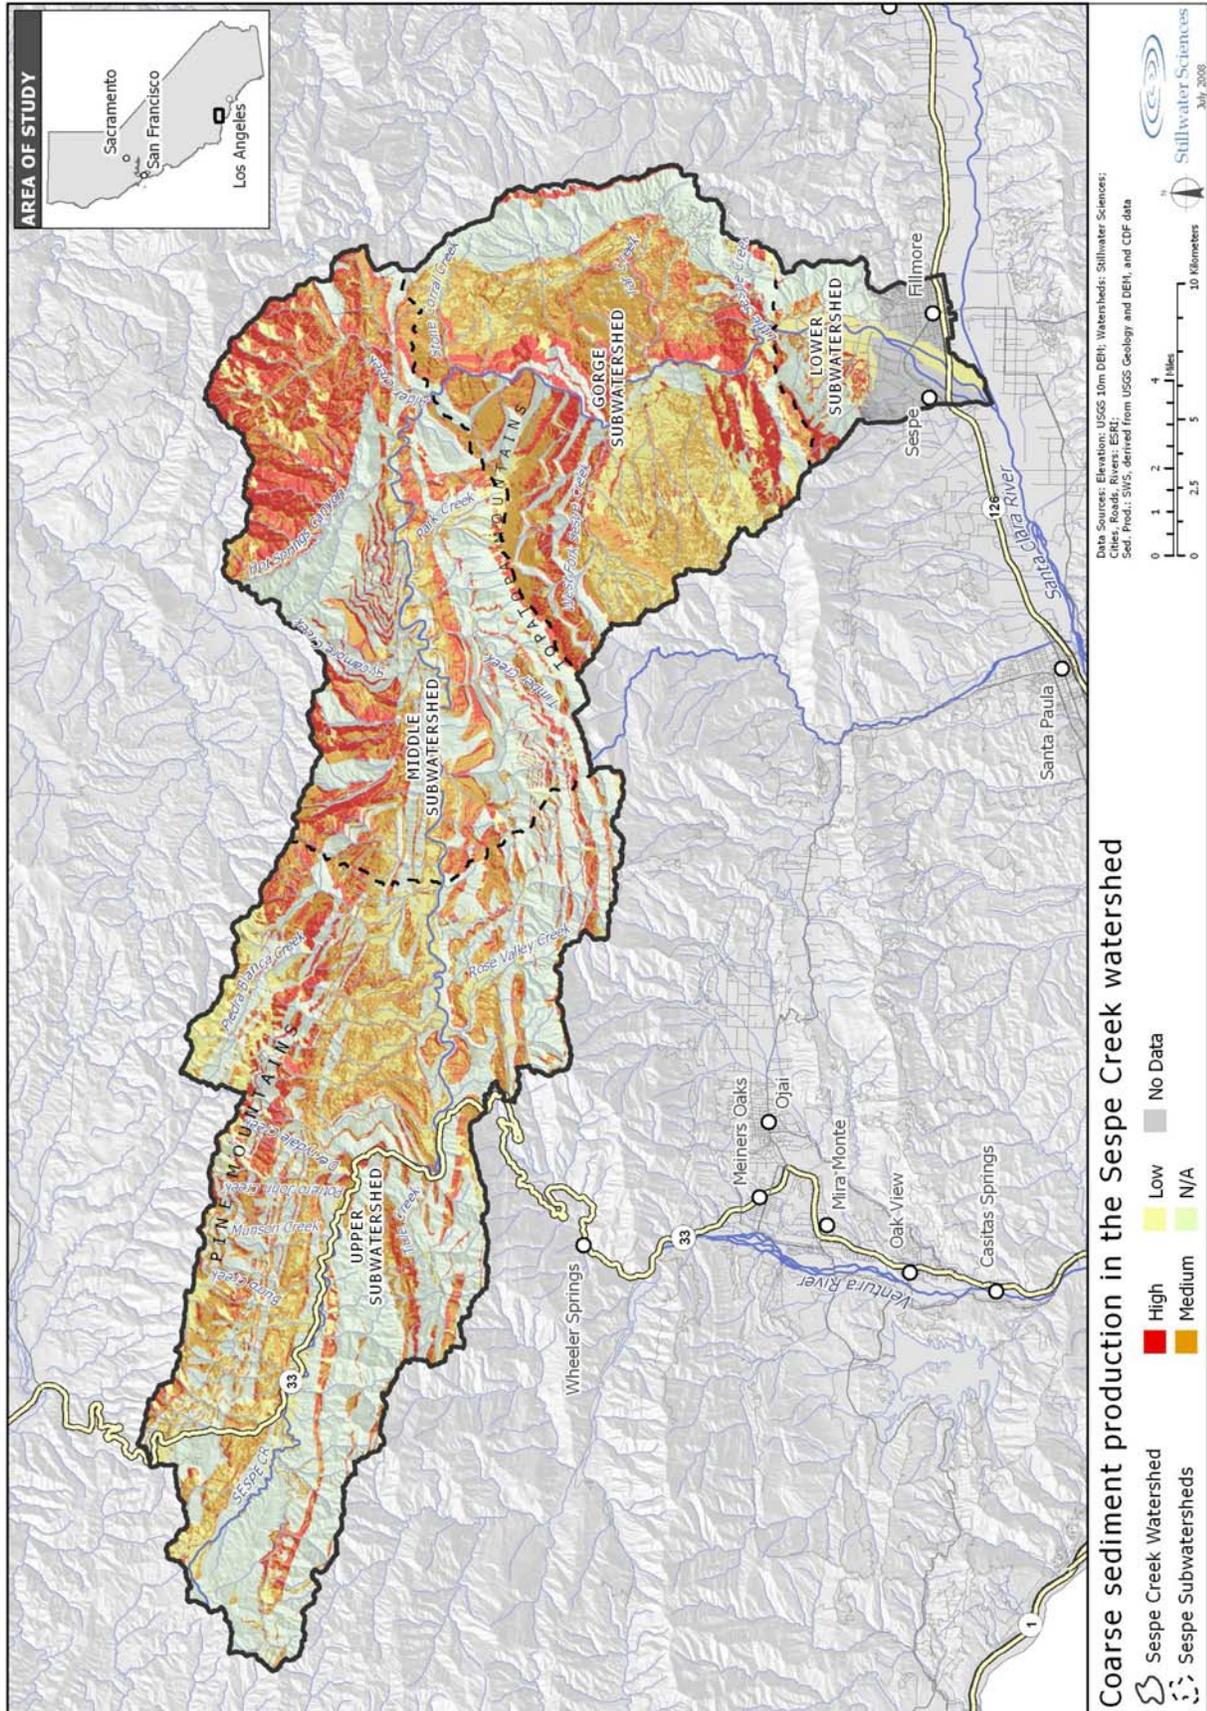
Figure 2-16. Predicted coarse-sediment production in the Sespe Creek watershed.
