SESPE CREEK HYDROLOGY, HYDRAULICS, AND  
SEDIMENTATION ANALYSIS:

## Watershed Assessment of Hillslope and River Geomorphic Processes

**FINAL REPORT**  
April 2010

*Prepared by*  
Stillwater Sciences  
2855 Telegraph Avenue, Suite 400  
Berkeley, CA 94705

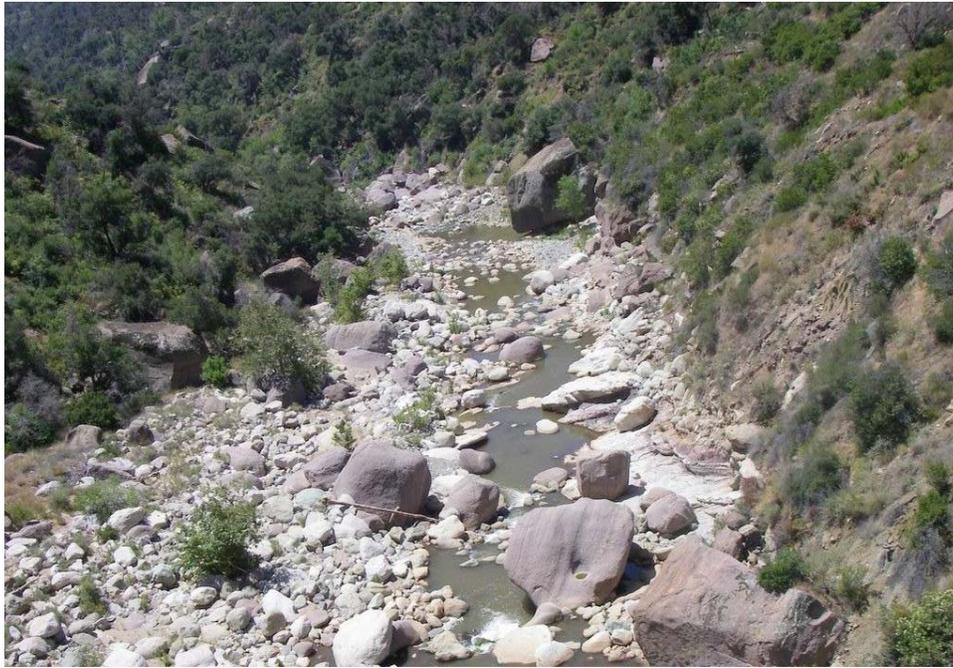
Figure 2-17. Relatively rapid delivery of Sespe Sandstone boulders from steep, nominally shrub-covered hillslopes of the Gorge subwatershed.

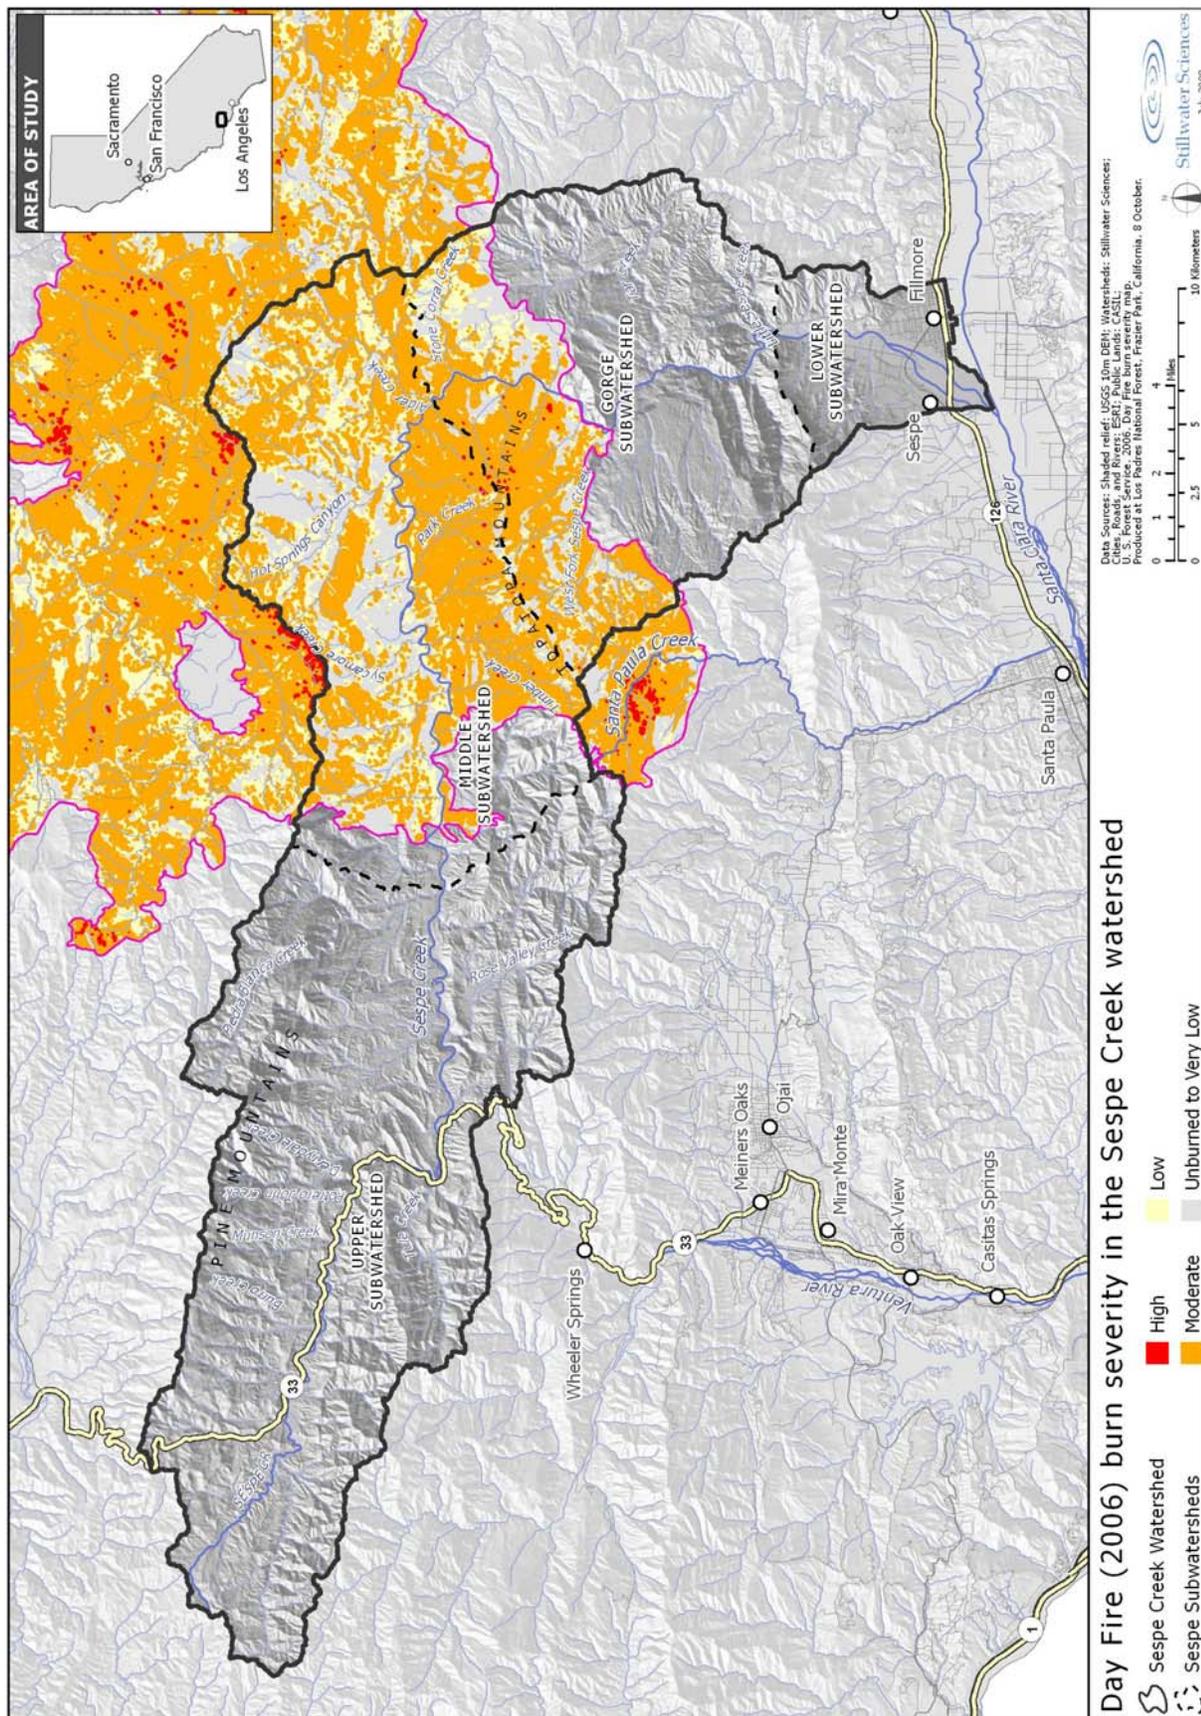
Figure 2-21. Day Fire burn severity based on the USFS (2006) Burned Area Emergency Response (BAER) report.

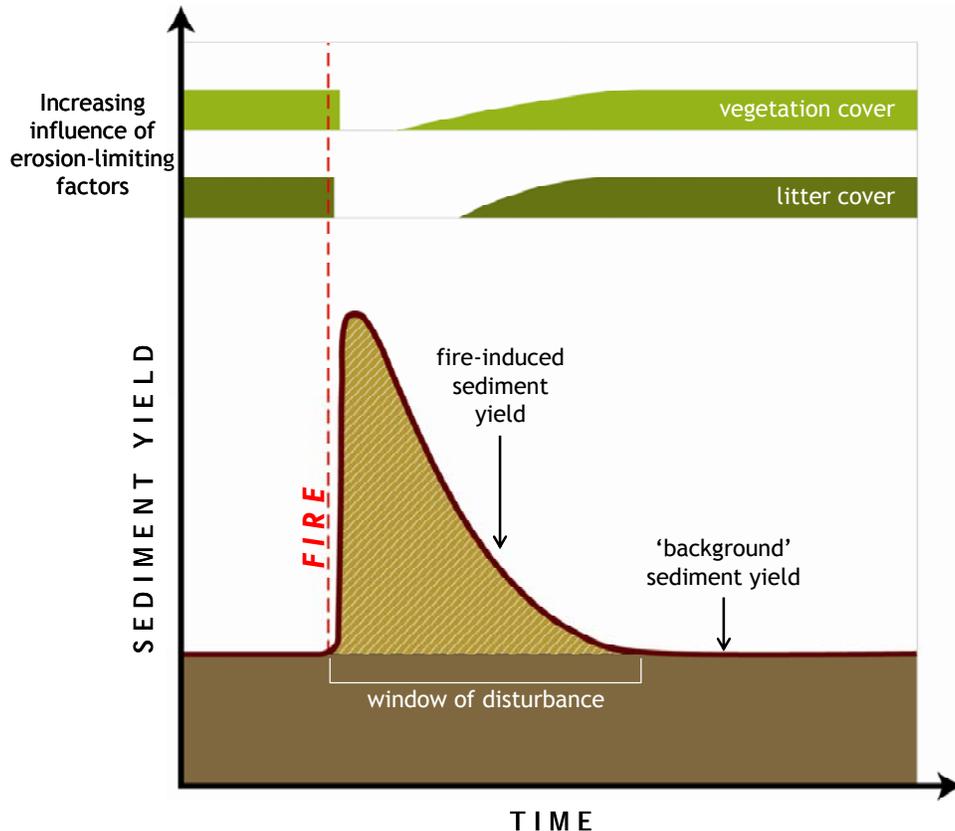
Figure 2-22. Conceptualization of sediment yield and associated vegetation and litter recovery during the fire-induced "window of disturbance" (based on Shakesby and Doerr 2006).

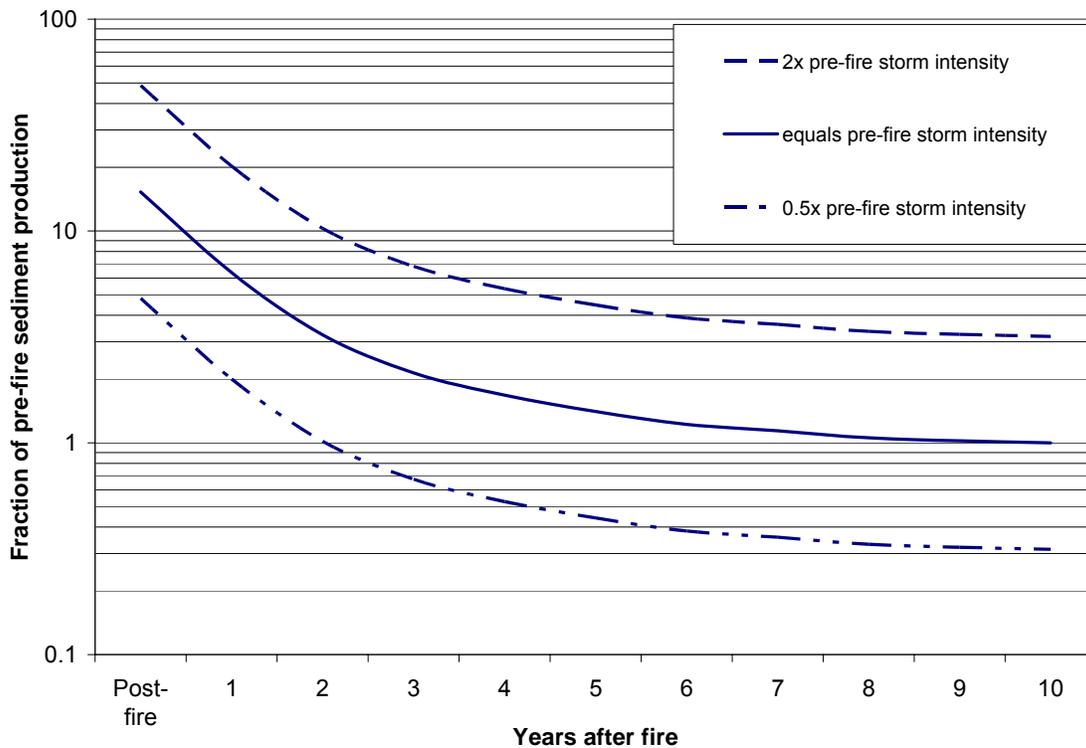
Figure 2-23. Fire effects on sediment production in Los Angeles County debris basins as a function of storm intensity and time since burn (LACFCD 1959, as given in Lave and Burbank 2003).

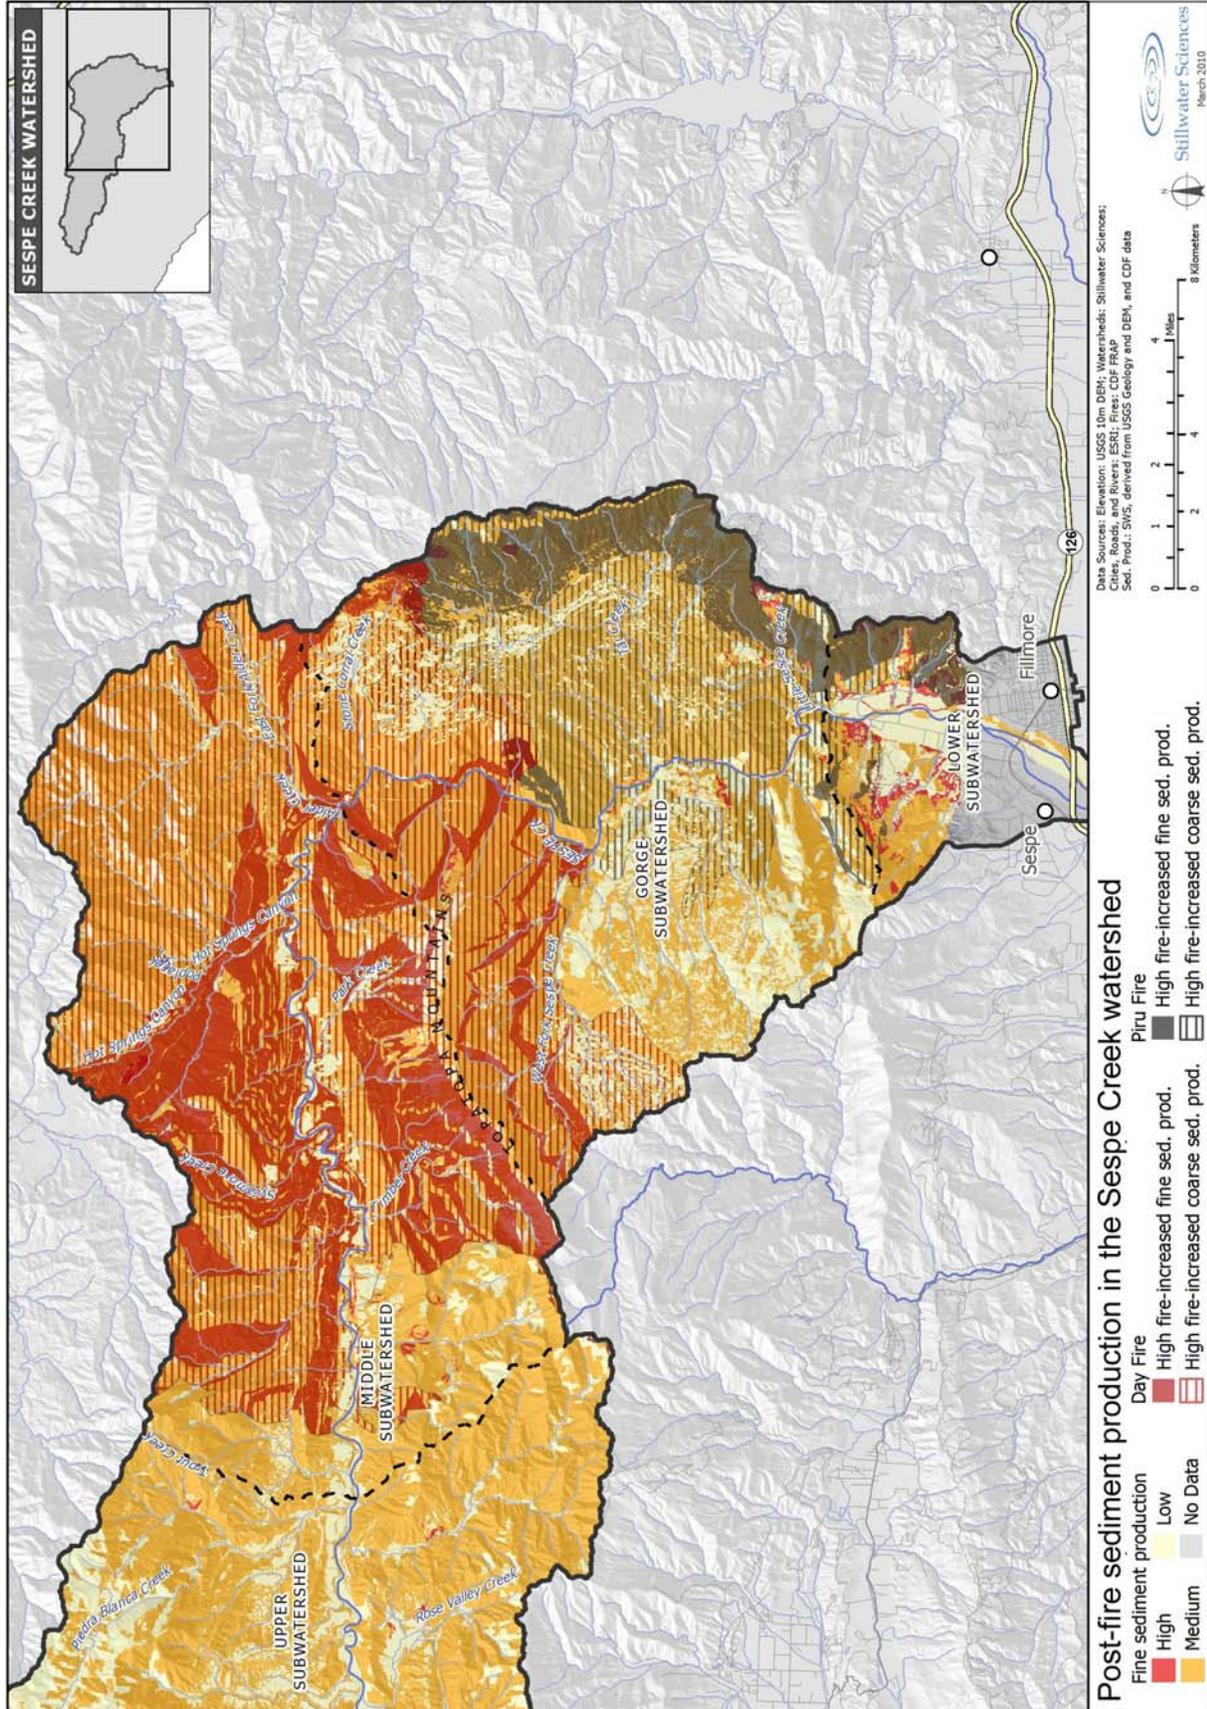
Figure 2-24. Predicted fine-sediment production for pre-fire and post-fire (Day and Piru fires) scenarios in the Sespe Creek watershed.

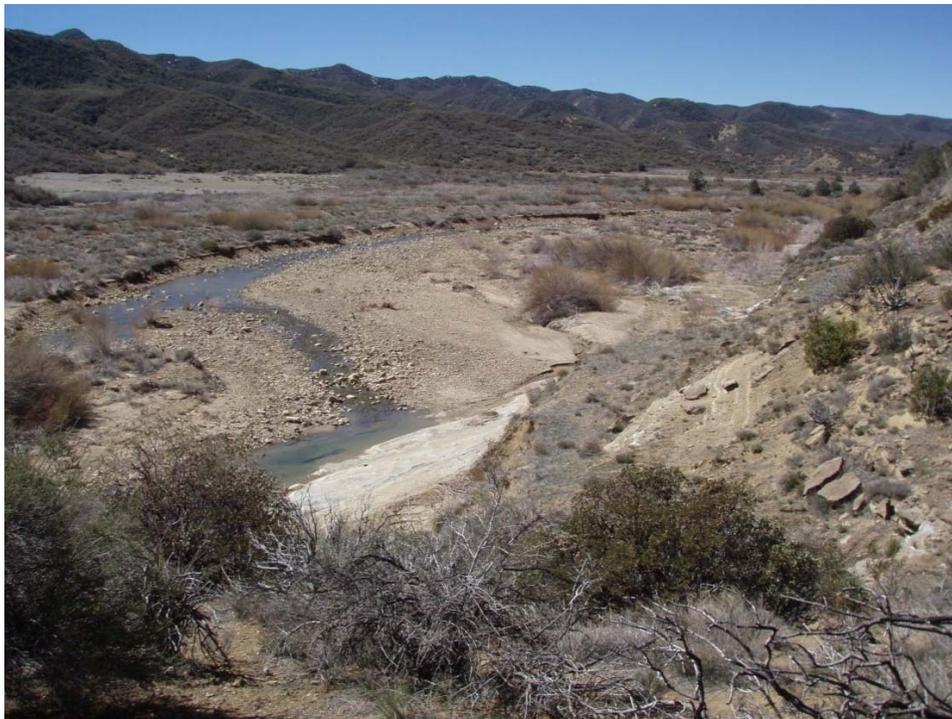
Figure 2-27. View of Wash reach of the Upper subwatershed near Cherry Creek. The channel is bordered by a floodplain to the south and the bed substrate is cobbly-gravel ( $D_{50} = 10$  mm,  $D_{84} = 50$  mm as shown in photo) with some bedrock exposures (left bank).

the confluence with Abadi Creek, the valley bottom broadens and Sespe Creek transitions to the Wash reach. This is characteristically a wider (29 m), lower gradient (0.9%), and mostly alluvial channel with occasional bedrock exposures (Figure 2-27). Because this reach is situated upstream of the constricted Upper Gorge reach, it effectively serves as an area of sediment storage with a bordering floodplain composed of alluvial materials (silts to coarse cobbles). The bed substrate is composed of fine gravel to medium cobble deposits (cobbly-gravel [CG]) ( $D_{50} \approx 20$  mm,  $D_{84} \approx 80$  mm) (see Appendix A for information on facies designation) overlying shale bedrock of the Cozy Dell Formation. The channel bed morphology is generally plane-bedded, but with occasional shallow pools and riffles. Sediment stored within the lower 100 m of Cherry, Godwin, and Chorro Grande creeks was characterized as cobbly-sandy-gravel, with relatively similar particle sizes ( $D_{50} = 20 - 35$  mm,  $D_{84} = 80 - 100$  mm) (see Appendix B for observational data and photos of tributary confluences). These slightly steeper (1-2%), plane-bedded streams were bordered by a relatively wide floodplain or low terrace within approximately 200 m of their respective confluences with Sespe Creek.

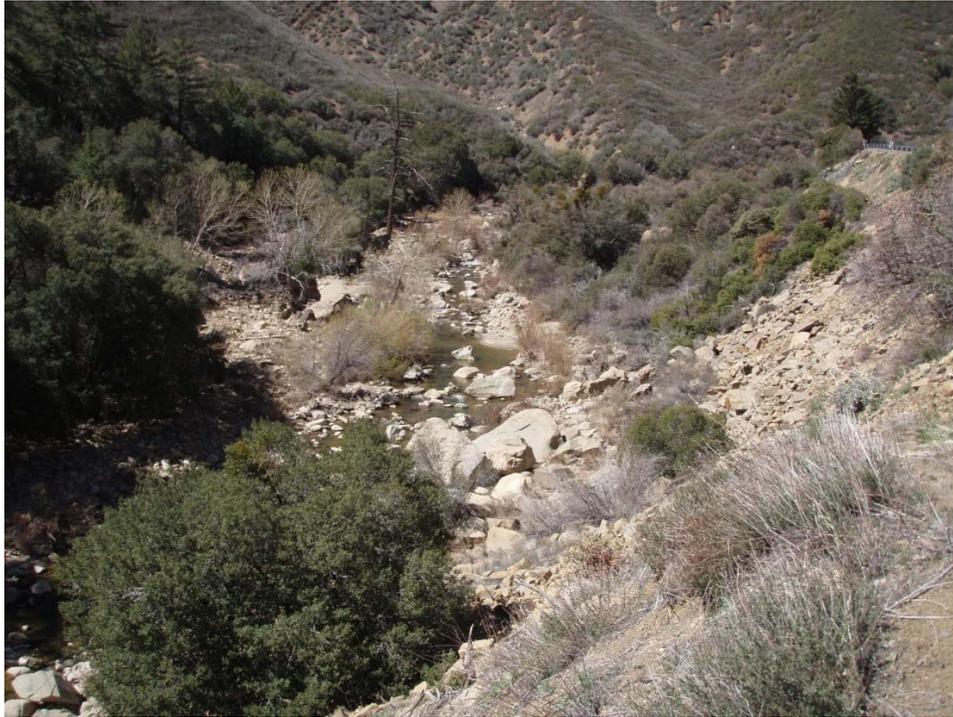
Figure 2-28. View of Upper Gorge reach of the Upper subwatershed near Potrero John Creek. The channel is confined by steep valley walls with exposed bedrock. The channel bed substrate is bouldery-cobbly-gravel ( $D_{50} = 60$  mm,  $D_{84} = 200$  mm as shown in photo).

The Upper Gorge reach begins below Chorro Grande Creek and extends 1.5 km downstream of Derrydale Creek, where the creek trends to the south rather than to the east (Figure 2-28). The creek crosses varied shale and sandstone rock units of the Cozy Dell, Matilija, and Juncal formations. The Upper Gorge reach is characterized by a steeper gradient (1.7%) relative to the Wash and Upper Terrace reaches upstream and downstream, and an average channel width of 25 m. Similar to the much larger gorge in the Gorge subwatershed, this upper gorge is confined by steep valley walls, with nearly vertical walls in sections (e.g., at the USGS gauging station [1111500]), and it lacks any adjacent floodplain areas. In addition to the steep valley walls, the creek is also impinged by Highway 33 throughout this area as the road runs along the creek in the

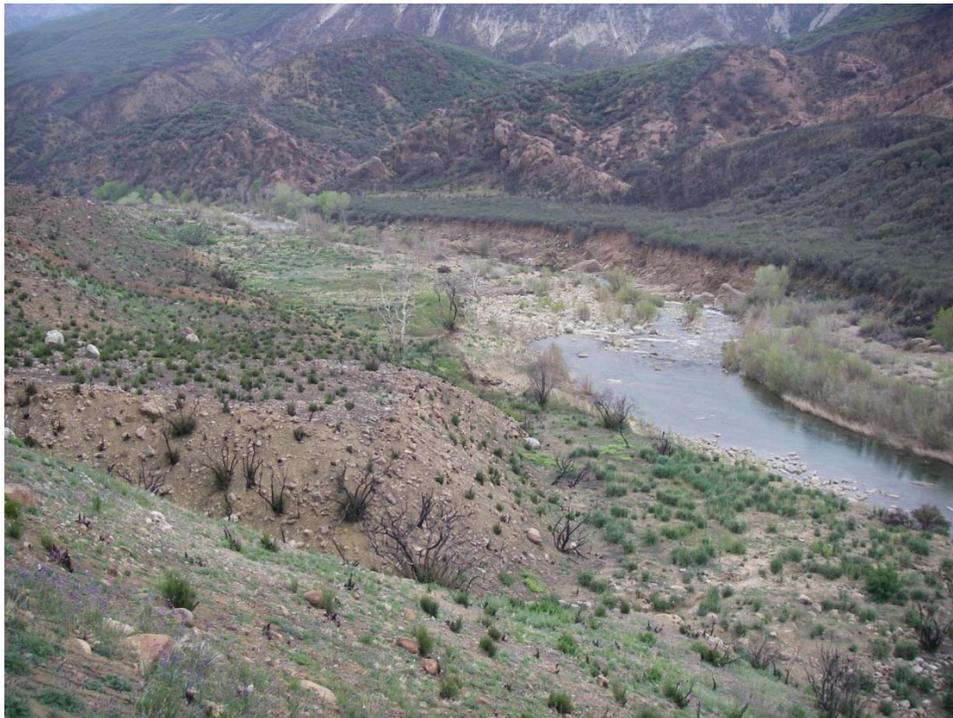
Figure 2-30. View of the Middle Terrace reach of the Middle subwatershed. The view is looking downstream and is located 1.5 km downstream of Trout Creek. A floodplain is present to the left side of the channel and a low terrace is immediately to the right. The bed substrate in this segment is a bouldery-sandy-cobble ( $D_{50} \approx 80$  mm).

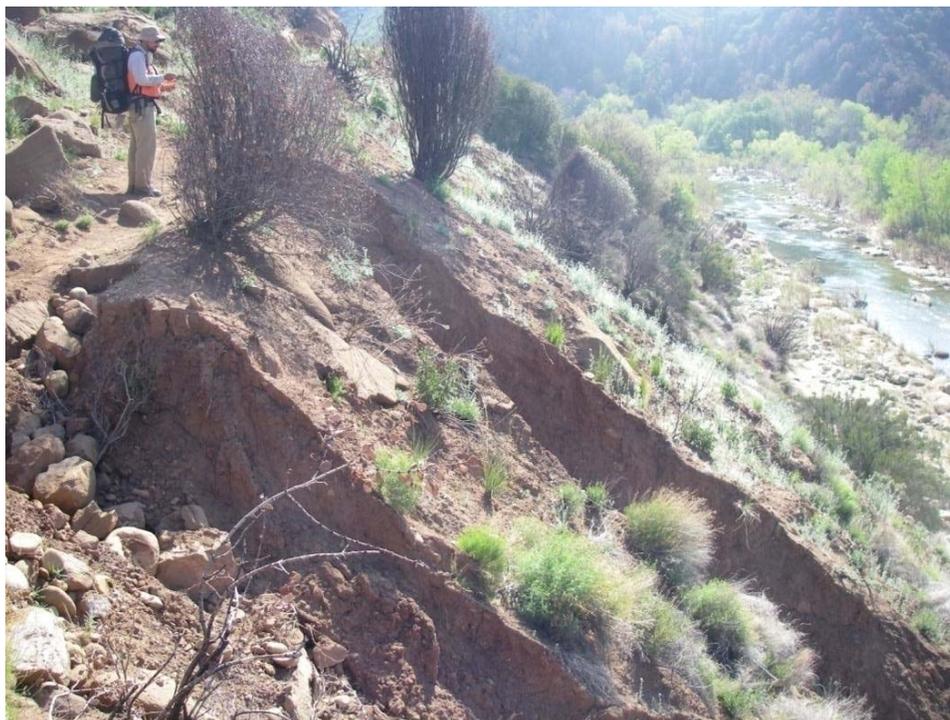
Figure 2-31. Sediment delivery directly to Sespe Creek from large-scale rilling on hillslopes burned during the Day Fire (2006) in the Middle Terrace reach.

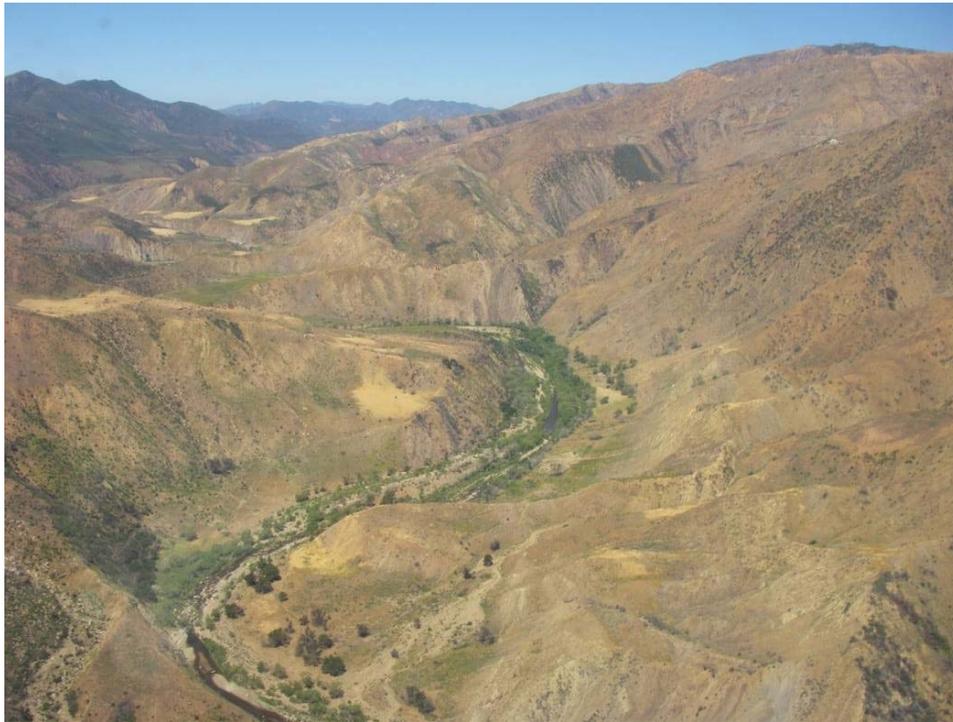
Figure 2-32. View of the Granitics reach of the Middle subwatershed. The view is looking upstream towards the west and is located above the VCWPD rain gage between Park Creek and Hot Springs Canyon. Available floodplain areas are considerably less in this portion of the Middle subwatershed as compared to the Middle Terrace reach upstream. The adjacent hillslope are mostly without vegetation due to the Day Fire.

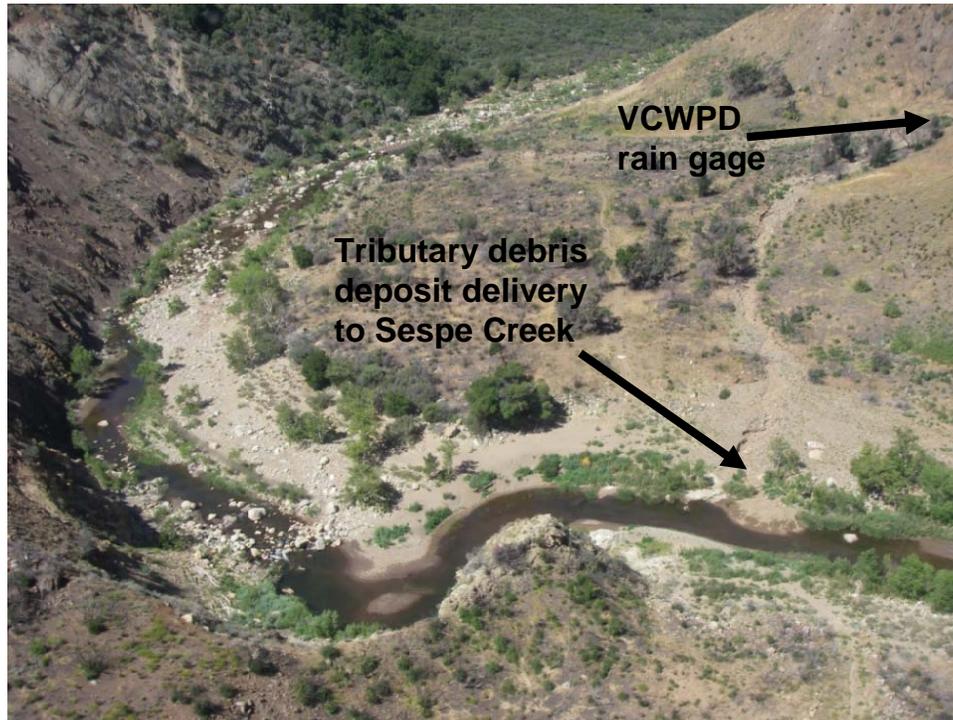
Figure 2-33. View of a post-Day Fire tributary debris fan in the Granitics reach located 1 km downstream of Park Creek. A fine-grained sandy-gravel ( $D_{50} = 20$  mm,  $D_{84} = 60$  mm) fan deposit enters a sand-bedded segment of Sespe Creek. The debris deposit buried vegetation with recent burn damage indicating that the tributary-derived sediment deposited after the 2006 Day Fire. The VCWPD rain gage is located where the tributary exits its confined valley.

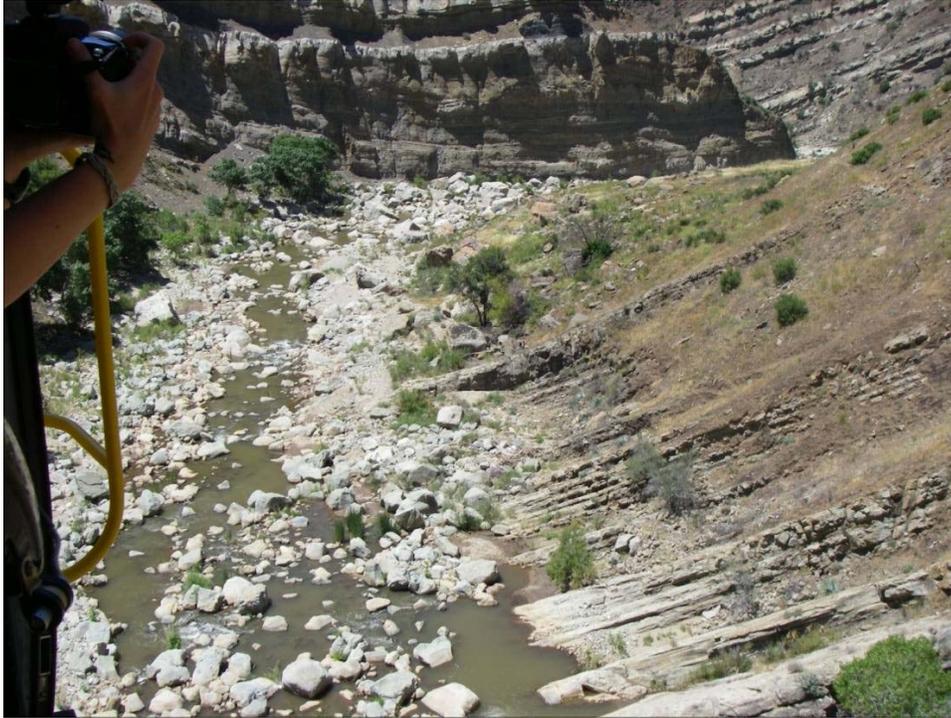
Figure 2-34. View of Lower Gorge reach. View is looking downstream and is located upstream of West Fork Sespe Creek. Bed substrate is a coarse cobble with some post-Day Fire sand deposition. Bedrock of the Cozy Dell Shale Formation (Tcd) is exposed on both sides of the gorge in this segment.

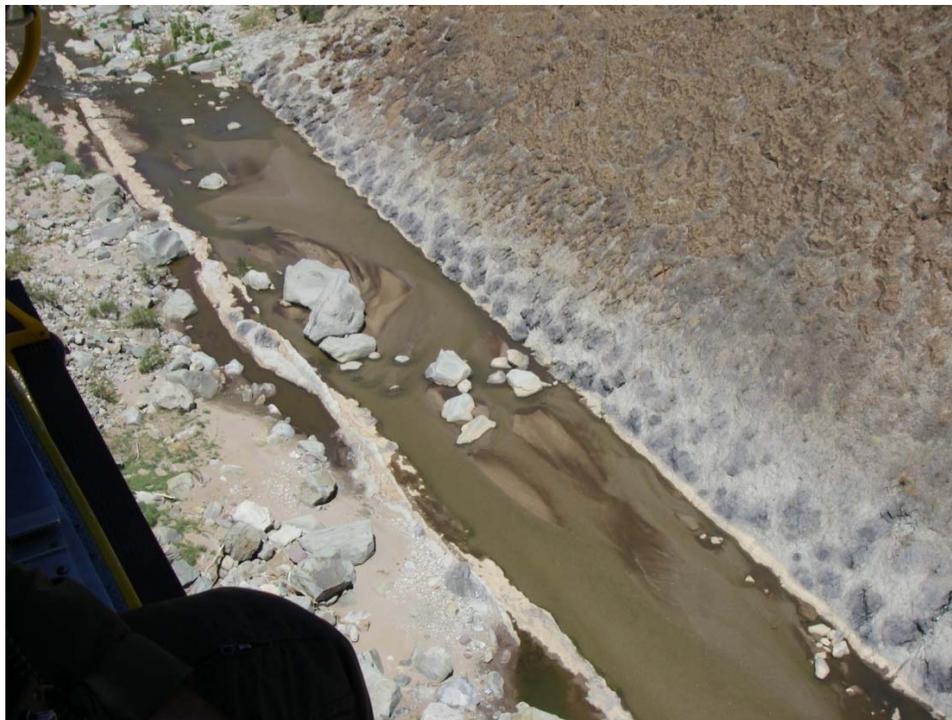
Figure 2-35. View of post-Day Fire aggraded fine sediment on the channel bed and in pools along the Lower Gorge reach. View is looking downstream and is located upstream of West Fork Sespe Creek. Bedrock of the Matilija Sandstone (Tma) is exposed on the right side.

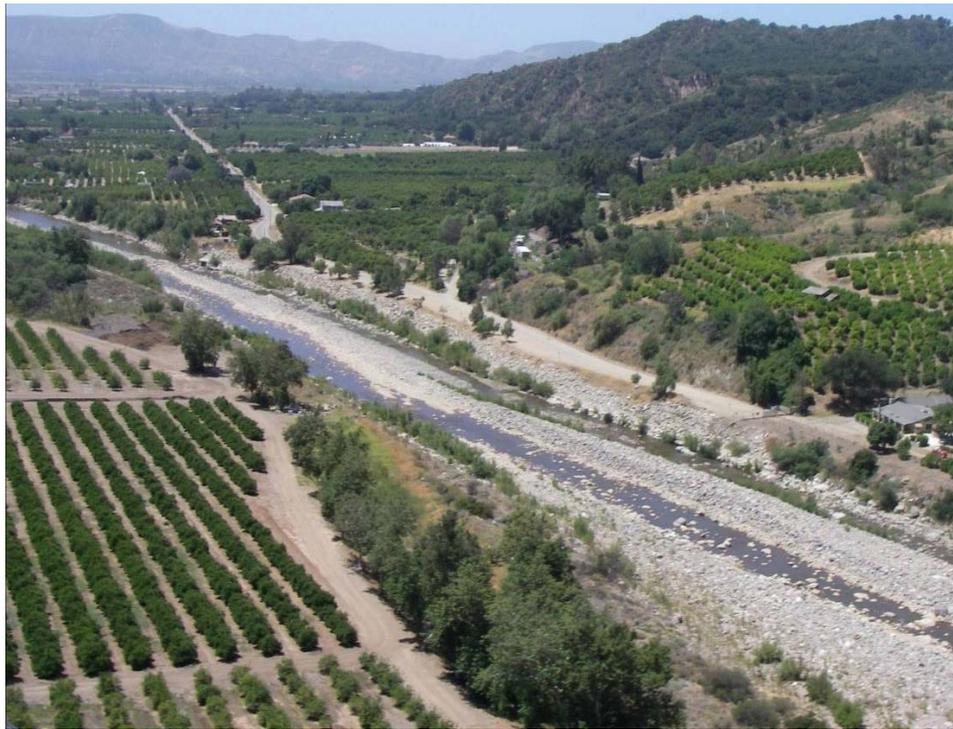
Figure 2-36. View of the Valley reach of the Lower subwatershed. View is looking downstream and is located downstream of Little Sespe Creek as the valley broadens towards the Santa Clara River. Bed substrate is sandy-gravelly-cobble ( $D_{50} = 70$  mm,  $D_{84} = 158$  mm [LADPW 2008]).

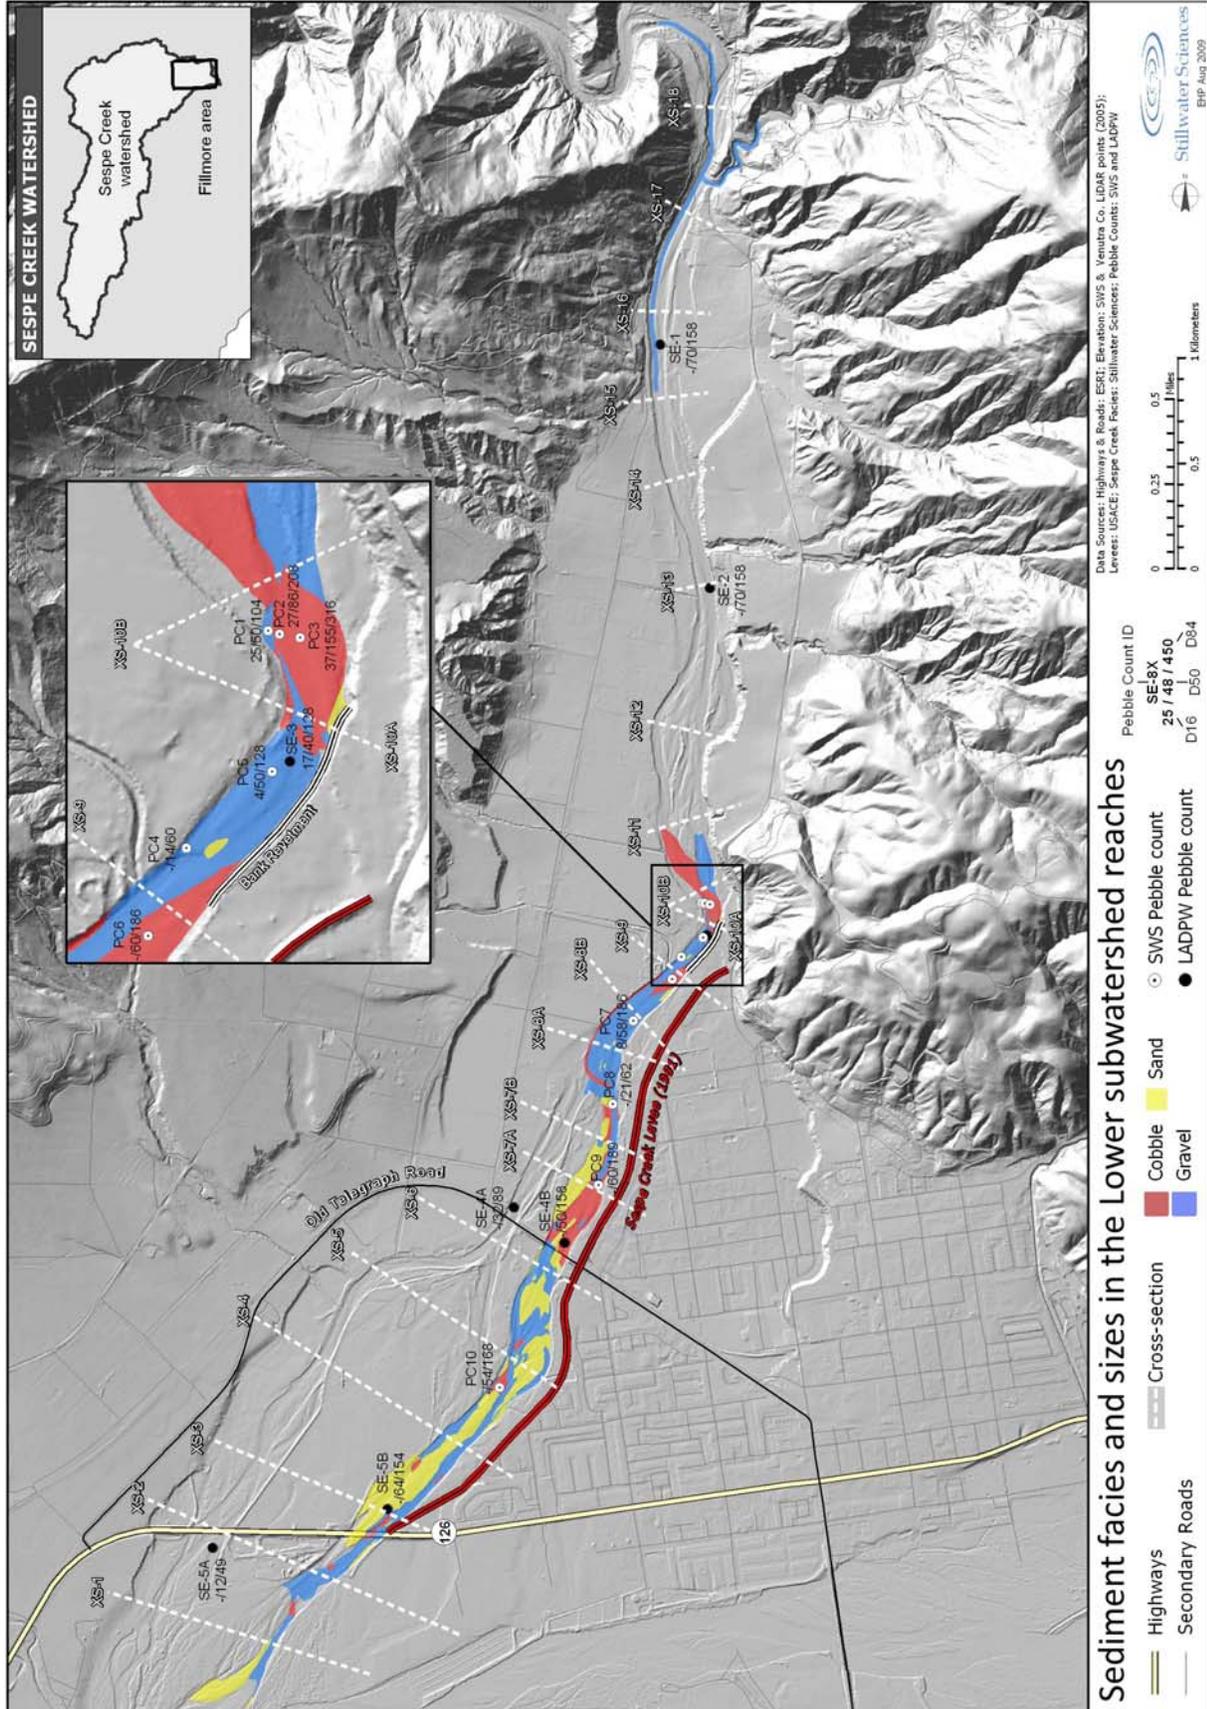
Figure 2-37. Dominant facies type and sediment size measurement locations and results in the Lower subwatershed reaches.

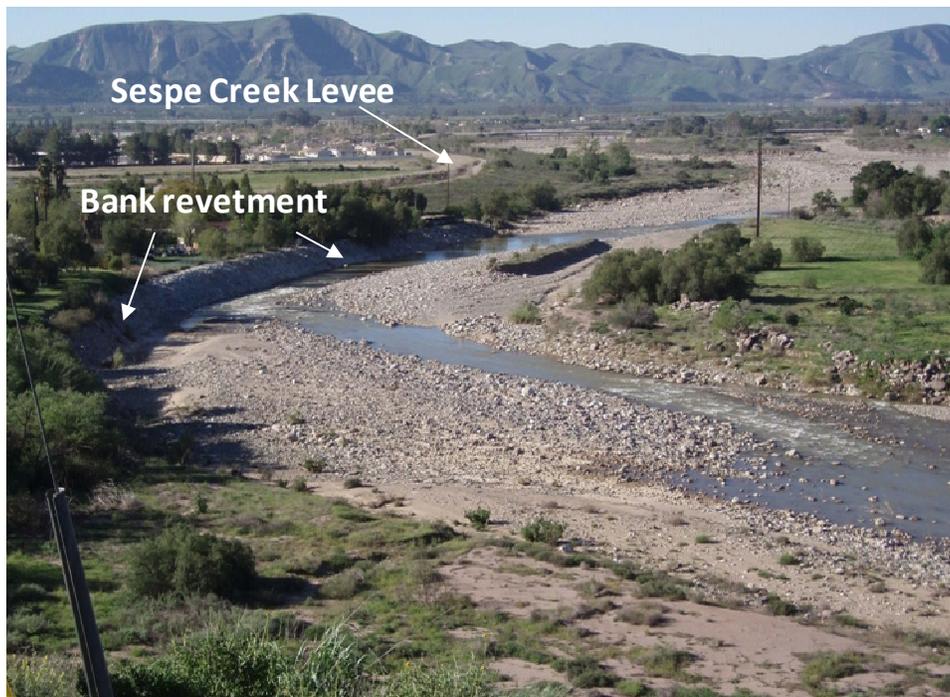
Figure 2-38. View of the concrete-rock bank revetment structure located along the left bank upstream of the Sespe Creek Levee in the Fillmore reach. View is looking downstream.

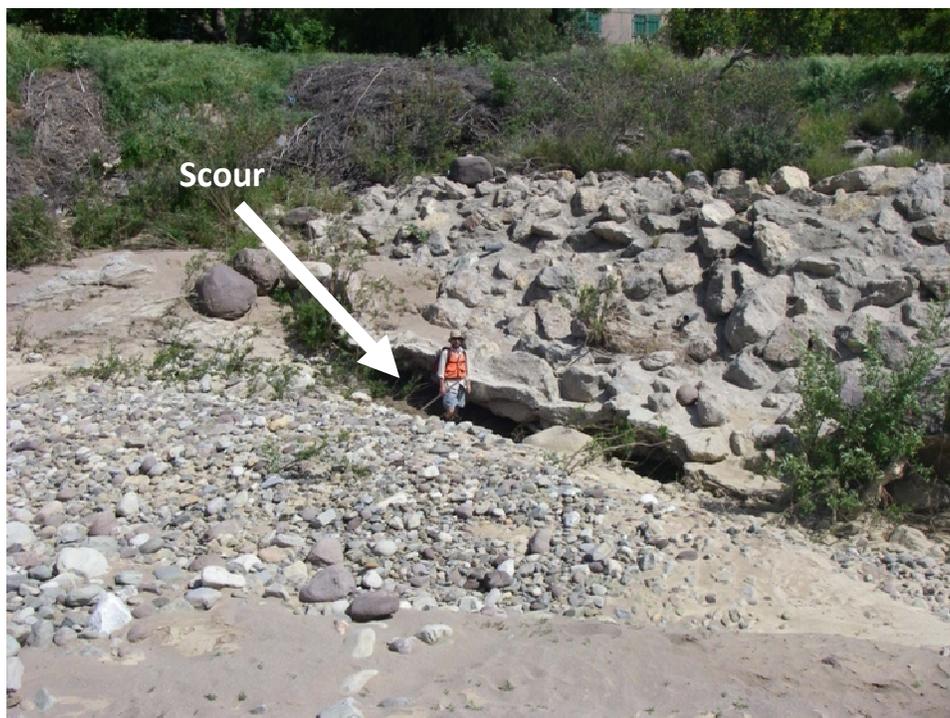
Figure 2-39. View of scour at the upstream end of the bank revetment structure located along the left bank upstream of the Sespe Creek Levee.

Evidence of active migration of the channel, is provided by nearly vertical cut-banks present along the outer side of meander bends in the stream course. Complemented by opposing point bars on the inner side of the bends, together these features viewed in cross-section show an asymmetrical form typical of meandering streams (see Section 3.3 and Appendix C for cross-section analysis results). Bank erosion is prevented along the left side (east) of a channel bend upstream of the levee where the bank has been revetted with concrete and rock to protect several residential properties (Figures 2-38). This is an area of focused energy during high flows due to: 1) a high angle of attack of flow towards the bank, and 2) relatively narrow channel width compared with wider channel widths immediately upstream. Within 250 m upstream of the bend apex, the active channel boundary constricts abruptly from 142 m to 104 m (see cross-sections [XS] 10B and XS 10A in Figures C-14 and C-13, respectively, in Appendix C), a difference of 38 m (125 ft). The revetted bank was damaged most recently during the 2005 flood event and was subsequently repaired. Bed scour and undermining of the revetment was observed in spring 2008 (Figure 2-39).

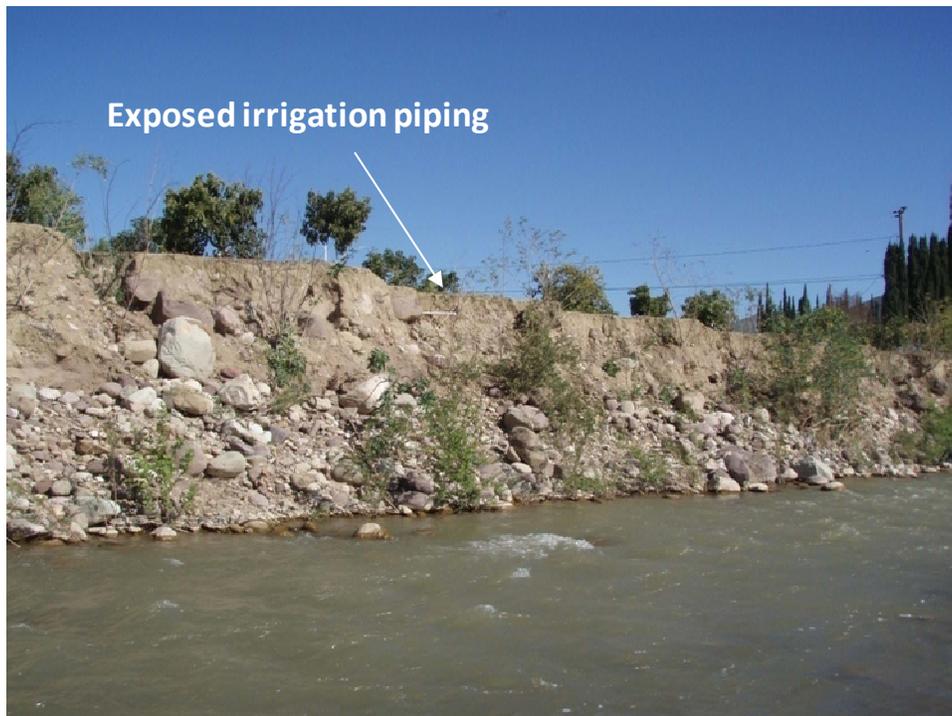
Figure 2-40. View of exposed irrigation piping and fruit tree roots at actively eroding right bank opposite the upstream end of the Sespe Creek Levee in the Fillmore reach.

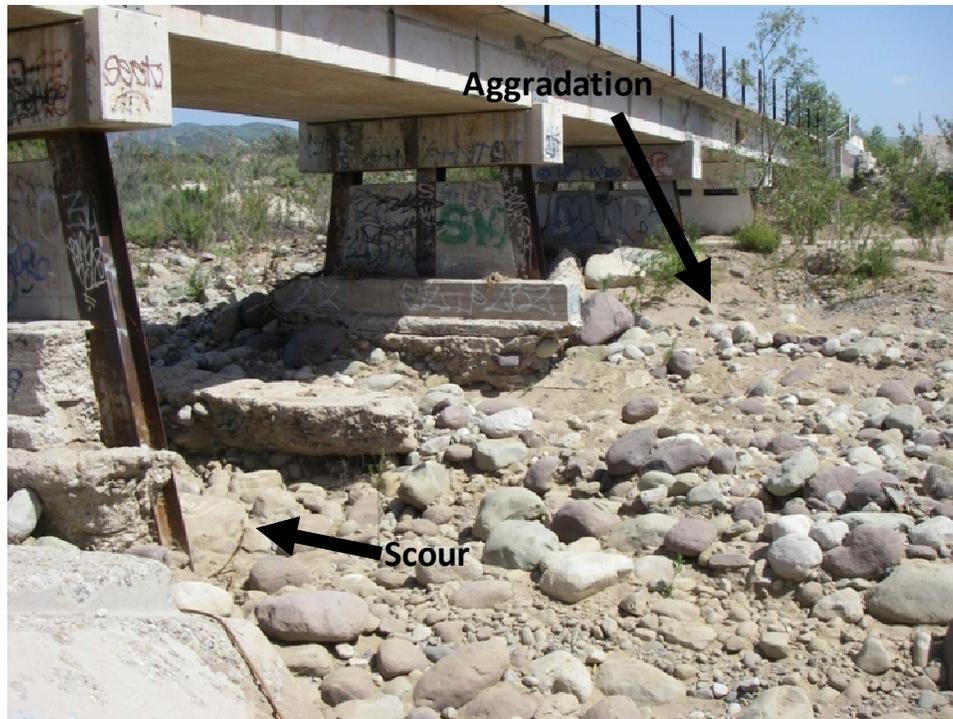
Figure 2-41. View of scour and deposition on either side of a bridge support for the Southern Pacific Railway bridge immediately upstream of the Old Telegraph Road Bridge on the east fork (overflow) of Sespe Creek in the Fillmore reach.

Besides the Sespe Creek Levee and the concrete bank revetment in the Lookout Point area, the other major infrastructure elements directly in contact with lower Sespe Creek are the bridges of Highway 126, Old Telegraph Road, and Southern Pacific Railway (see Figure 3-4). These bridges each span the entire width of the creek channel and include bridge pilings to support them above the channel. The bridge abutments on either side of the channel act to fix the channel width, preventing any natural bank erosion from occurring, while the pilings create turbulent flow conditions when flows are high in the channel. The differential flows passing by the pilings result in variable occurrences of scour (where flows concentrate) and deposition (where flows slow down). This sort of variable scour and deposition is clearly seen in the photograph of the Southern Pacific Railway bridge where scouring flows exposed piling foundations and sediment deposition buried adjacent piling foundations (Figure 2-41). These structures, therefore, clearly have an influence on sediment transport through lower Sespe Creek by altering flow patterns and promoting locally variable bed erosion and deposition.

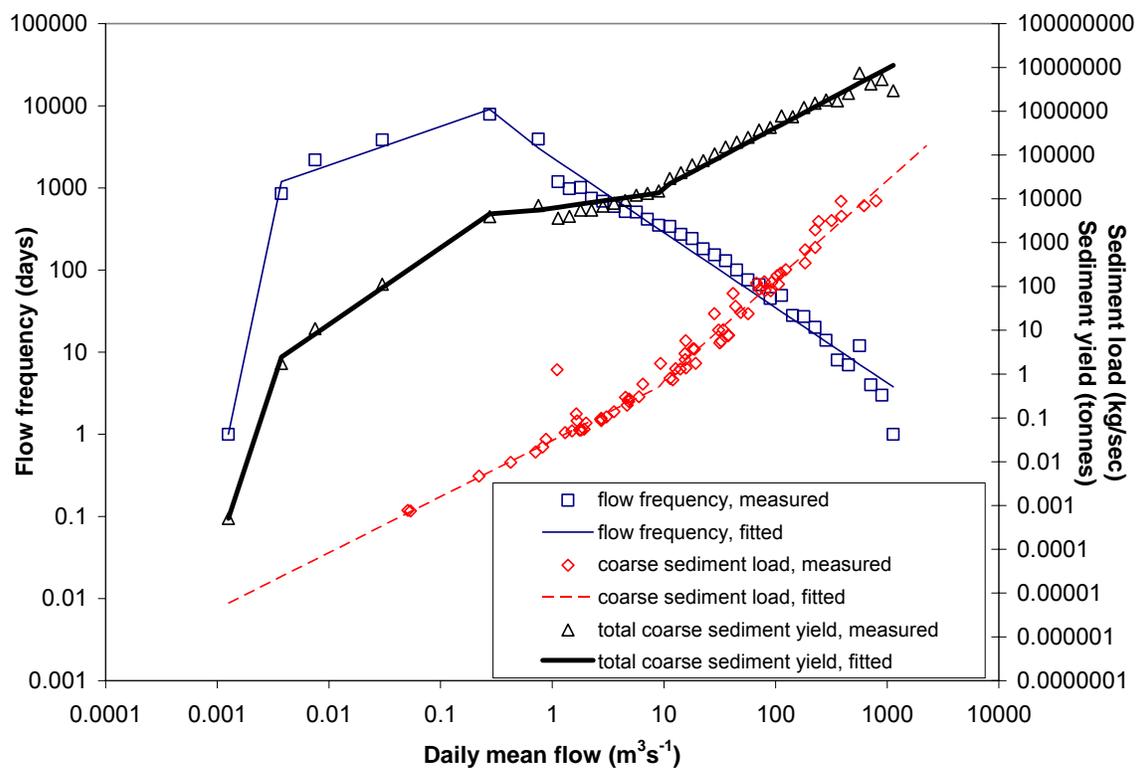
Figure 3-3. Flow frequency and coarse (>0.0625 mm) sediment load for long-term daily mean flow record for Sespe Creek at Fillmore [USGS gage 11113000]. Note: the daily mean flow values for WY 1986-1990 were absent for this gauge, but were derived here based on a correlation ( $R^2=86\%$ ) with the Santa Paula Creek gauge (USGS 11113500).

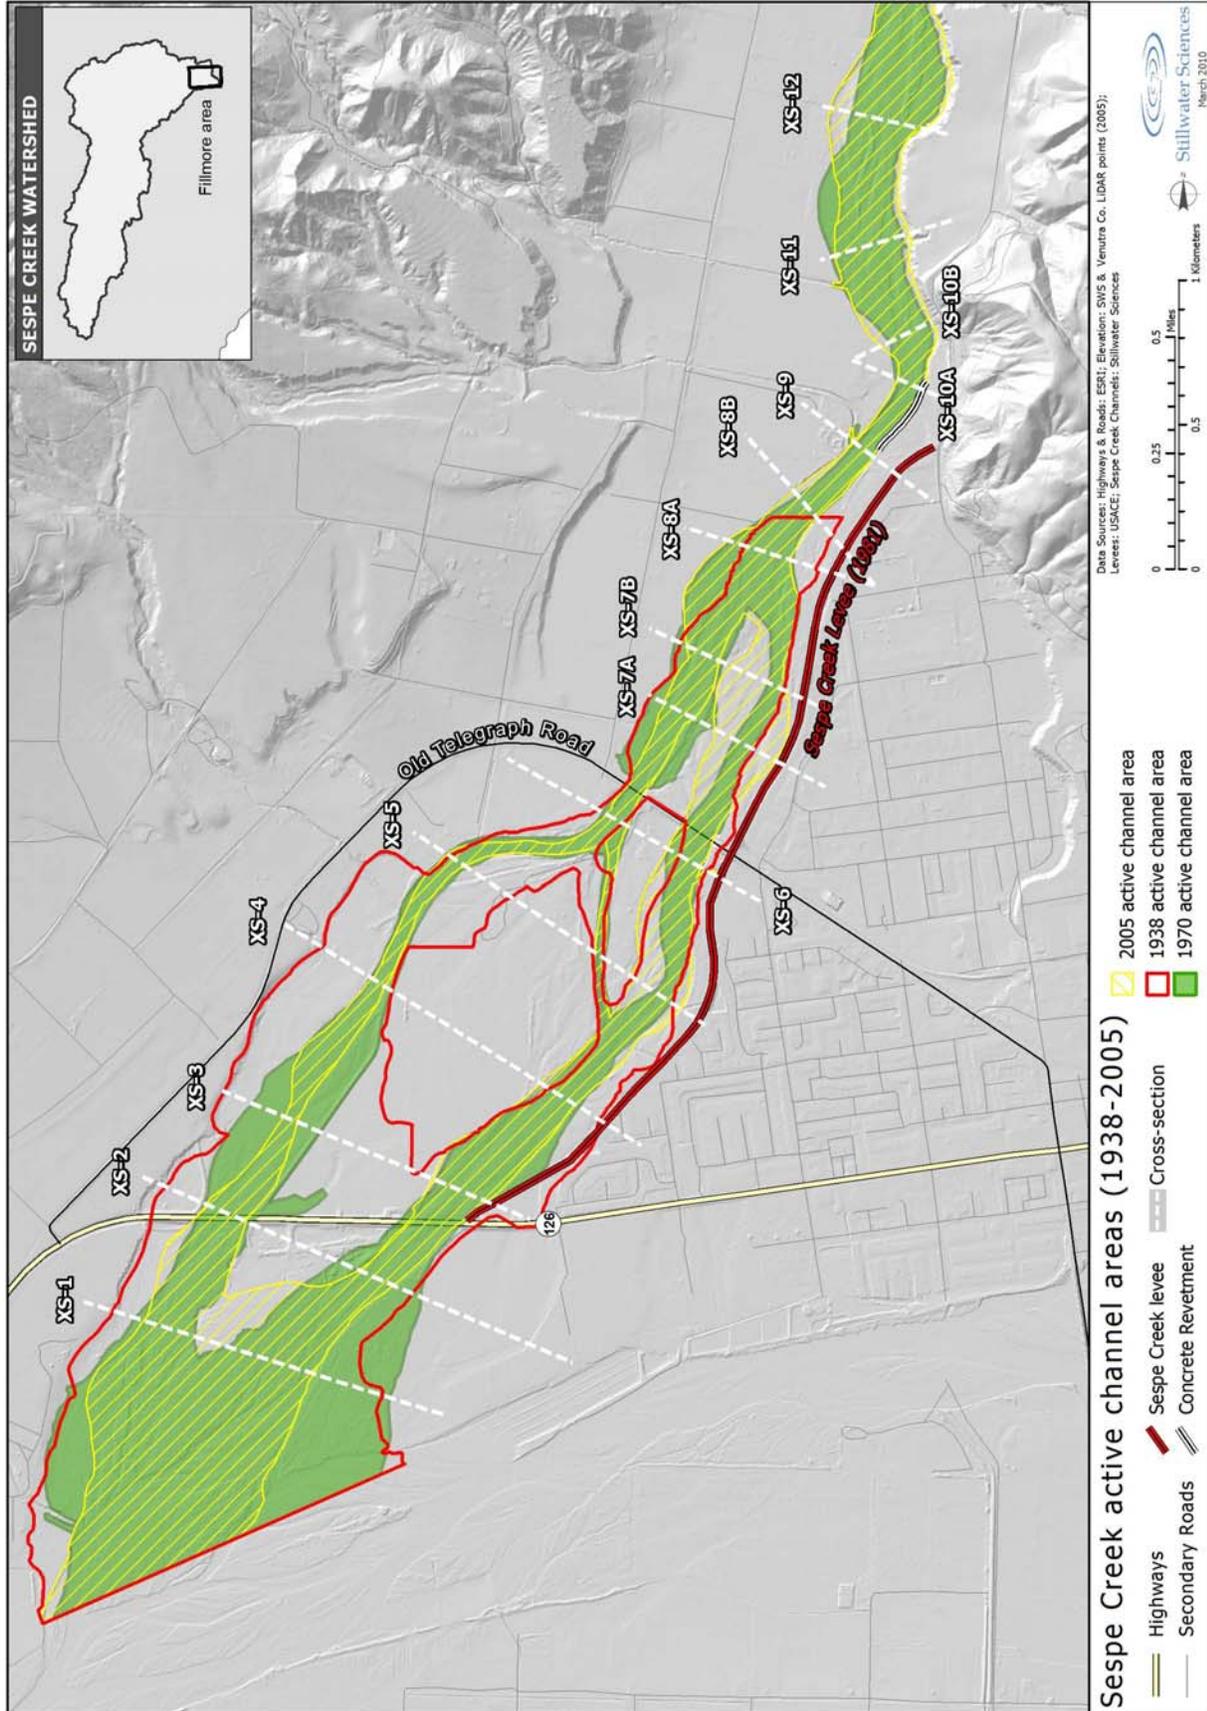
Figure 3-5. Active channel areas in 1938, 1970, and 2005 in the Fillmore reach of Sespe Creek.
