SESPE CREEK HYDROLOGY, HYDRAULICS, AND  
SEDIMENTATION ANALYSIS:

## Watershed Assessment of Hillslope and River Geomorphic Processes

**FINAL REPORT**  
April 2010

*Prepared by*  
Stillwater Sciences  
2855 Telegraph Avenue, Suite 400  
Berkeley, CA 94705

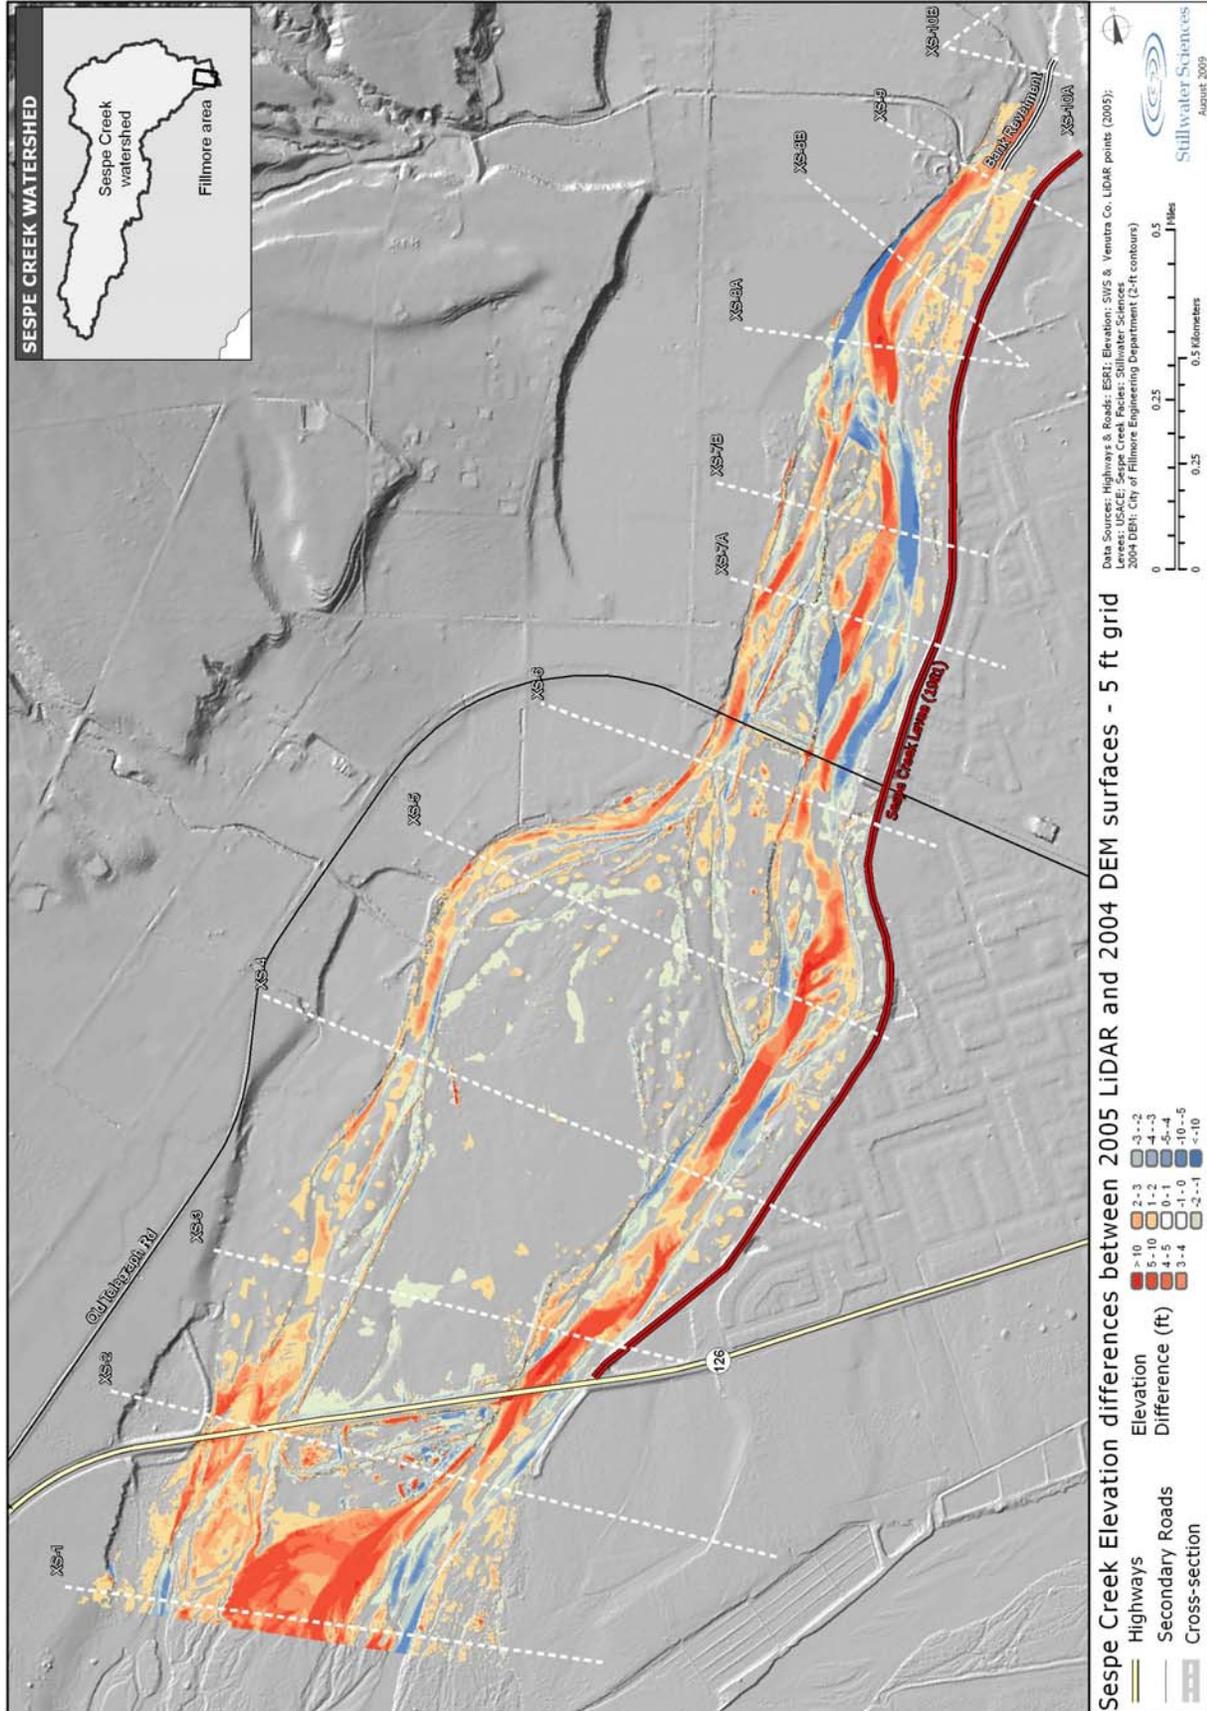
Figure 3-6. Channel surface elevation differences between 2004 and 2005 in the Fillmore reach of Sespe Creek.

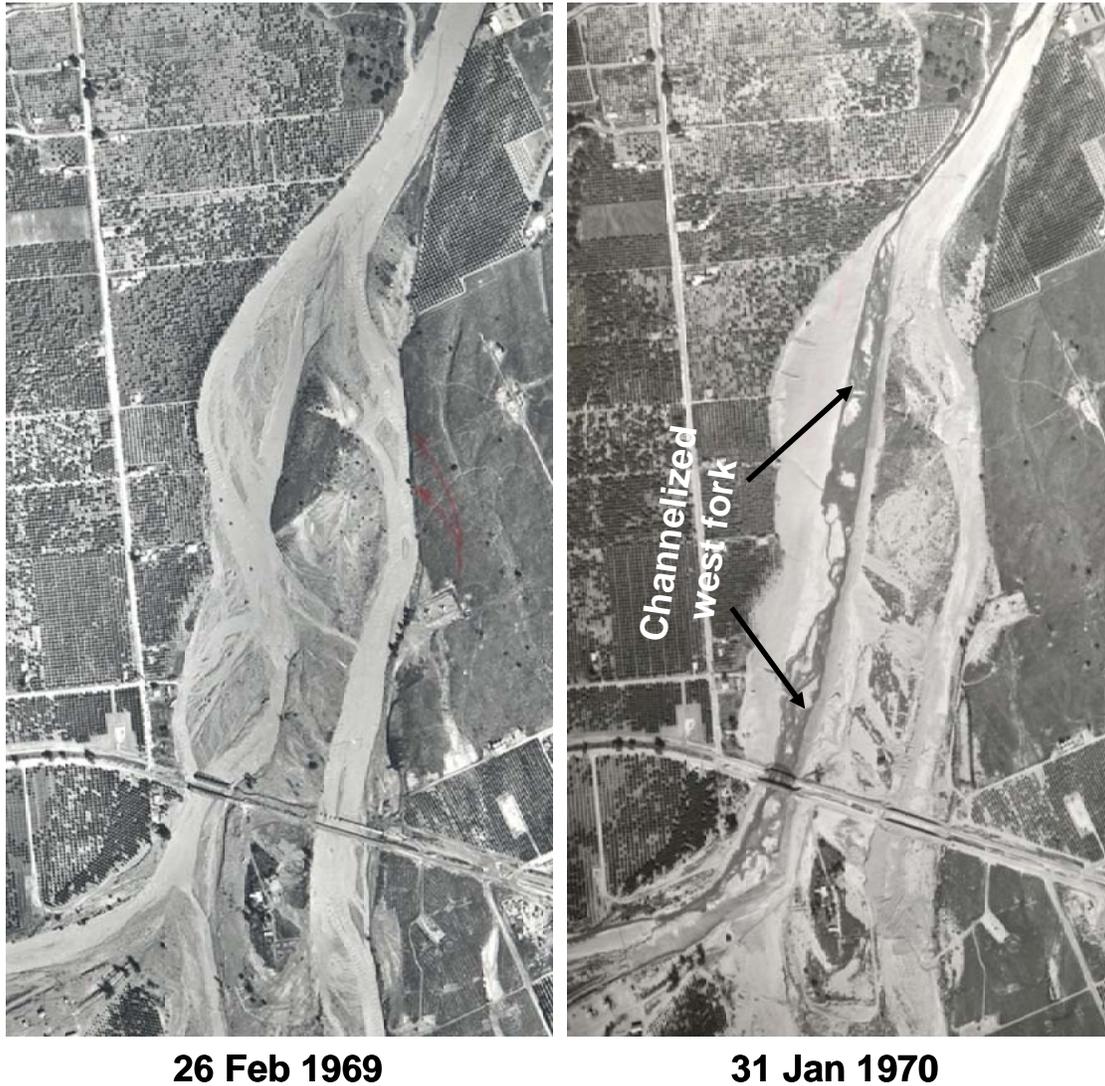
Figure 3-7. Aerial images taken in 1969 (left) and 1970 (right) of the Fillmore reach of lower Sespe Creek showing a channelized form of west fork (mainstem) channel upstream and downstream of the Old Telegraph Road bridge in 1970. The east spans of the road and railway bridges were damaged during the 1969 floods and were repaired before 1970.

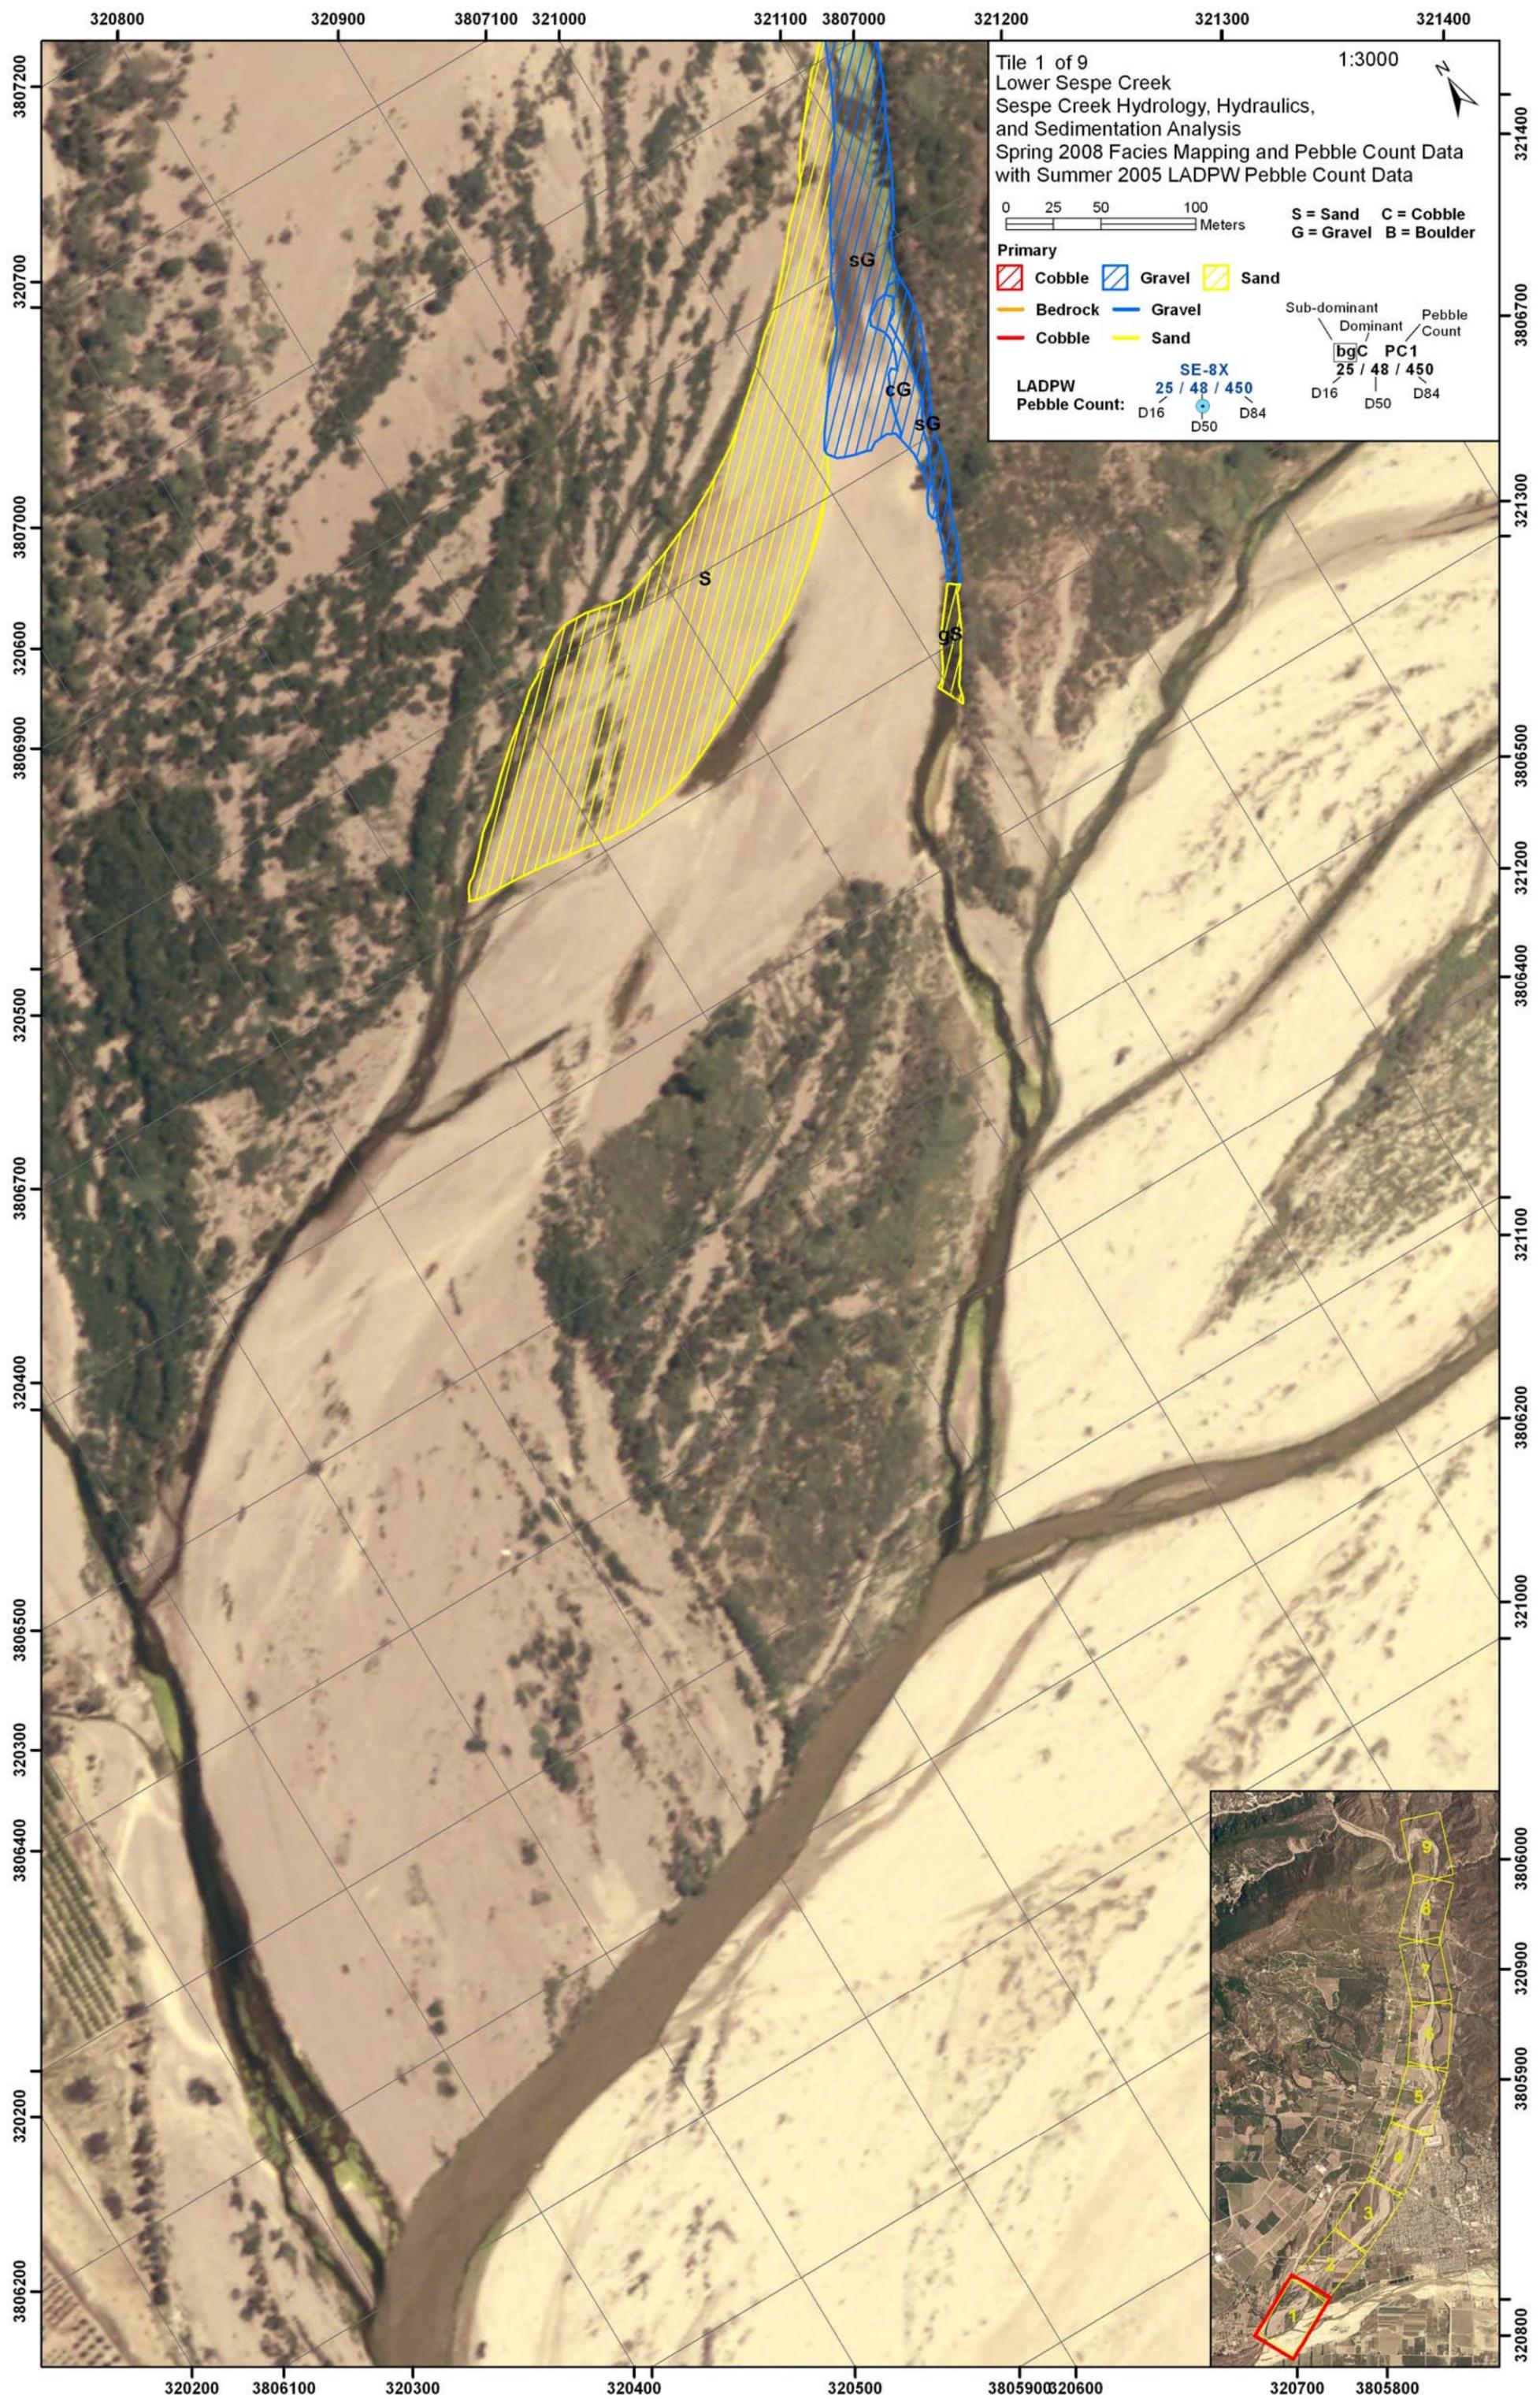
Tile 1 of 9  
 Lower Sespe Creek  
 Sespe Creek Hydrology, Hydraulics,  
 and Sedimentation Analysis  
 Spring 2008 Facies Mapping and Pebble Count Data  
 with Summer 2005 LADPW Pebble Count Data

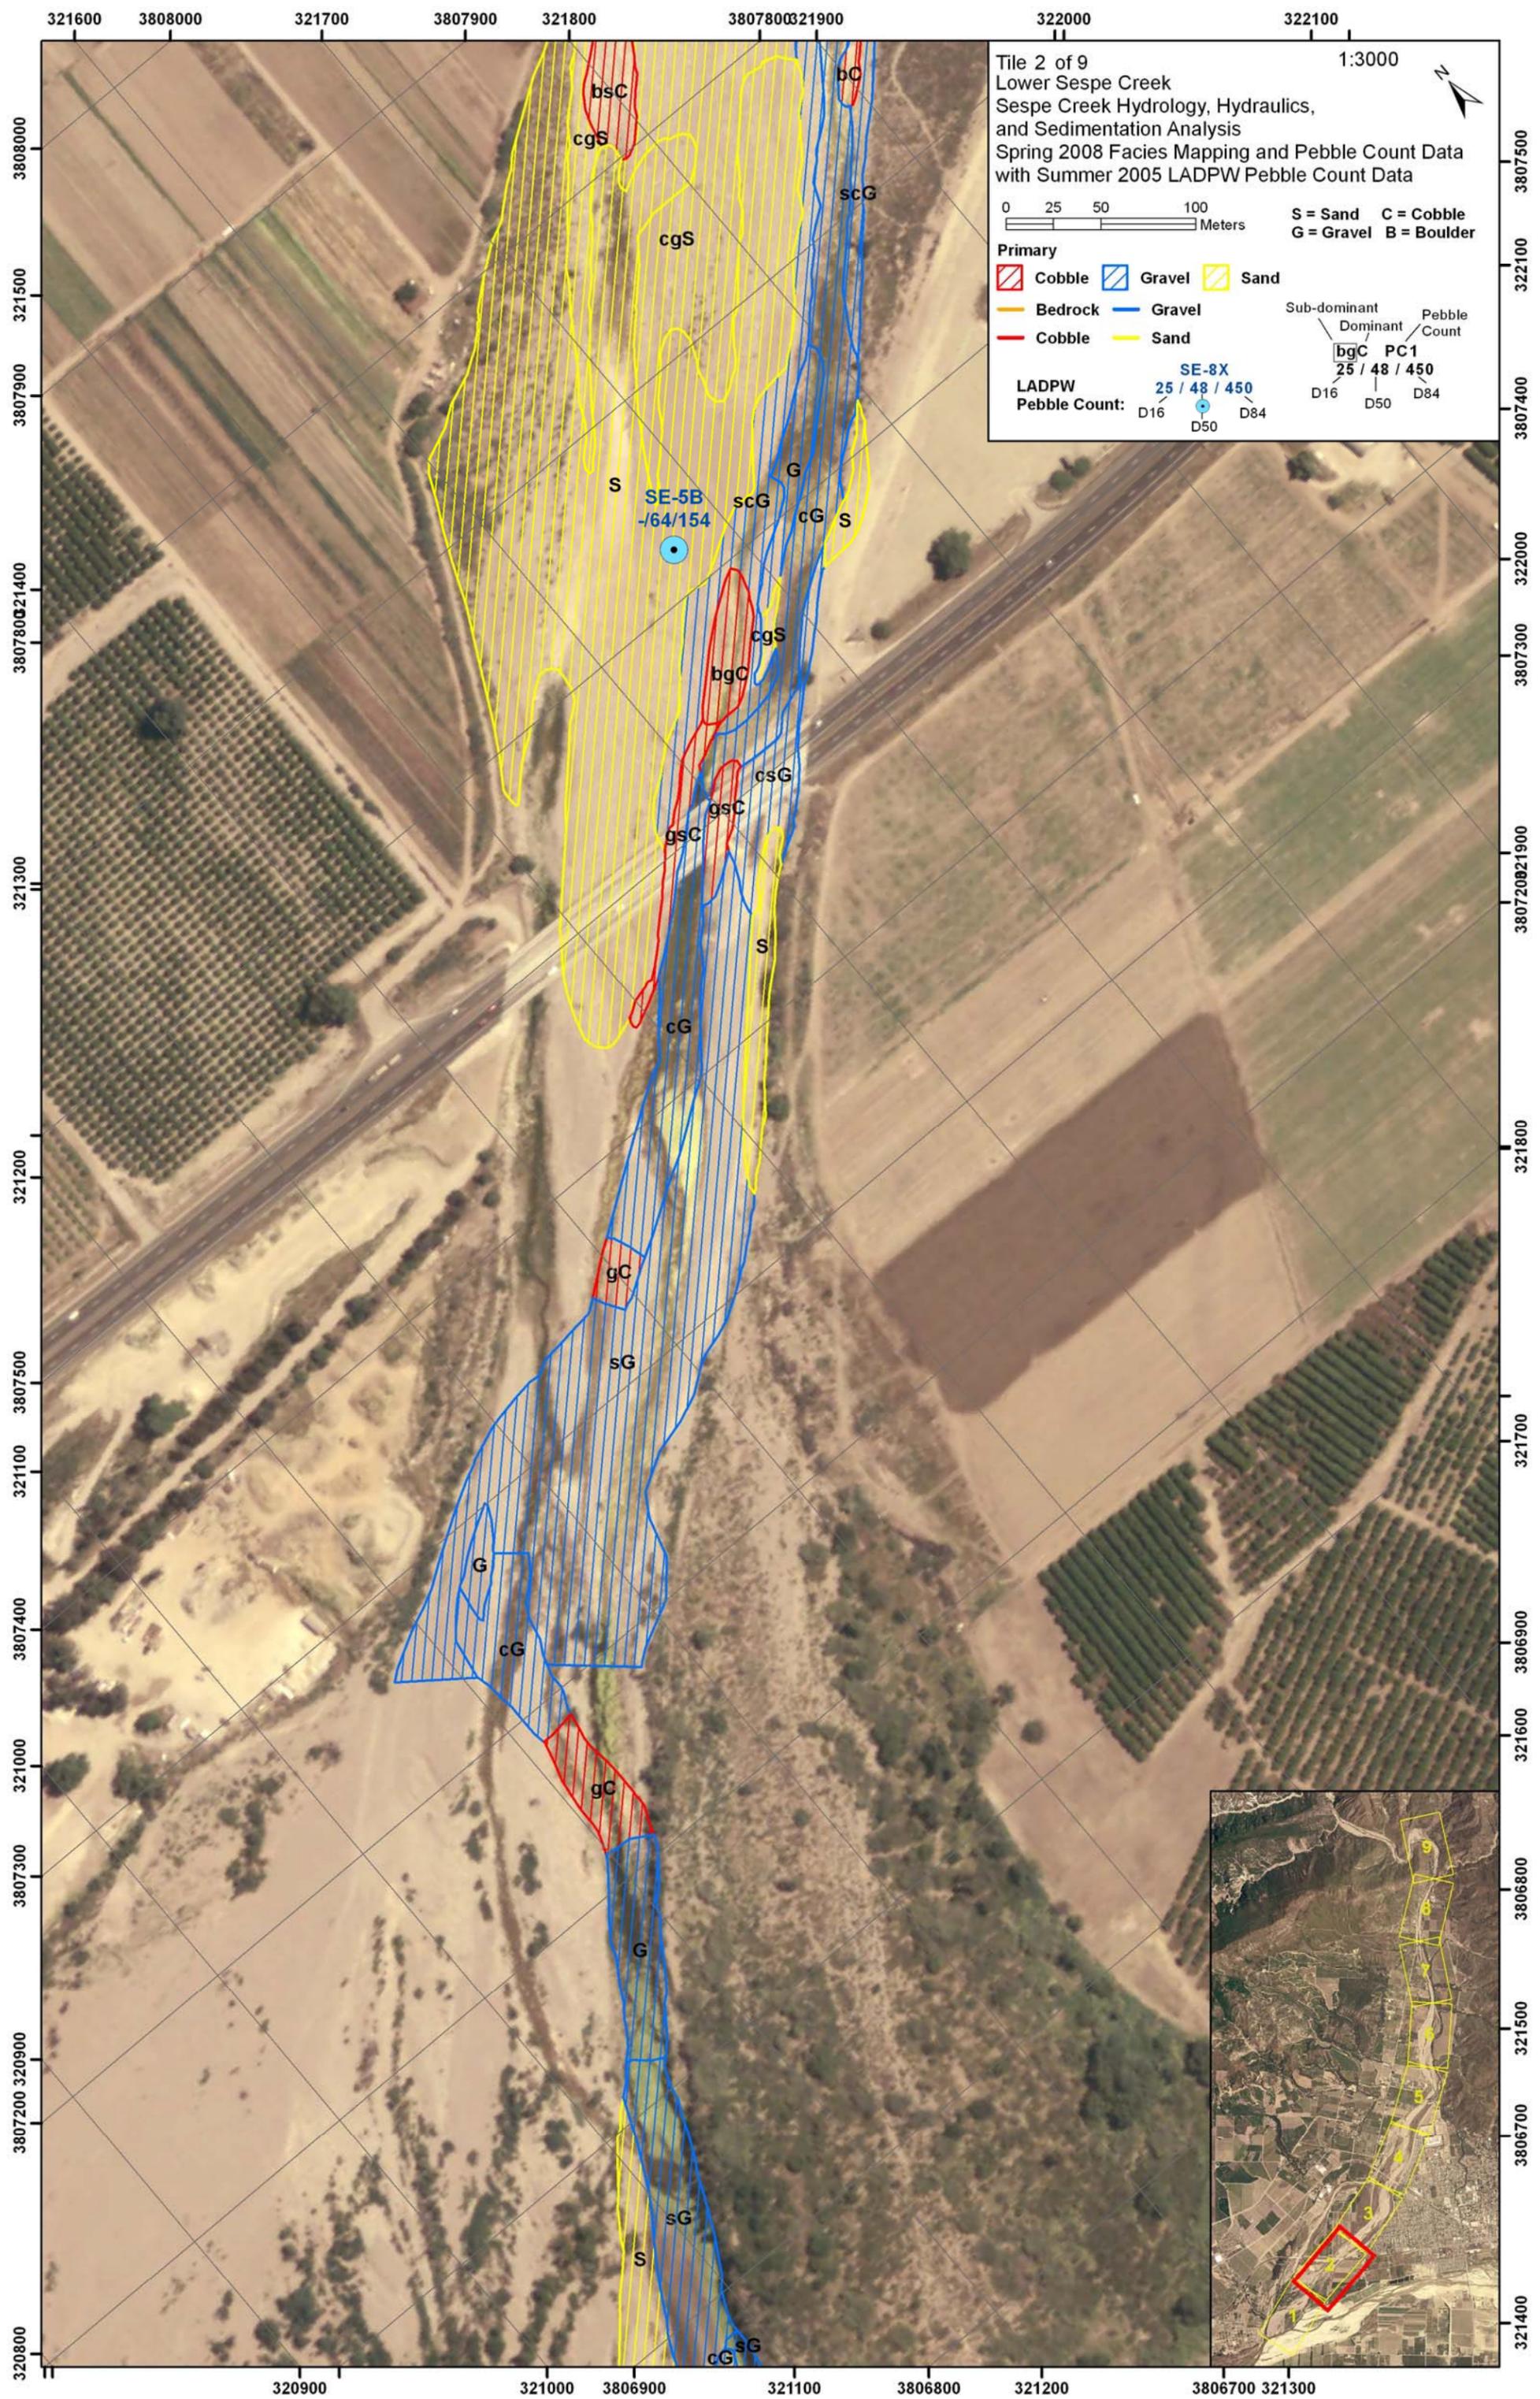
Tile 2 of 9  
 Lower Sespe Creek  
 Sespe Creek Hydrology, Hydraulics,  
 and Sedimentation Analysis  
 Spring 2008 Facies Mapping and Pebble Count Data  
 with Summer 2005 LADPW Pebble Count Data

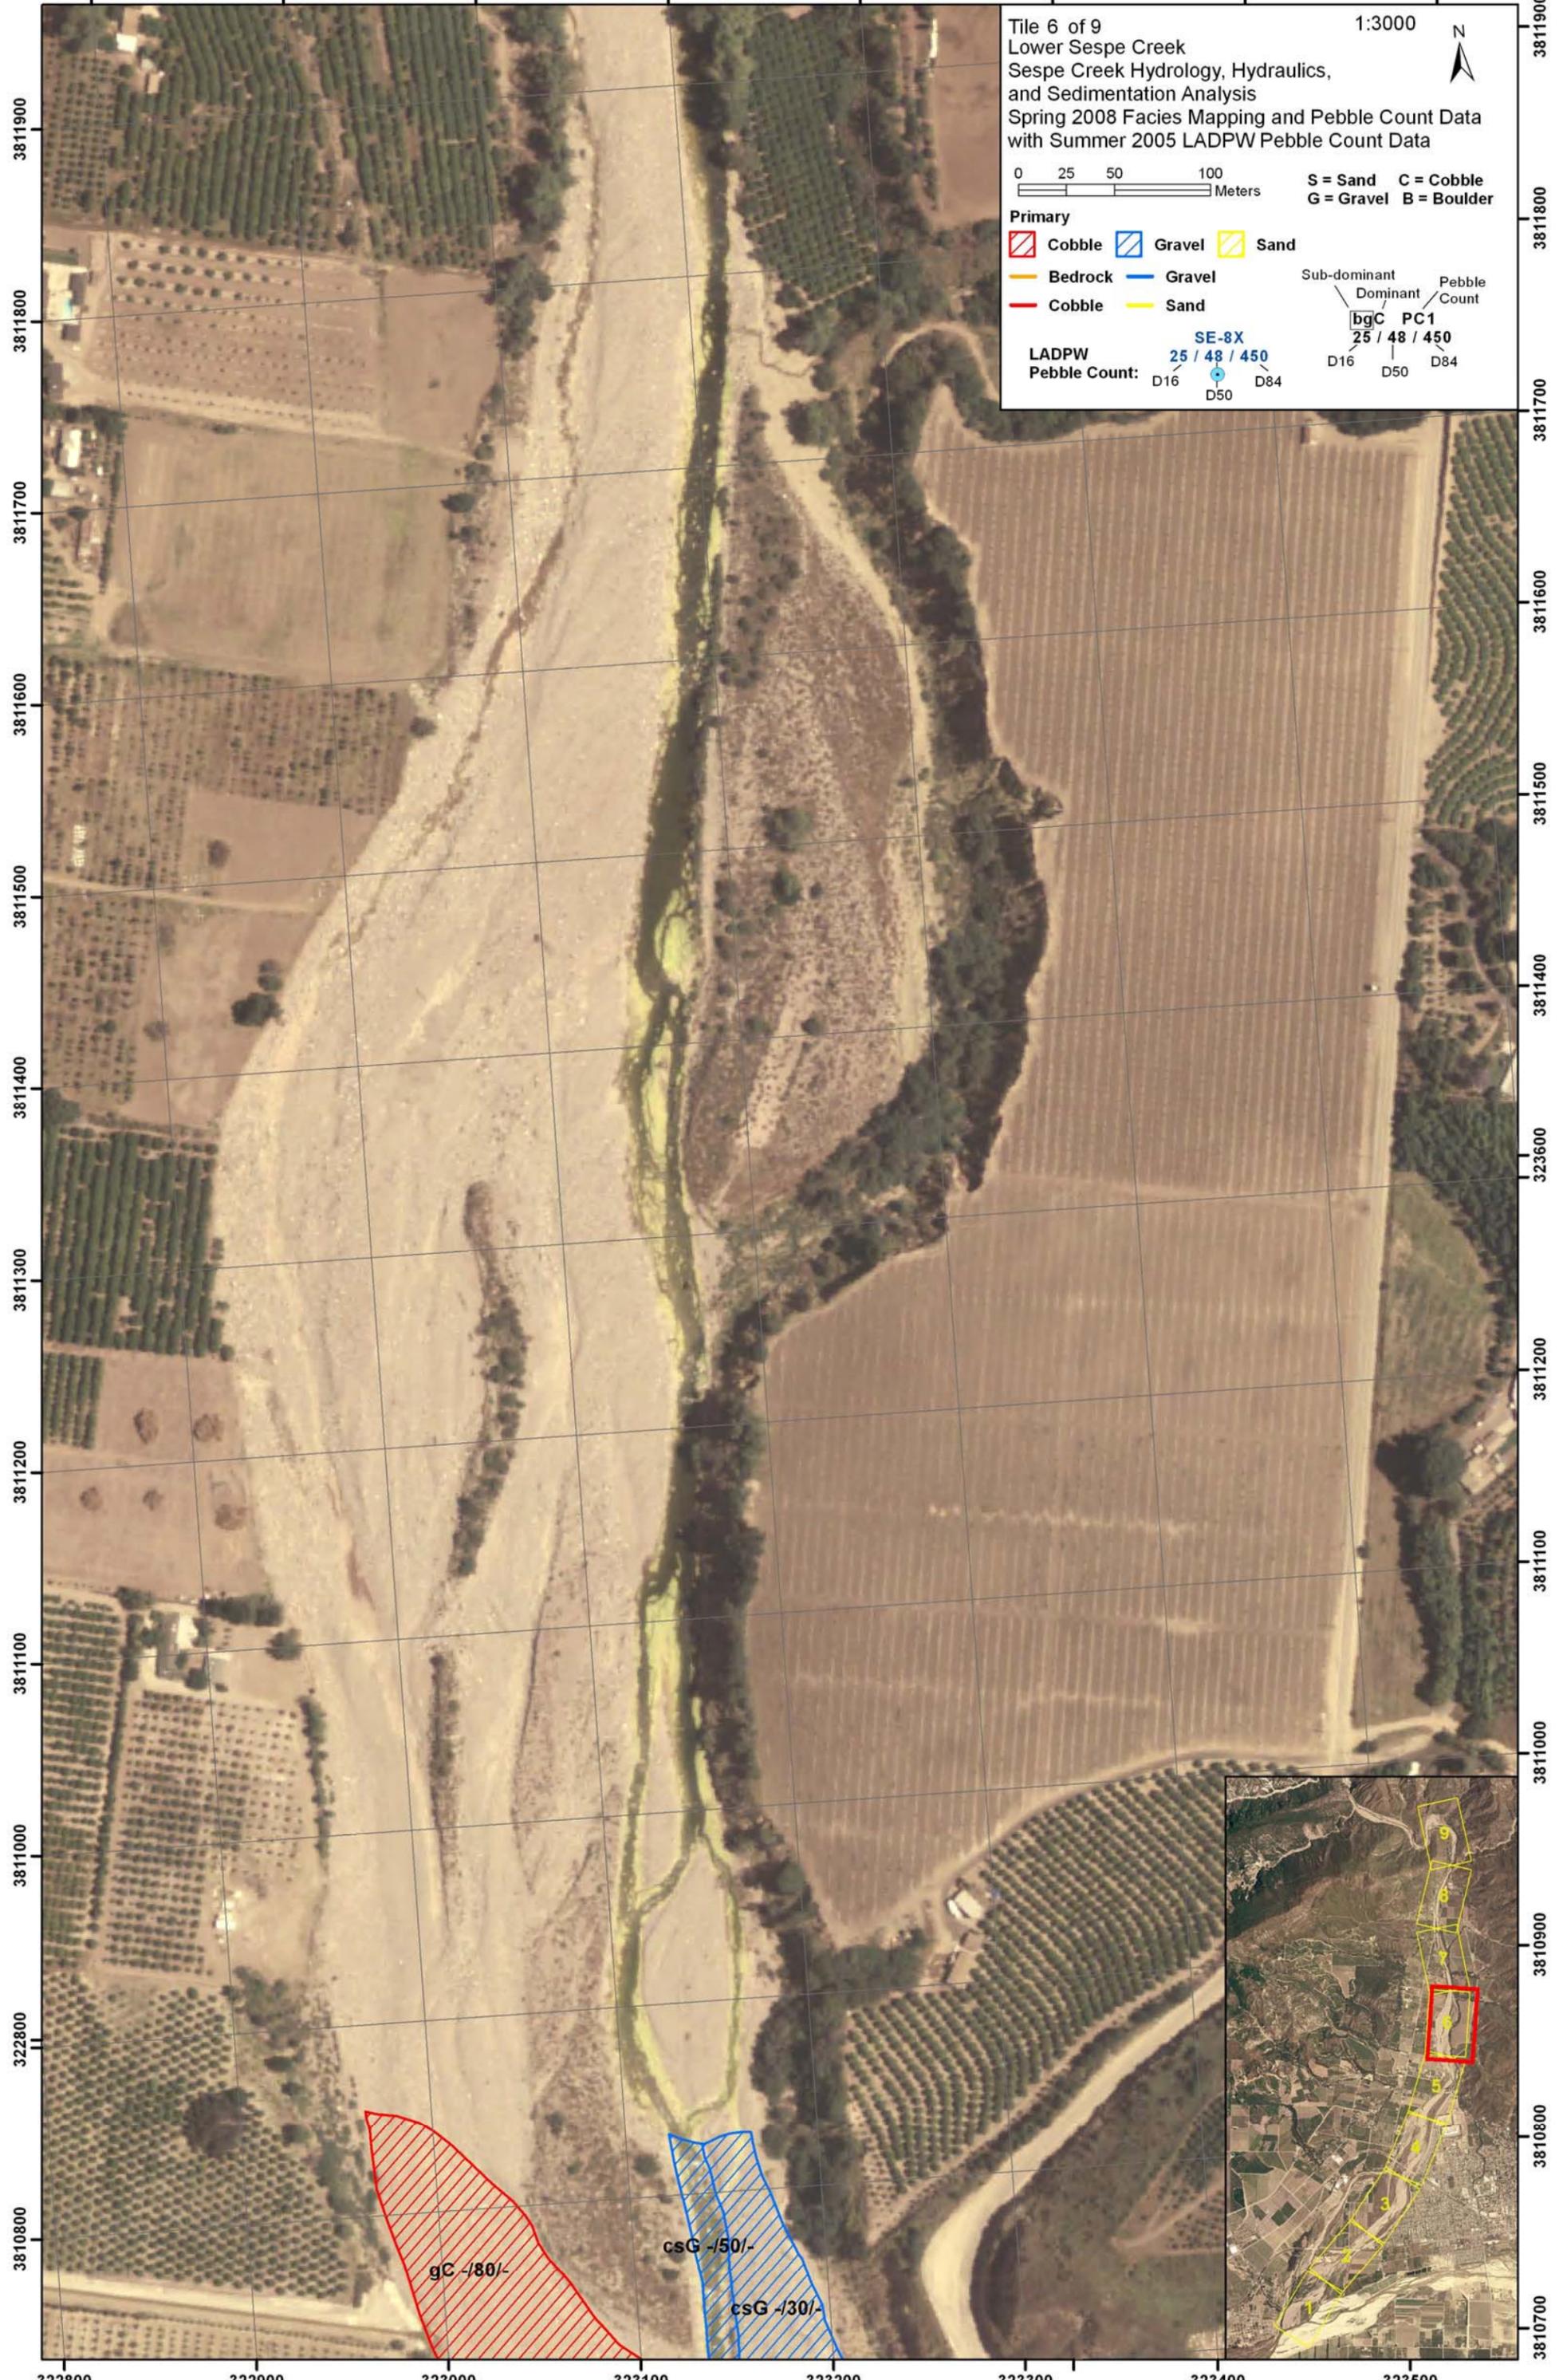
Tile 6 of 9  
 Lower Sespe Creek  
 Sespe Creek Hydrology, Hydraulics,  
 and Sedimentation Analysis  
 Spring 2008 Facies Mapping and Pebble Count Data  
 with Summer 2005 LADPW Pebble Count Data

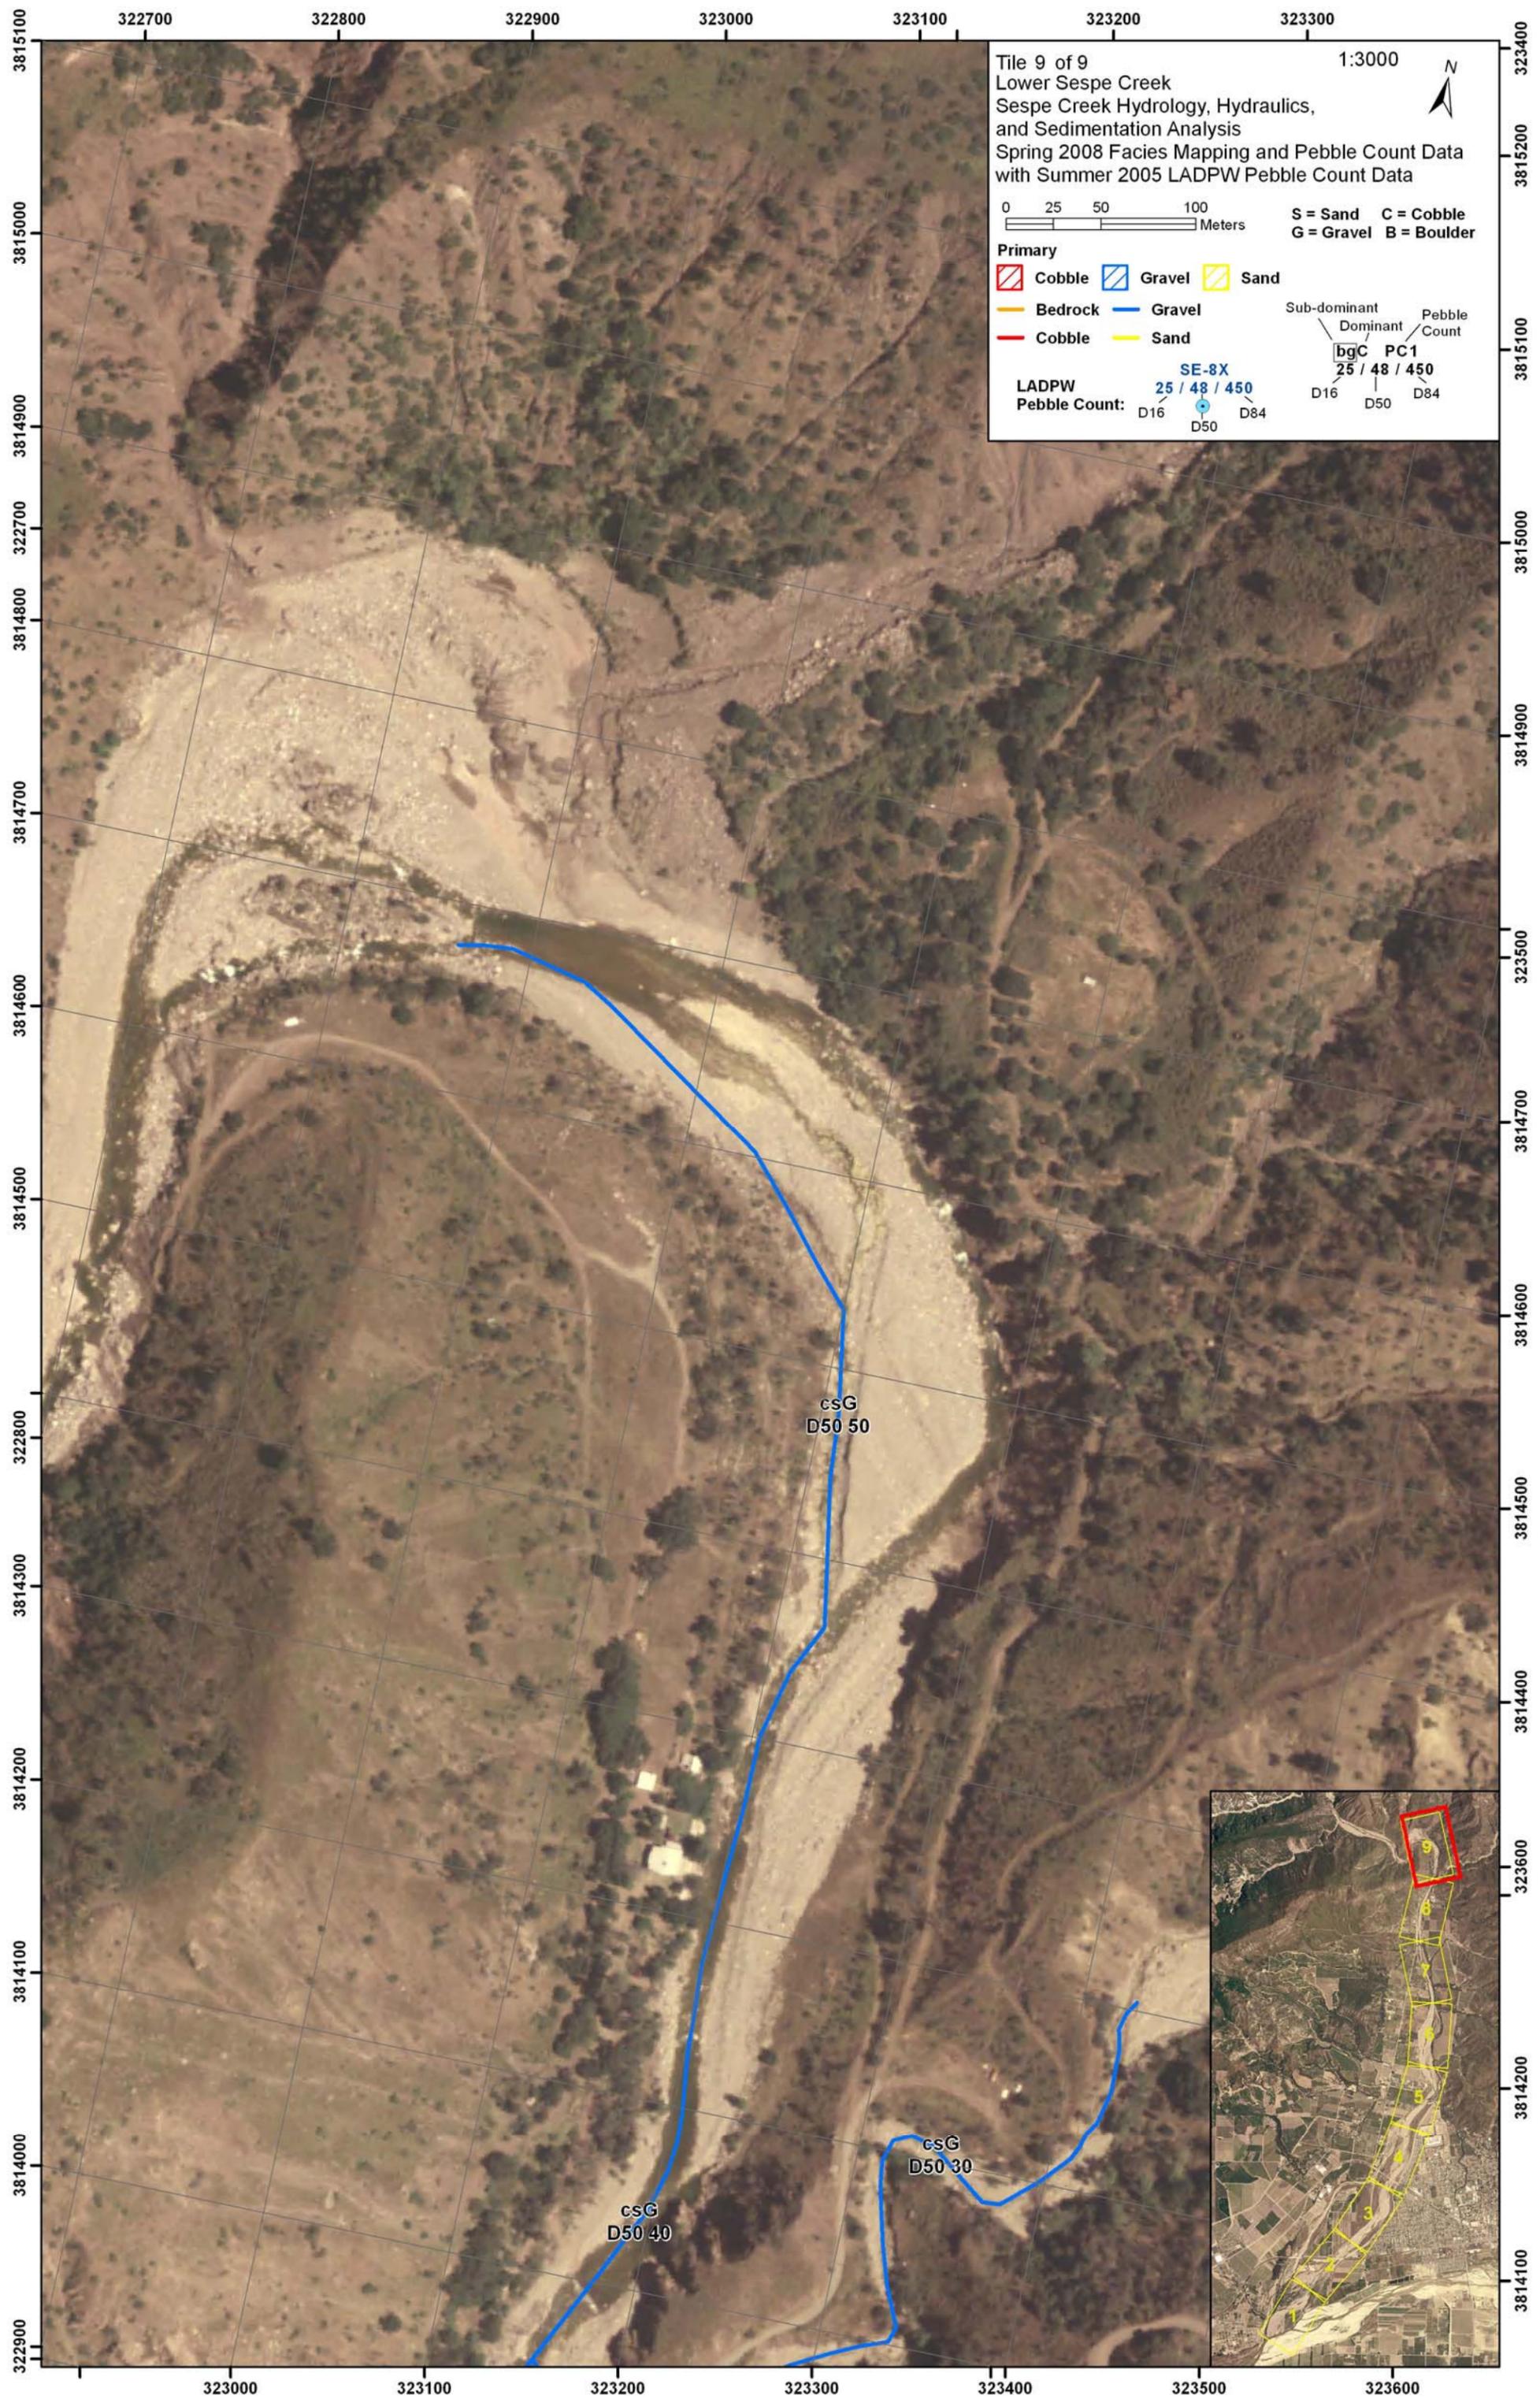
Tile 9 of 9  
 Lower Sespe Creek  
 Sespe Creek Hydrology, Hydraulics,  
 and Sedimentation Analysis  
 Spring 2008 Facies Mapping and Pebble Count Data  
 with Summer 2005 LADPW Pebble Count Data

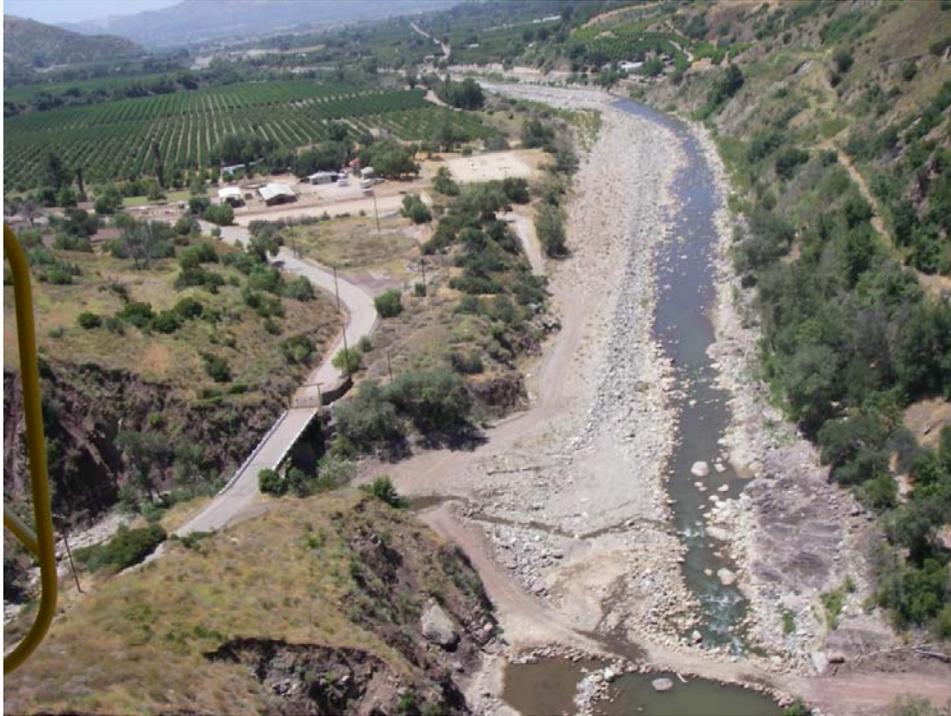
Figure B-1. View of sediment stored at the downstream end of Little Sespe Creek upstream of the Lower subwatershed of Sespe Creek. (Little Sespe Creek enters Sespe Creek under the private road bridge on the left side of the photo.)

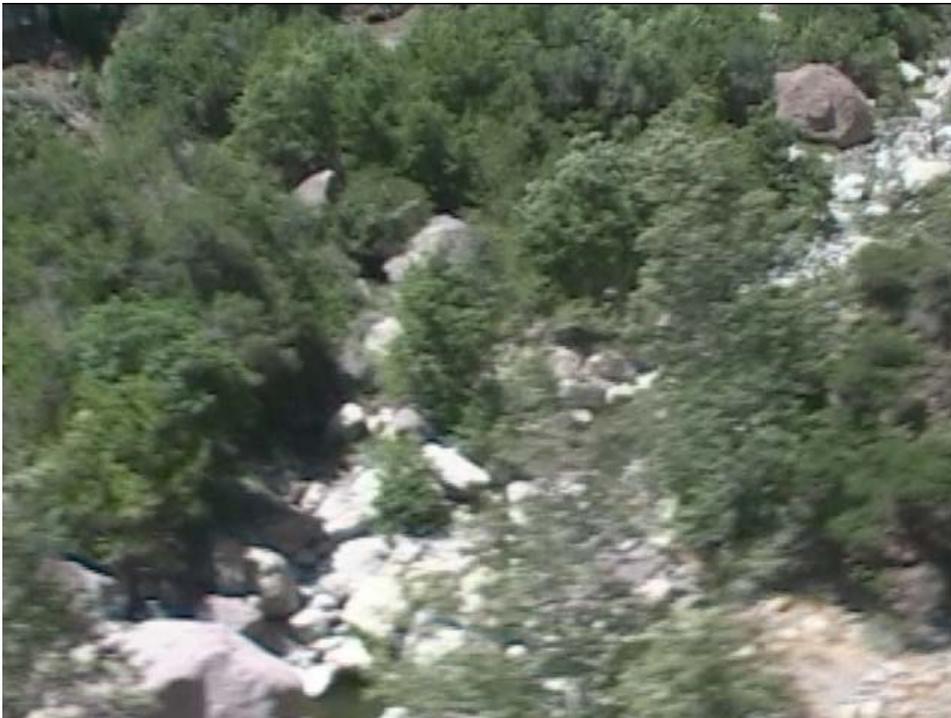
Figure B-2. View of sediment stored at the downstream end of West Fork Sespe Creek in the Lower Gorge reach of Sespe Creek. (View looking upstream.)

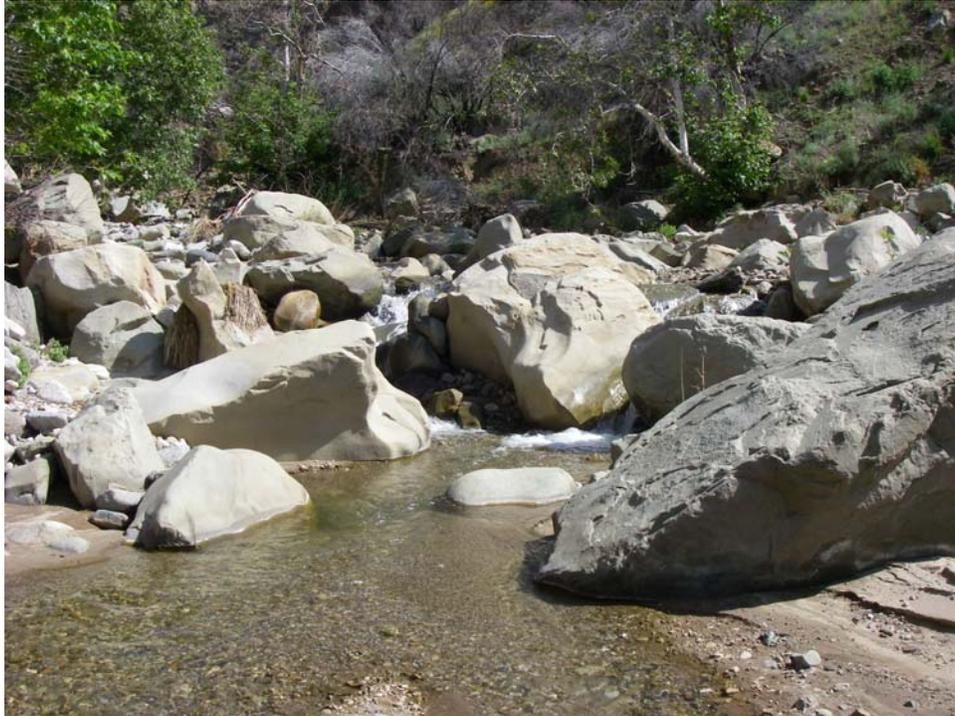
Figure B-3. View of sediment stored at the downstream end of Alder Creek in the Granitics reach of Sespe Creek. (View looking upstream.)

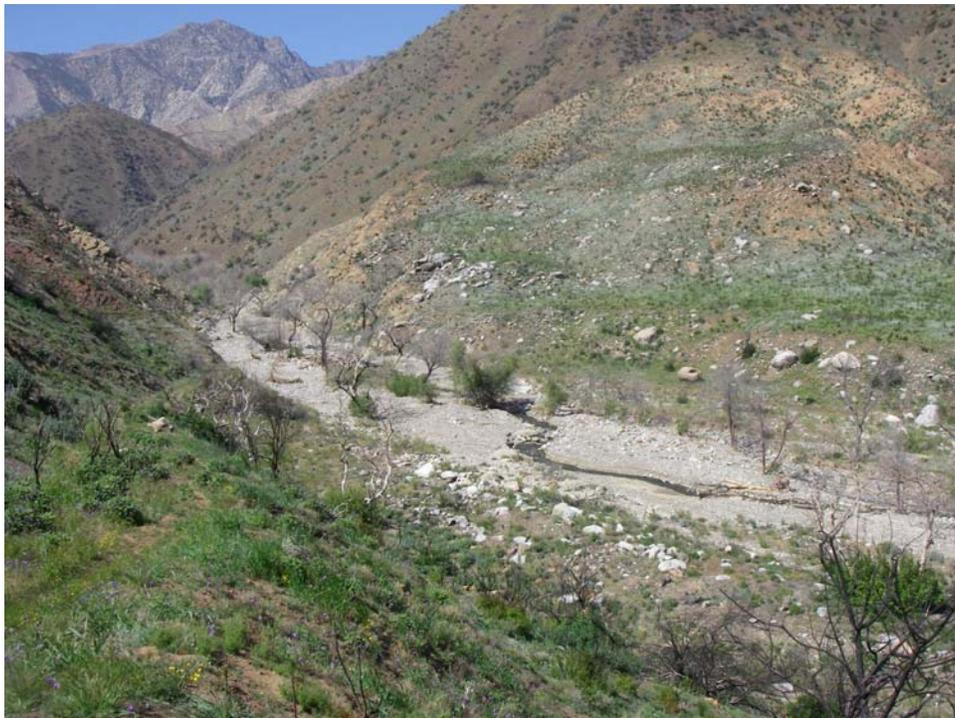
Figure B-4. View of sediment stored at the downstream end of Hot Springs Canyon in the Granitics reach of Sespe Creek. (View looking upstream.)

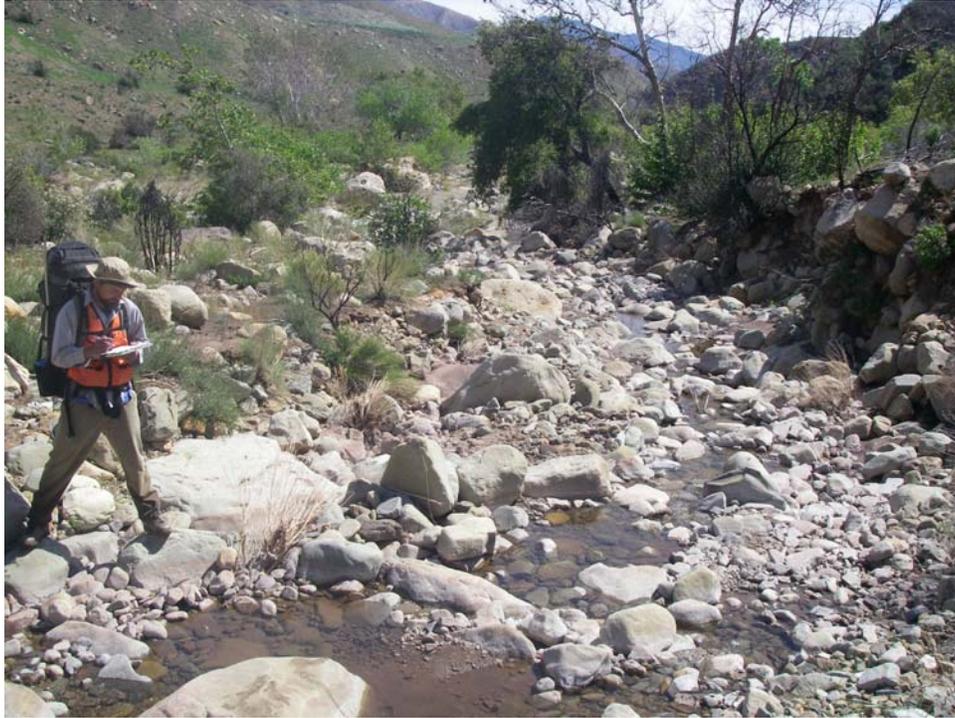
Figure B-5. View of sediment stored at the downstream end of Park Creek in the Middle Terrace reach of Sespe Creek. (View looking upstream.)

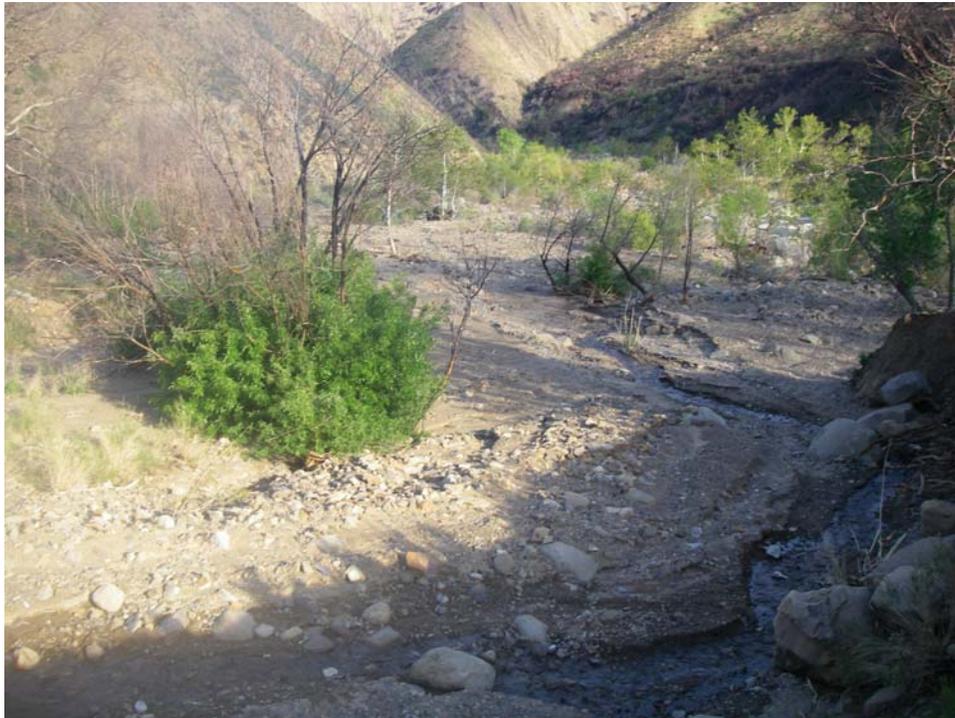
Figure B-6. View of sediment stored at the downstream end of Sycamore Creek in the Middle Terrace reach of Sespe Creek. (View looking upstream.)
