SESPE CREEK HYDROLOGY, HYDRAULICS, AND  
SEDIMENTATION ANALYSIS:

## Watershed Assessment of Hillslope and River Geomorphic Processes

**FINAL REPORT**  
April 2010

*Prepared by*  
Stillwater Sciences  
2855 Telegraph Avenue, Suite 400  
Berkeley, CA 94705

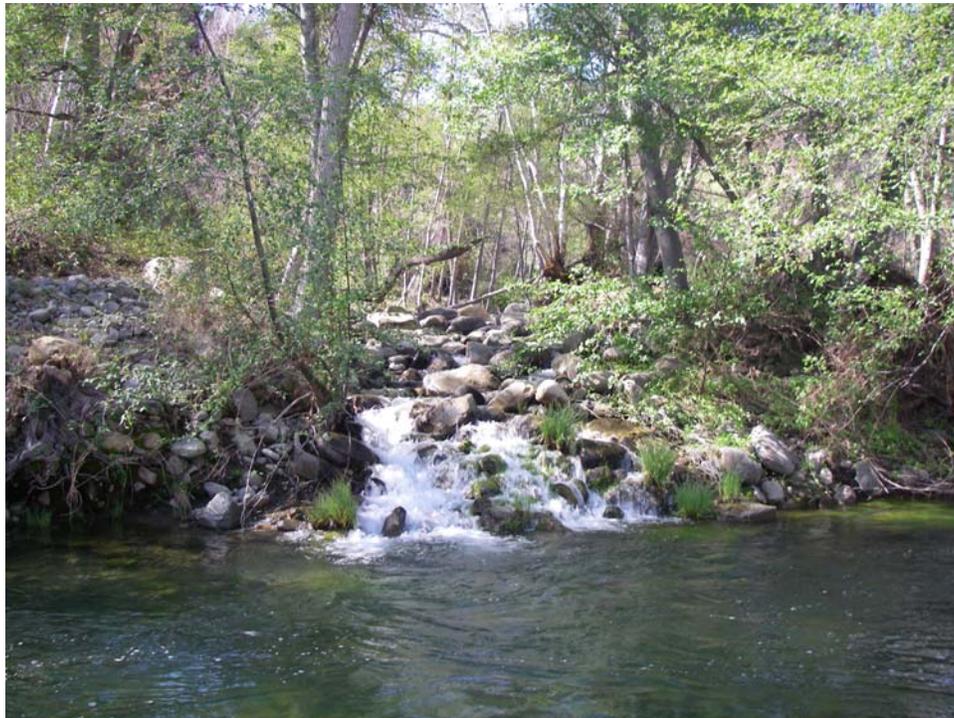
Figure B-8. View of sediment stored at the downstream end of Bear Canyon in the Middle Terrace reach of Sespe Creek. (View looking upstream.)

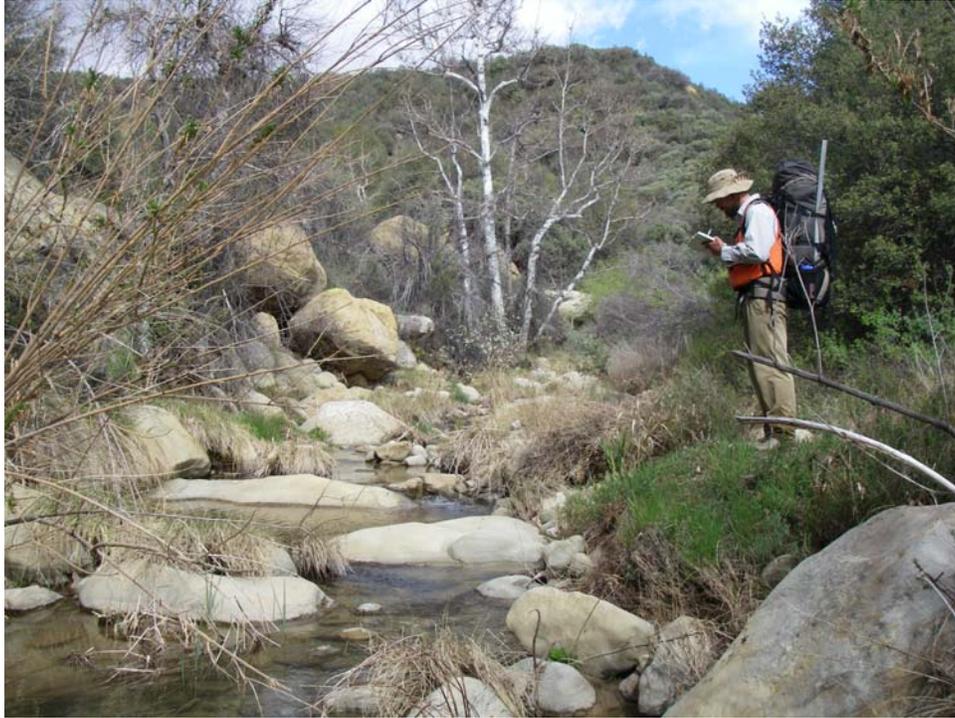
Figure B-9. View of sediment stored at the downstream end of Trout Creek in the Middle Terrace reach of Sespe Creek. (View looking upstream.)

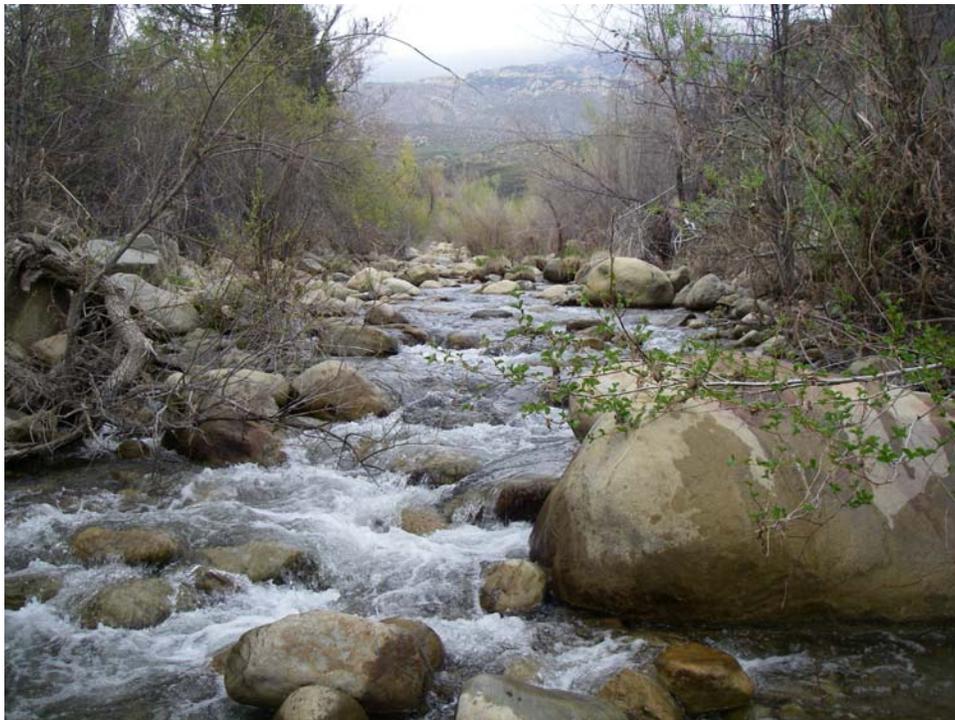
Figure B-10. View of sediment stored at the downstream end of Piedra Blanca Creek in the Upper Terrace reach of Sespe Creek. (View looking upstream.)

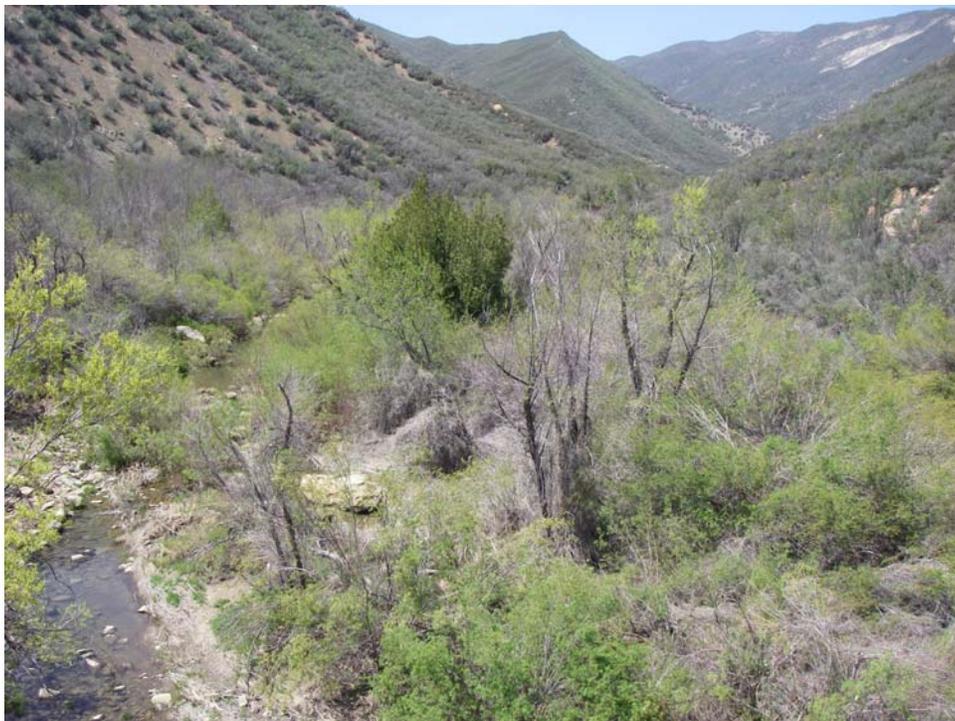
Figure B-12. View of sediment stored at the downstream end of Tule Creek in the Upper Terrace reach of Sespe Creek. (View looking upstream.)

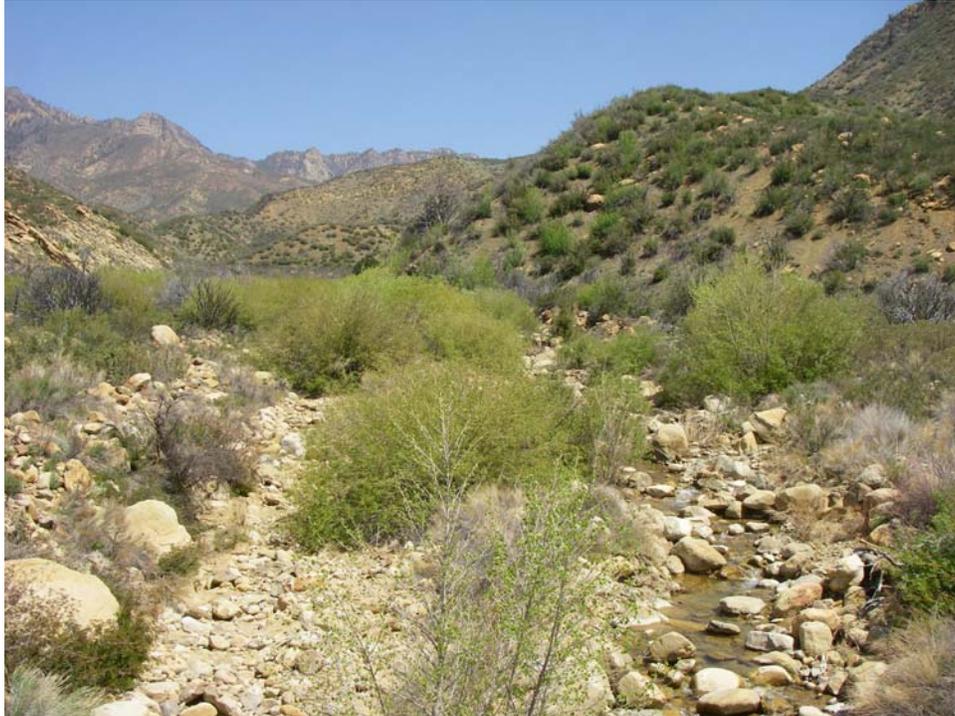
Figure B-13. View of sediment stored at the downstream end of Derry Dale Creek in the Upper Gorge reach of Sespe Creek. (View looking upstream with new vegetation growth on hillslopes burned by the 2002 Wolf Fire.)

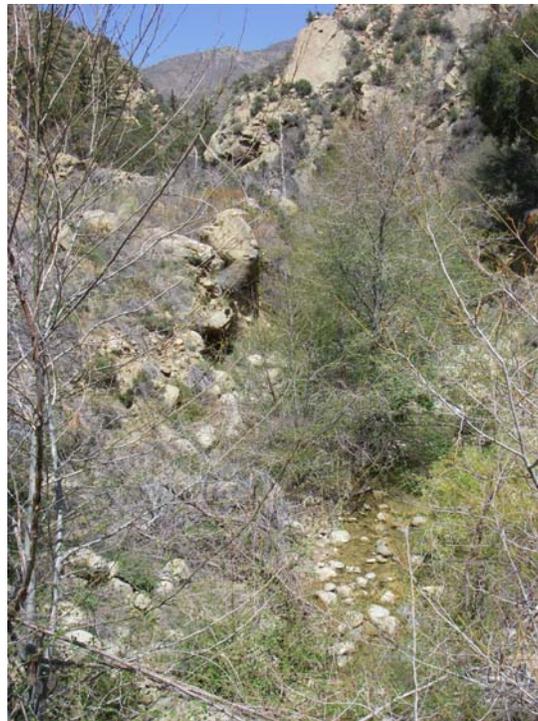
Figure B-14. View of sediment stored at the downstream end of Potrero John Creek in the Upper Gorge reach of Sespe Creek. (View looking upstream.)

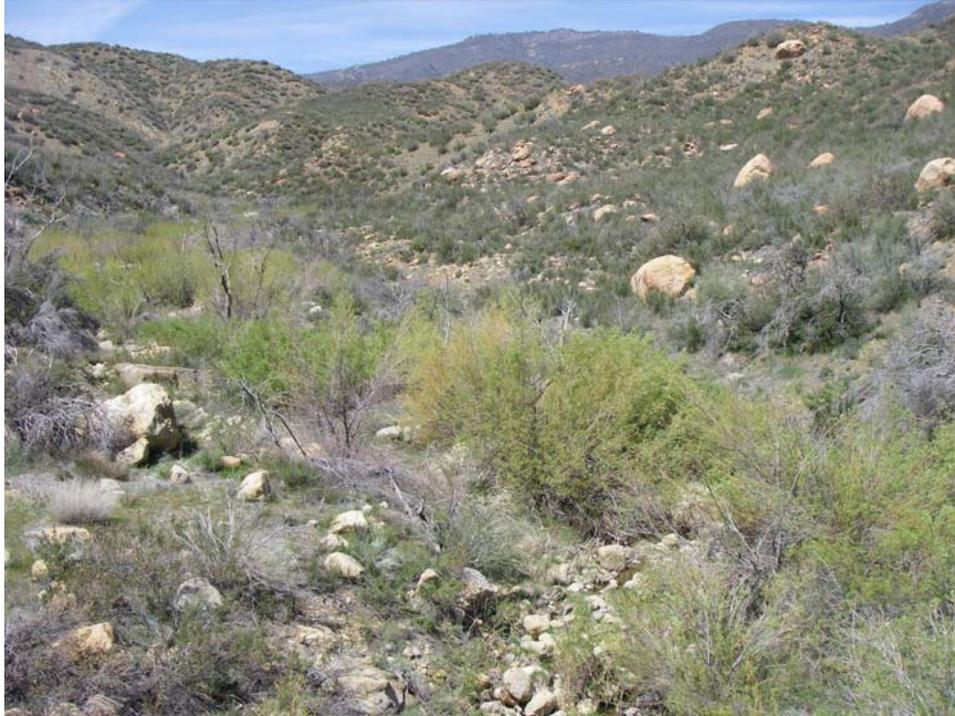
Figure B-15. View of sediment stored at the downstream end of Munson Creek in the Upper Gorge reach of Sespe Creek. (View looking upstream.)

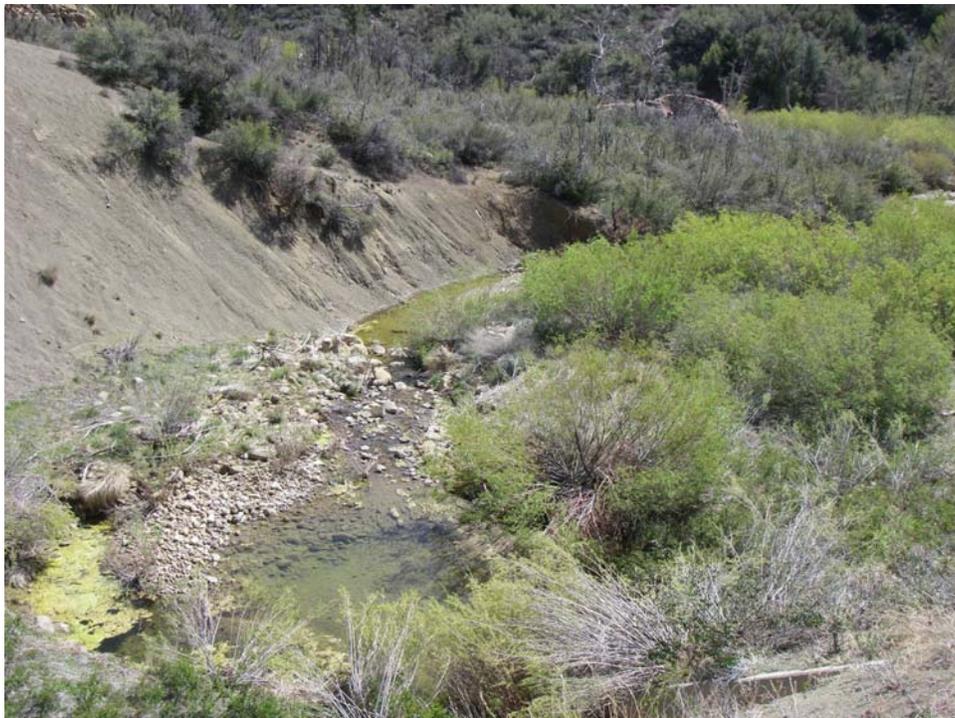
Figure B-16. View of sediment stored at the downstream end of Burro Creek in the Upper Gorge reach of Sespe Creek. (View looking downstream.)

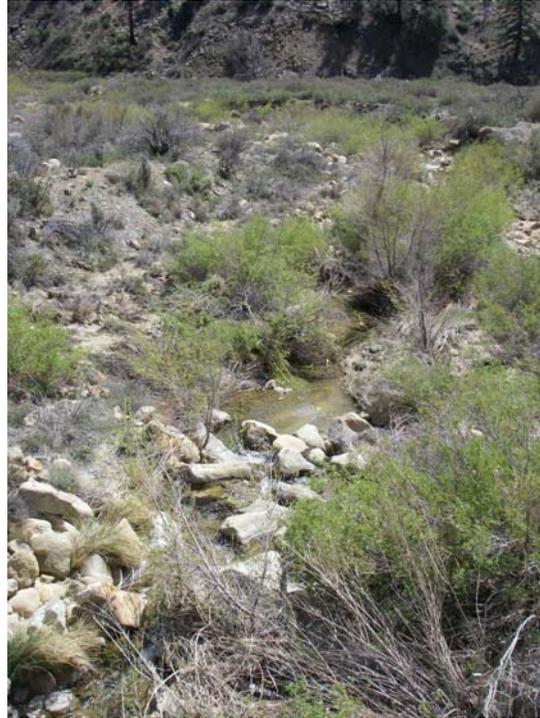
Figure B-17. View of sediment stored at the downstream end of Chorro Grande Creek in the Wash reach of Sespe Creek. (View looking downstream.)

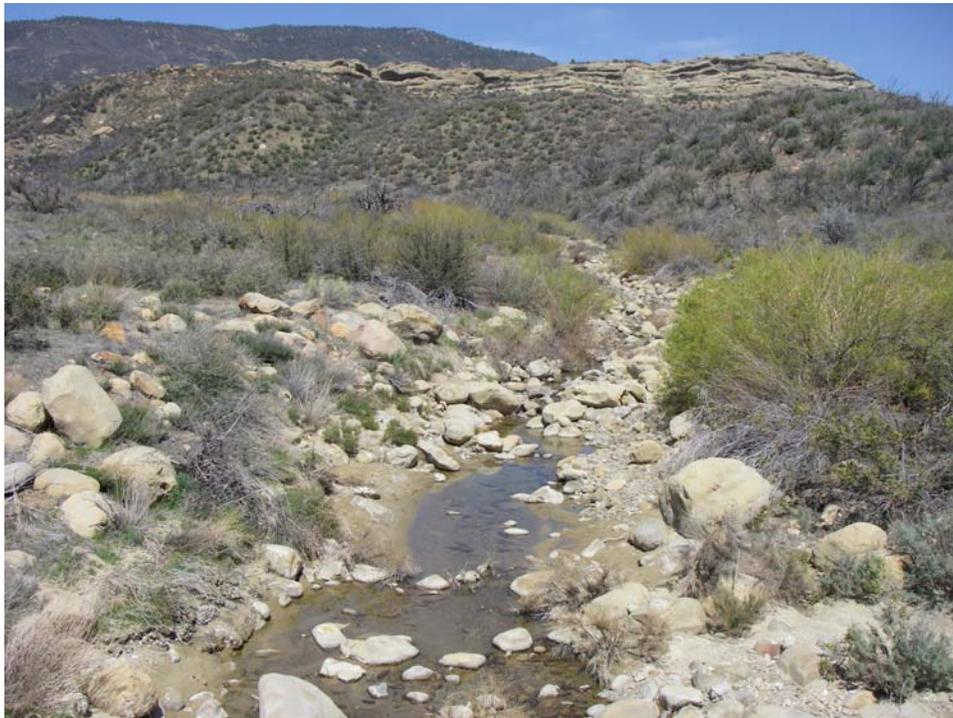
Figure B-18. View of sediment stored at the downstream end of Godwin Creek in the Wash reach of Sespe Creek. (View looking upstream.)

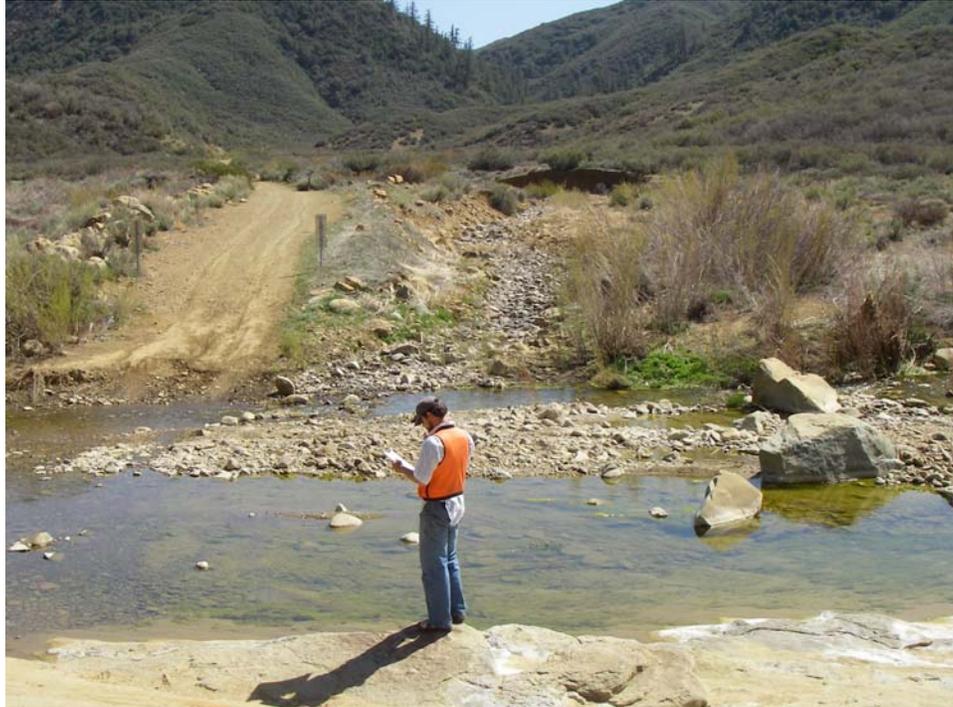
Figure B-19. View of sediment stored at the downstream end of Cherry Creek in the Wash reach of Sespe Creek. (View looking upstream.)
