Santa Paula Creek Watershed Assessment and Steelhead Restoration Plan

Santa Paula Creek Watershed Assessment and Steelhead Restoration

January 2009

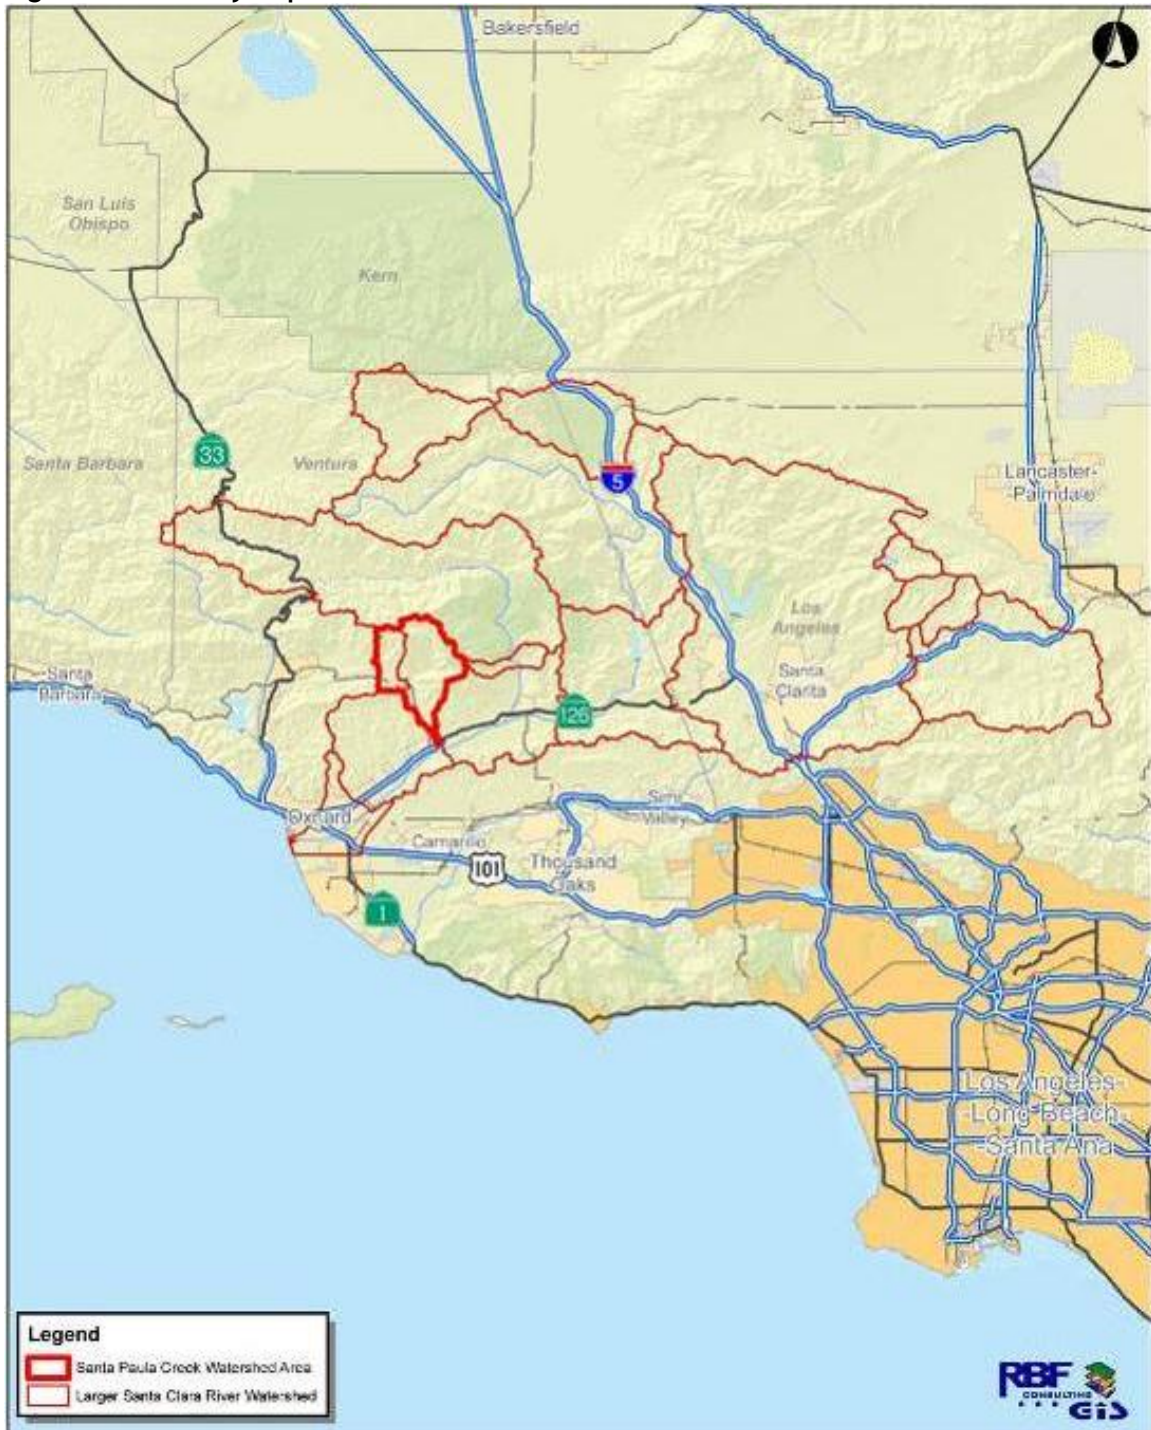
Figure 1-1: Vicinity Map and Santa Clara River Watershed

Santa Paula Creek is a major tributary to the Santa Clara River, draining approximately 44.4 square miles (Figure 1-1). The headwaters are located along the south-facing slopes of the Topatopa Mountains where the maximum watershed elevation is over 6,500 above mean sea level [MSL]. The downstream limit of the watershed is at the creek confluence with the Santa Clara River. The major tributaries within the lower Santa Paula Creek watershed include Sisar Creek, Anlauf Canyon, and Mud Creek.

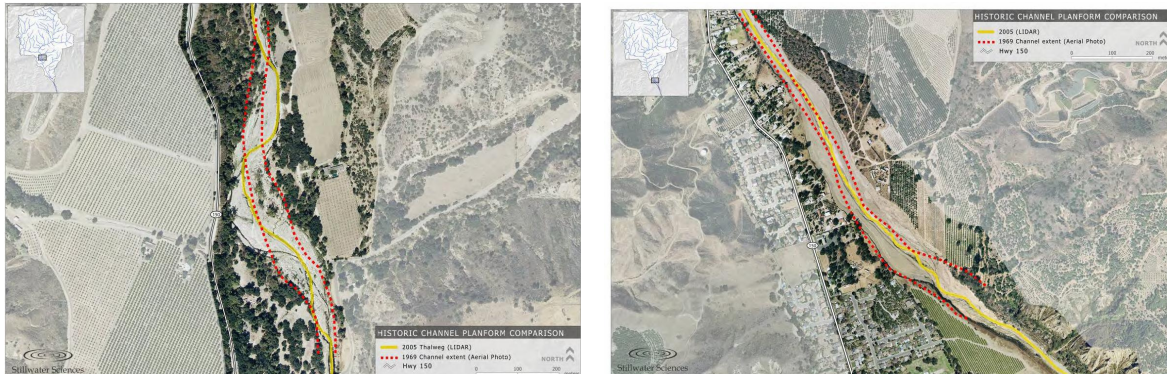
Figure 3-2: Historic (1969) and current (2005) channel width comparison in Reaches 2 and 7/8

Channel morphologic characteristics (channel thalweg location, channel thalweg elevation/slope, and channel width) in Santa Paula Creek were compared over the past 100 years to determine how the channel has responded to watershed perturbations such as major storm events, changes in sediment and/or water input, and in-channel modifications (e.g., in-channel structures and sediment removal). Data sources included orthorectified topographic maps from 1901, 1947, and 2005, and aerial photography from 1969, 1998, and 2005. Over the past 100 years, Santa Paula Creek between the Sisar Creek confluence/Highway 150 bridge and the Mud Creek confluence/Harvey Diversion Dam has migrated within an active channel valley with pronounced incision at the upstream end followed by pronounced channel downstream aggradation and localized channel widening in downstream portion of the zone. Compared to the upstream geomorphic zone, Santa Paula Creek downstream of the Mud Creek confluence/Harvey Diversion Dam shows significant variations in position, elevation, and width from 1901 to 2005. Specifically, this geomorphic zone is characterized by a long depositional reach characterized by channel slope decrease and local widening located between reaches with significant channel incision. Figures 3-2 and 3-3 illustrate the changes visible in the creek's form and vegetation over several decades in the twentieth century. Further details are provided in the Geomorphology and Channel Stability Assessment Report (Stillwater Sciences 2007).

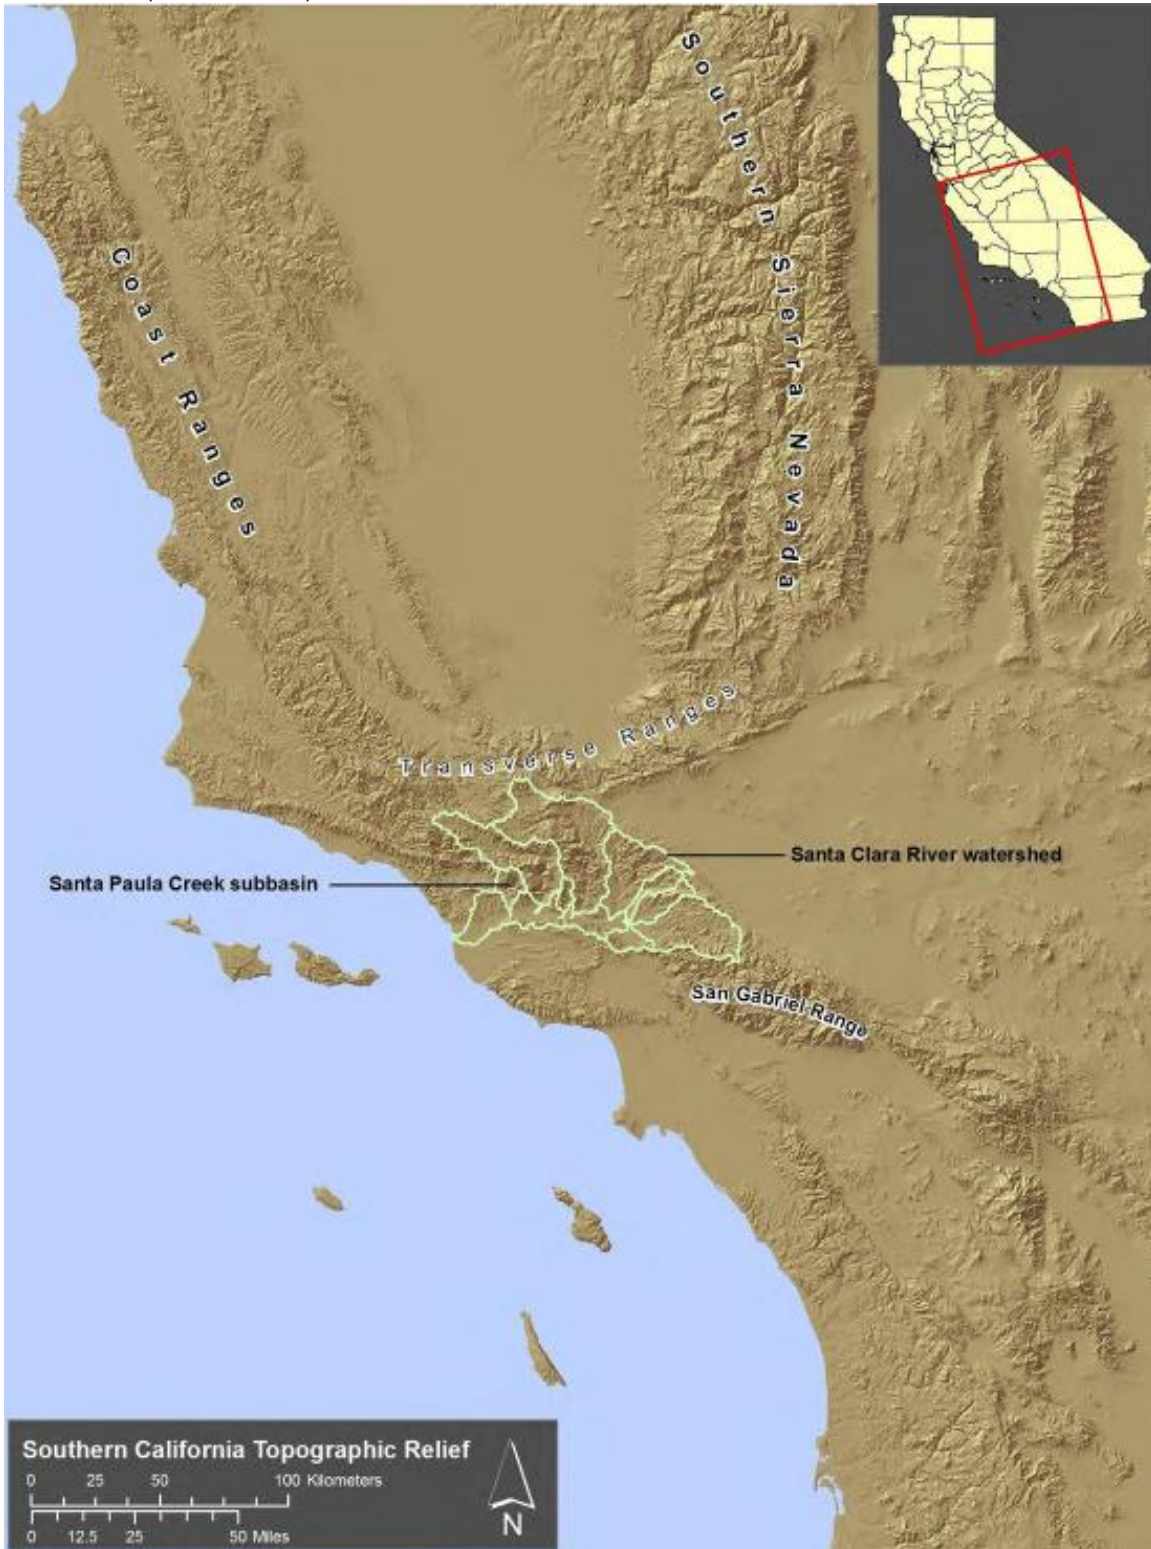
Figure 4-1: Relief Map of Southern California showing location of Santa Paula Creek watershed (or sub-basin) within the Santa Clara River Watershed

The Santa Paula Creek watershed is a subwatershed within the larger Santa Clara River watershed (Figure 4-1), which is one of the largest watersheds in Southern California. The Santa Clara River Valley contains the city of Santa Paula, with a population of slightly less than 29,000 (US Census, 2000). The headwaters to the Santa Paula Creek are located along the south-facing slopes of the Topatopa Mountains where the maximum watershed elevation is over 6,500 above mean sea level [MSL]. The downstream limit of the watershed is at the creek confluence with the Santa Clara River. The major tributaries within the lower Santa Paula Creek watershed include the Upper Santa Paula Creek, Middle Santa Paula Creek, Lower Santa Paula Creek, Sisar Creek, Anlauf Canyon, and Mud Creek.

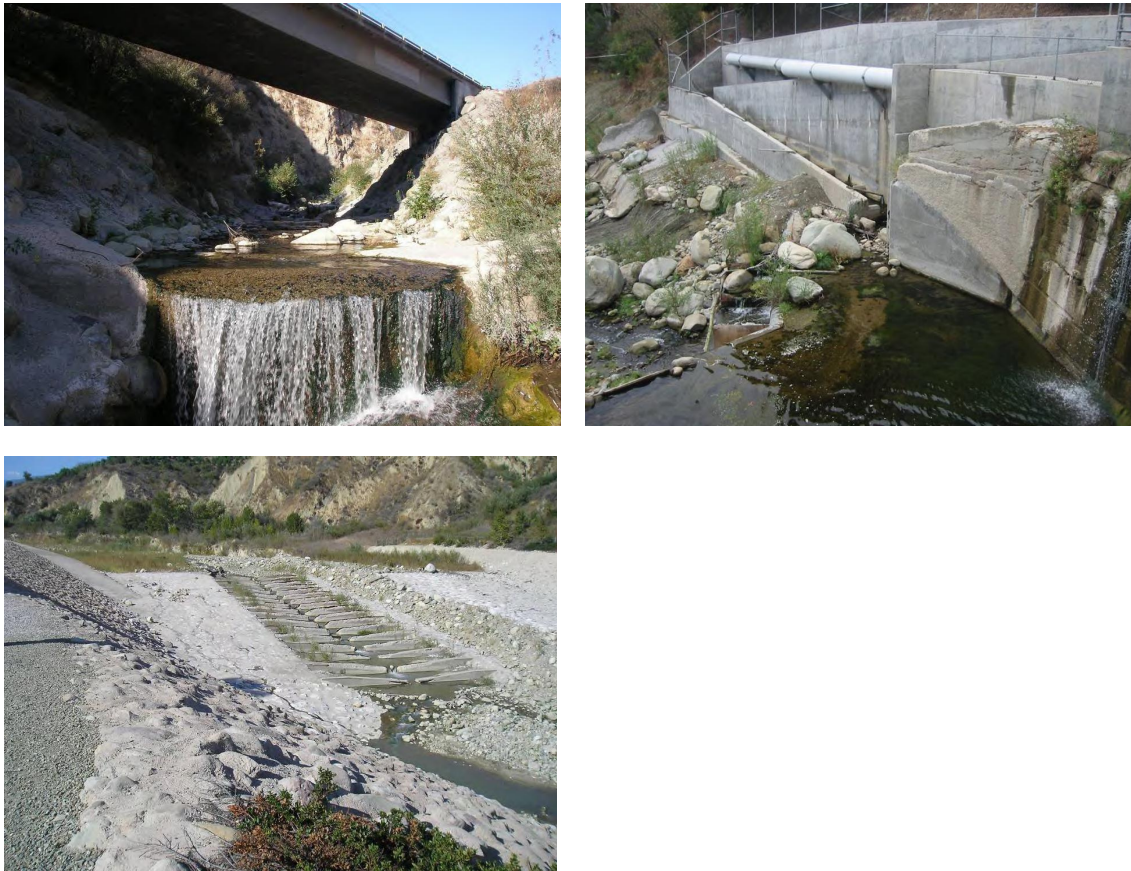
Figure 4-2: Photographs of damaged fish ladder facilities (from left to right, Hwy 150 Bridge, Harvey Diversion, USACE Fish ladder).

The creek is one of three historic spawning tributaries to the Santa Clara River for the endangered southern steelhead trout. The creek holds approximately 18.5 miles of habitat historically accessible to steelhead (Stoecker and Kelley 2005). The record floods of January and February 2005 severely damaged fish passage facilities and caused significant channel incision and bank erosion in the lower reaches of Santa Paula Creek, resulting in complete barriers to upstream fish passage and major damage to properties located within the floodplain. Damaged facilities include the fish ladder at the upstream end of the USACE channelization project in lower Santa Paula Creek, the Harvey Diversion fish ladder near the confluence with Mud Creek, and the Highway 150 drop structure near the confluence of Santa Paula and Sisar creeks (Figure 4-2).

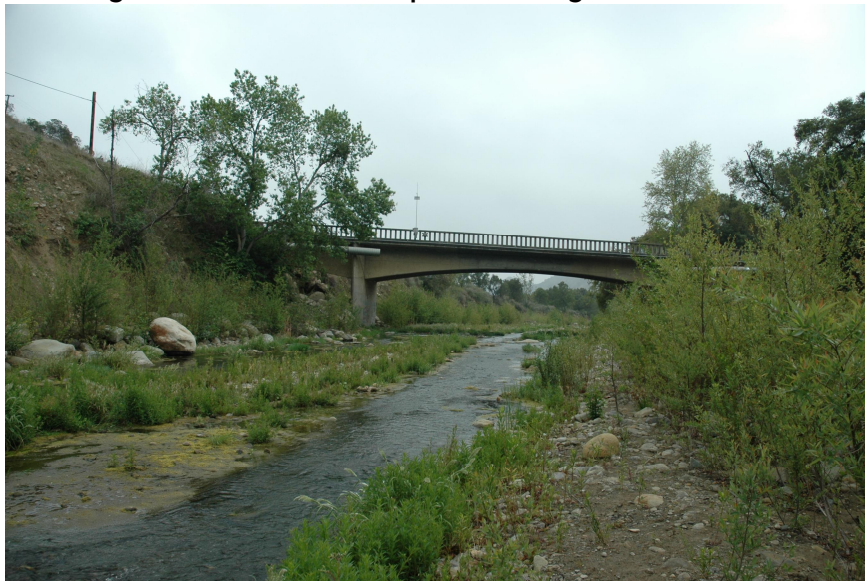
Figure 4-10: Looking downstream at the Mupu Road Bridge.

The Mupu Road Bridge crosses Santa Paula Creek within Steckel Park (reach 3). The bridge was constructed in 1946 over a confined channel reach and includes a 3-span reinforced concrete section. Only minor riprap bank protection is included at the bridge to provide local scour protection for the bridge abutments.

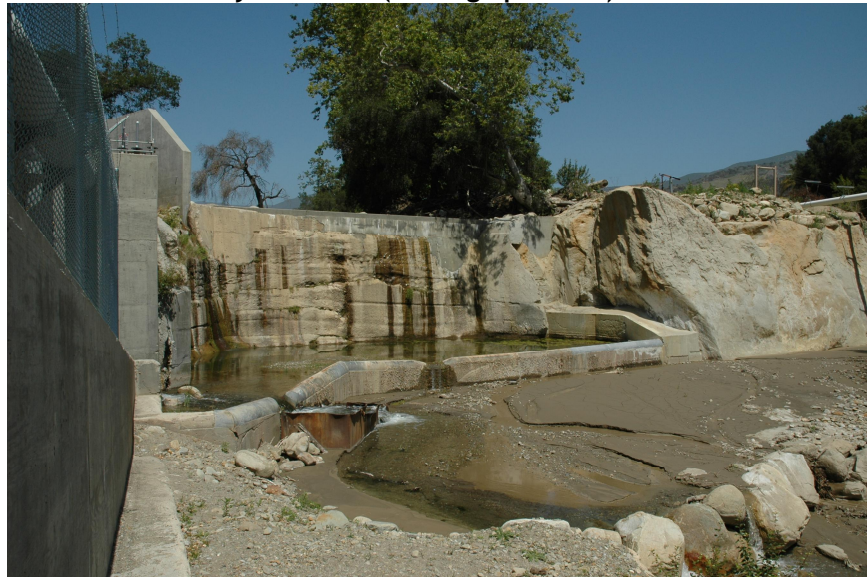
Figure 4-11: Below the Harvey Diversion (looking upstream).

The original structure was built 6 ft high in 1910 and increased to 23 ft by 1923 (NMFS Southwest Regional Office website [<http://swr.nmfs.noaa.gov/hcd/soCalDistrib.htm>]). Repairs were made to the diversion in 1928, the facility was rebuilt in 1941, and additional cap repairs were made after major storm events in 1966, 1969, and 1987 (USACE 1995). Recently, sediment transported over the diversion during the 2005 storm event scoured a notch at the top of the diversion, prompting repairs. The fish ladder on the right-bank side of the diversion was initially constructed in 1939, rebuilt in 1950, and rebuilt again in 2000 to increase fish passage (USACE 1995, NMFS Southwest Regional Office website [<http://swr.nmfs.noaa.gov/hcd/soCalHistoric.htm>]). Subsequent storm events following construction of the new fish ladder in-filled the lower portion of the ladder with sediment and caused associated structural damage. Until recently, the fish ladder was disconnected from the Creek during all but moderate to high storm flows as a consequence of the 2005 storm. The 2007 diversion repair work included the installation of 4 rock weirs downstream of the existing ladder to re-establish the channel invert. However, based on a field review of the improvements, the rock weirs do not appear to provide fish passage in accordance with California Department of Fish and Game criteria, nor do they appear to be designed to withstand the impacts of a large storm event.

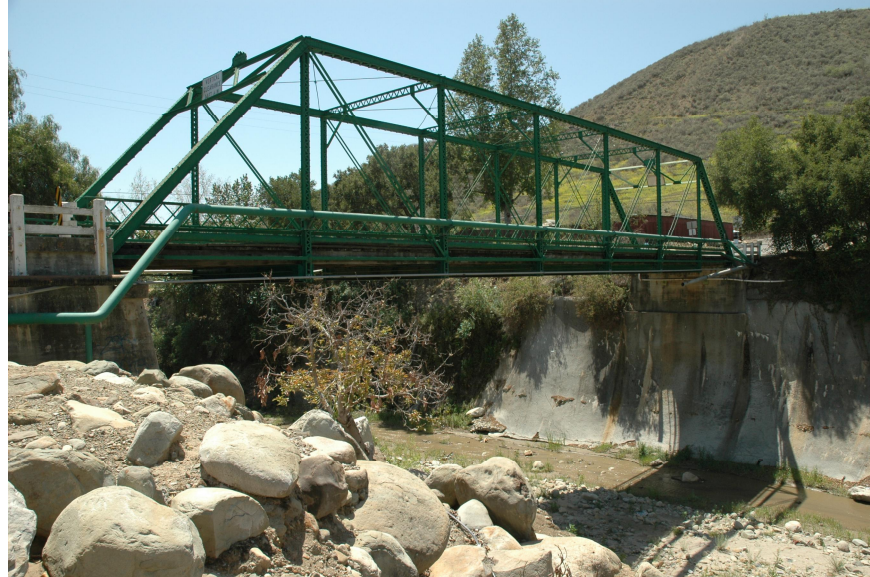
Figure 4-12: Bridge Road Bridge crossing of the confined stream reach.

The Bridge Road Bridge is a historic structure that crosses the creek over the confined limits of the canyon reach downstream of the Harvey Diversion (reach 6). The bridge was originally constructed as a single-span truss bridge at the turn of the century. The bridge was rehabilitated

in 1999 to stabilize the bridge abutments as a result of significant erosion and downcutting of the creek. The work included soil nails to stabilize the west abutment and shotcrete bank protection to prevent additional scour at the bridge abutments. In the current creek configuration, the bridge completely spans the channel section and provides no restriction to channel flow or sediment transport. However, the bridge does limit the potential for channel widening in this location.

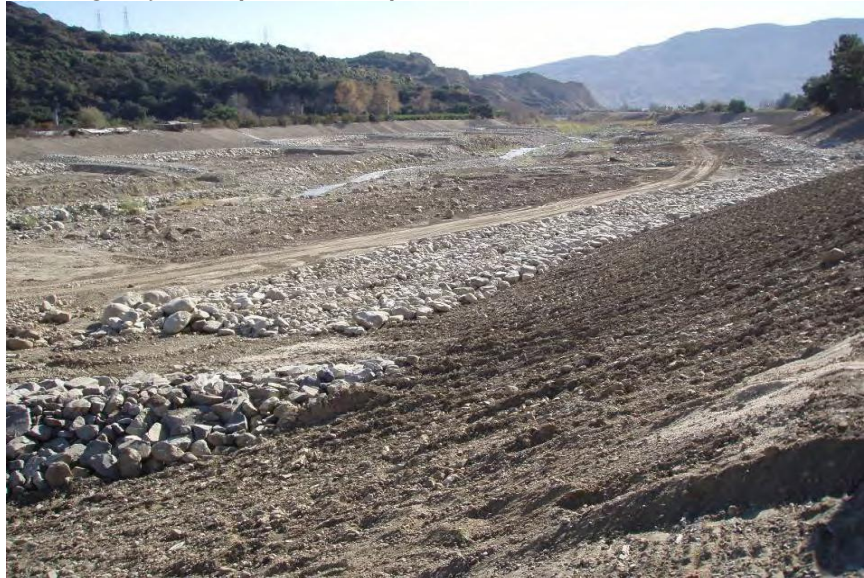
Figure 4-13: Emergency bank protection spur dikes.

The 2005 storm event caused severe erosion of stream banks along the Santa Paula Creek resulting in loss of property and threatened numerous residential homes, and public and private property (HDR 2006). As a result of this event, the Ventura County Watershed Protection District developed and installed an emergency streambank protection project that extends from the Bridge Road Bridge to approximately 4,600 feet downstream (reach 7). The improvements consisted of the construction of 24 (12 west bank and 12 east bank) rock spur dikes on the stream bed, and 730 feet of longitudinal bank protection. The design report (HDR 2006) indicates that the structures are oriented at a slight angle upstream near the banks to realign the channel flow to a path away from the banks, but change to an angle perpendicular to the flow closer to the banks of the low-flow channel, to ensure that the flow is oriented along the low-flow path. The report states that “Use of spur dikes in this configuration will promote stream flow to remain within the low-flow channel. This will lessen the potential for the flow to migrate to channel banks, further reducing erosion potential, but will also promote a cooler and more sustained flow for use by fish in passage upstream or downstream.”

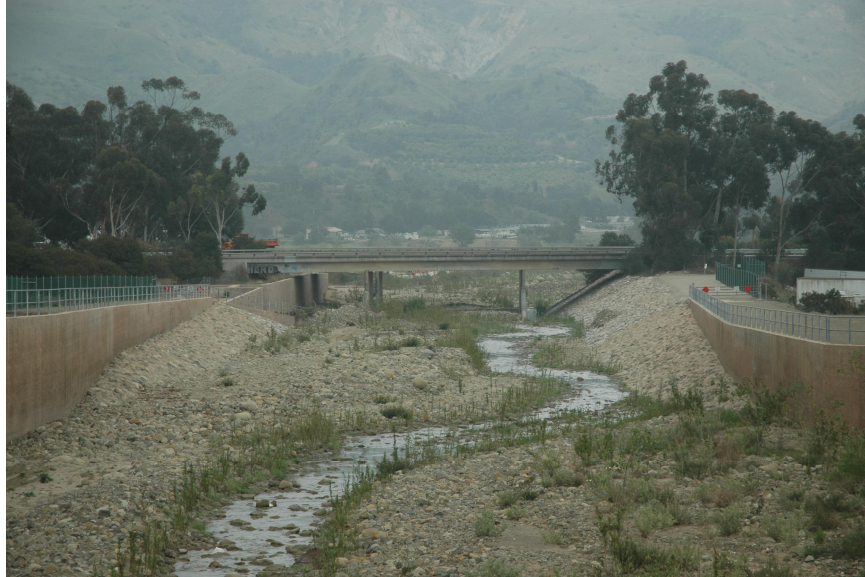
Figure 4-14: View of the existing USACE channelization (looking downstream at Hwy 126 crossing).

0.03049 feet per foot, and a depth ranging from 23 ft (at the downstream end) to 36 ft (at the upstream end). The soft-bottom channel base width varies from 72 to 130 feet. The USACE fish ladder was constructed as part of the inlet stabilization (*i.e.*, grade control to prevent head cutting and incision) at the upstream end of the improvements. The fish ladder is built on bedrock, and is approximately 650 ft long, has a 2:1 side slope (top width = 25.5 ft, bottom width = 13.5 ft), and has a invert slope of 0.074. The fish ladder suffered structural damage during the 2003 and 2005 storm events. A grouted riprap grade control structure was also constructed across the channel bottom downstream of the fish ladder to stabilize the channel invert.

Subsequent to the construction of the channel improvements, significant erosion was identified along the channel improvements resulting from the 2002-2003 and 2003-2004 WY storm events. The peak flow rate associated with these events was estimated to be approximately 2,000 cfs, which was estimated to have a 3-year reoccurrence interval. These storm events resulted in degradation of up to 5 feet along reaches of the channel. This erosion had threatened to undermine the grouted riprap bank protection, and resulted to barriers to fish passage. The grade control structures and fish ladder improvements constructed as part of this project have been previously identified by Stoecker and Kelley (2005) as barriers to fish passage. As a result of the identified channel degradation problem, the Corps developed alternatives to modify the existing channel improvements. Up to 20 alternatives were developed for temporary or permanent modifications to the channel to limit the potential for scour. Memorandums from the USACE indicate that the severity of the degradation was unexpected as historically this reach of the creek has been subject to severe deposition of sediment. No modifications to the channel have been completed by the time of this study.

Observations of the channel completed in 2007 and 2008 as part of this study indicate that much of the channel appears to be restored back to the original grade. This appears to be a result of the larger storm events that have occurred after 2004. While this may validate the USACE assumption about sediment deposition during large events, it does not mitigate the fact that the channel may be subject to erosion during smaller, more frequent storm events. And that a continued period of smaller events could result in potential bank failure and fish passage barriers.

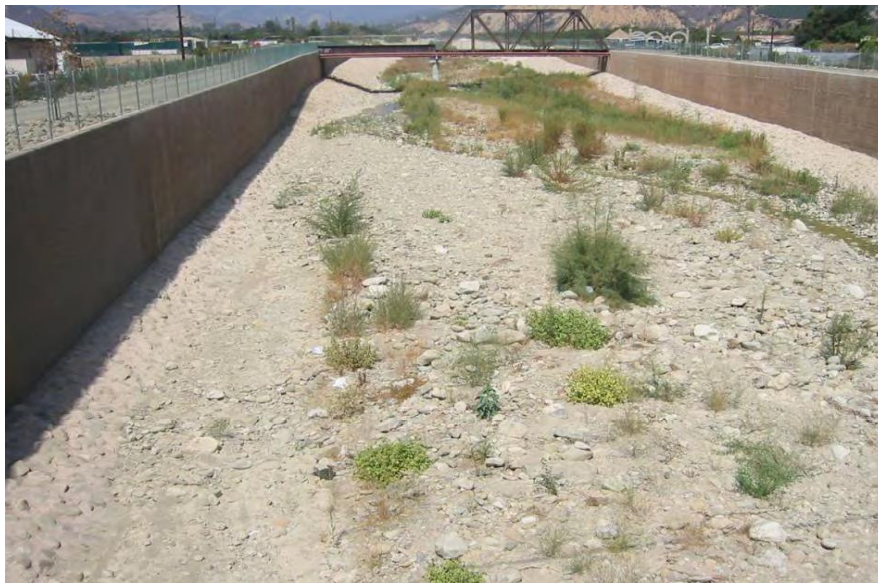
Figure 4-15: Looking downstream at the Southern Pacific Transportation Company (SPTC) truss bridge.

Within the lower portion of Santa Paula Creek (adjacent to the town of Santa Paula), the Southern Pacific Transportation Company (SPTC) truss Bridge and Telegraph Rd Bridge have been previously shown to impact flow hydraulics and sediment transport dynamics during high flow events. The SPTC truss bridge was constructed in 1912 as a 100-ft span with a channel capacity of approximately 10,000 cfs (i.e., the peak discharge for an 18-year flow event). This bridge span has been identified as the most critical flow constriction along the lower reach of Santa Paula Creek (USACE 1995). For example, the bridge caused significant flow impoundment and subsequent upstream flooding during the January 1969 flood event. The Telegraph Road Bridge (approximately 1,200 feet downstream of the SPTC truss bridge) was constructed sometime after 1960 and has a 120-ft span. Its capacity is larger than the SPTC truss bridge but it has been previously identified as the second most critical flow constriction in the lower reach of Santa Paula Creek, also contributing to localized flooding in Santa Paula during past flood events (USACE 1995). The impact of these two bridge structures on the creek hydraulics and sediment transports has been greatly reduced with the construction of the ASACE channel improvements.

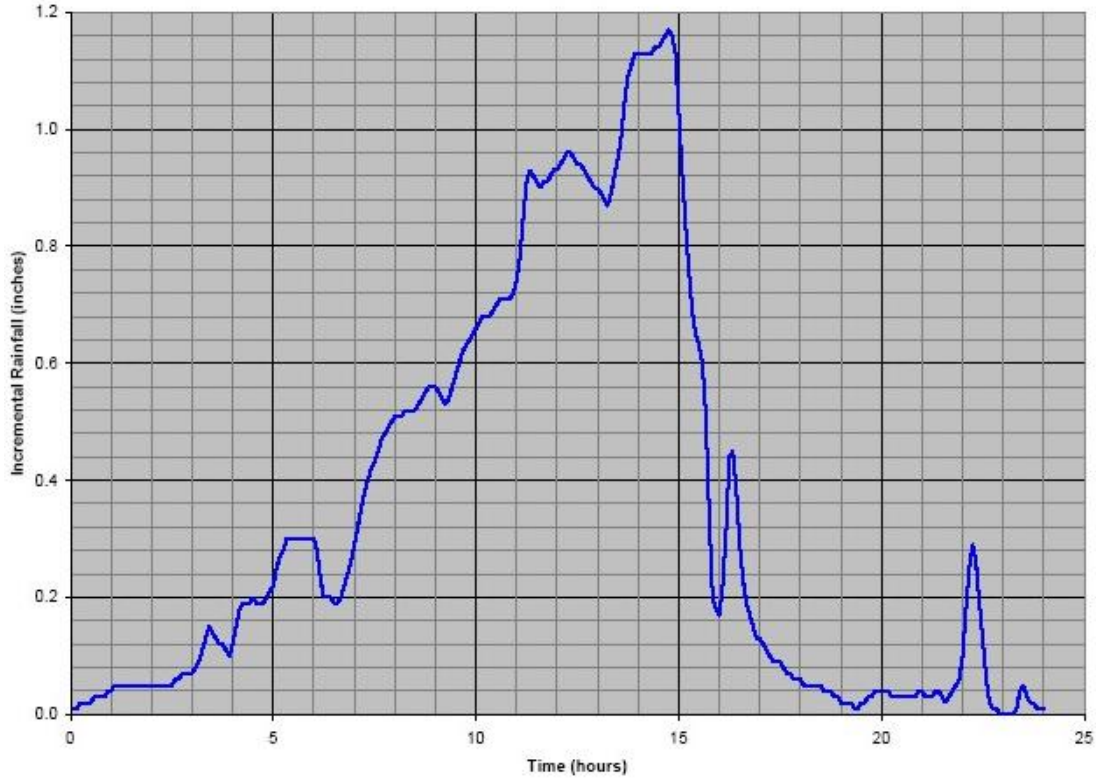
Figure 5-2. Southern California 24-hour storm, February 16, 1980 (LADCOE, 1986).

The 24-hour rainfall pattern was defined using the southern California intermediate storm, which occurred in the Los Angeles area on February 16, 1980 (USACE, 1986). This rainfall pattern is graphically shown in Figure 5-2.

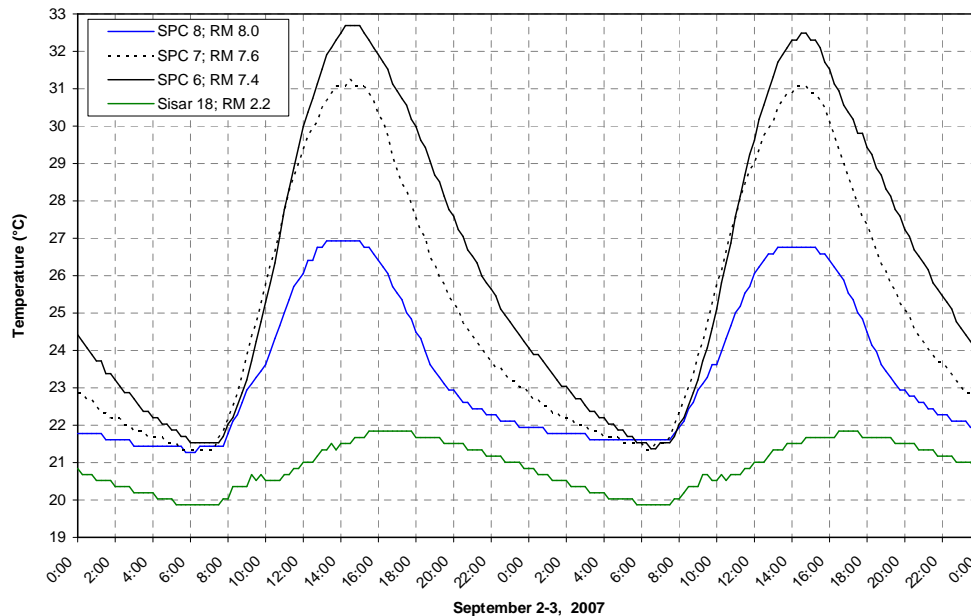
Figure 6-4: Continuous stream temperature in 15-minute intervals at four locations within the Santa Paula Creek watershed, September 4-5, 2007.

An exception to these patterns of temperature and *O. mykiss* presence was the observation of one age 1+ *O. mykiss* that was observed in an isolated pool in the middle of the dry reach (RM 7.1; Steelhead Assessment Map 7). Although data on small seeps was not gathered, some observations of local pockets of cool water in warm pools was observed during the previous survey, and may explain the rare presence of age 1+ *O. mykiss* within the dry reach. Stream temperature data is not available within the proximity of this isolated pool, making it difficult to come to conclusions on thermal tolerances at this location.
