Geomorphic Assessment of the Santa Clara River Watershed, Synthesis of the Lower and Upper Watershed Studies

Ventura and Los Angeles Counties, California

April 2011

Prepared by
Stillwater Sciences
2855 Telegraph Avenue, Suite 400
Berkeley, CA 94705

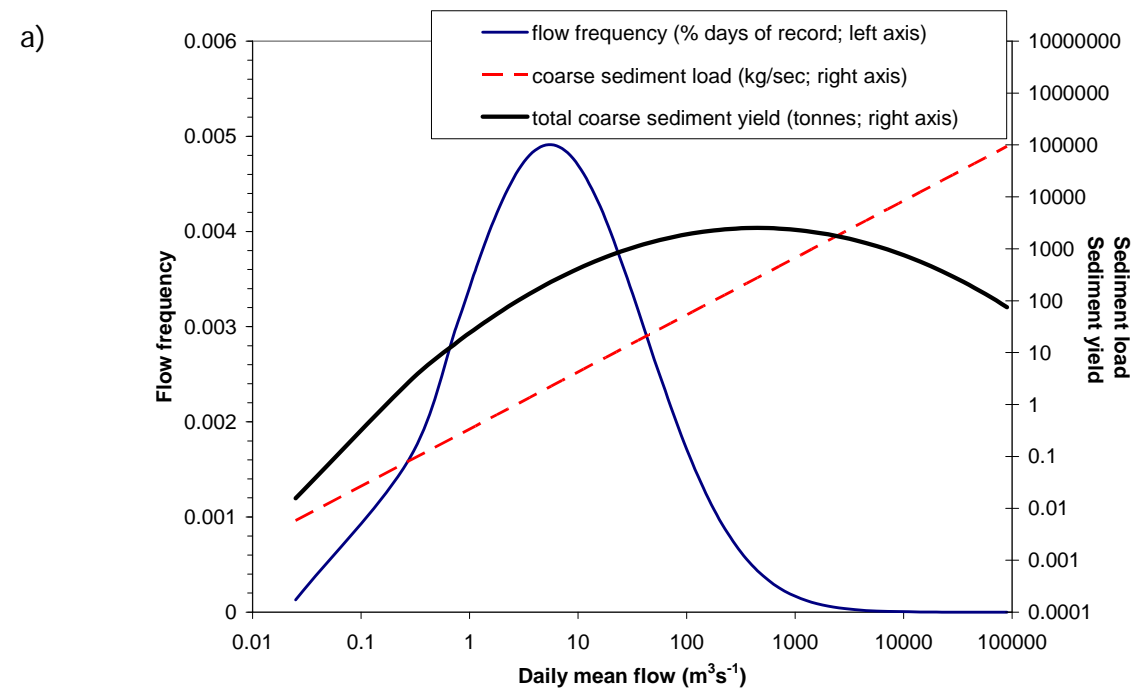
Figure 4-4a. Flow frequency (left axis, scaled to 1) and sediment load (right axis) plotted against flow, showing conceptual, dominant discharge model of an idealized alluvial river by Wolman and Miller (1960). Blue line tracks flow frequency (for mean daily flow), red line tracks sediment transport rate (in tonnes/day) and black line tracks total sediment load (in tonnes). Sediment load increases to a maximum at an intermediate flow.

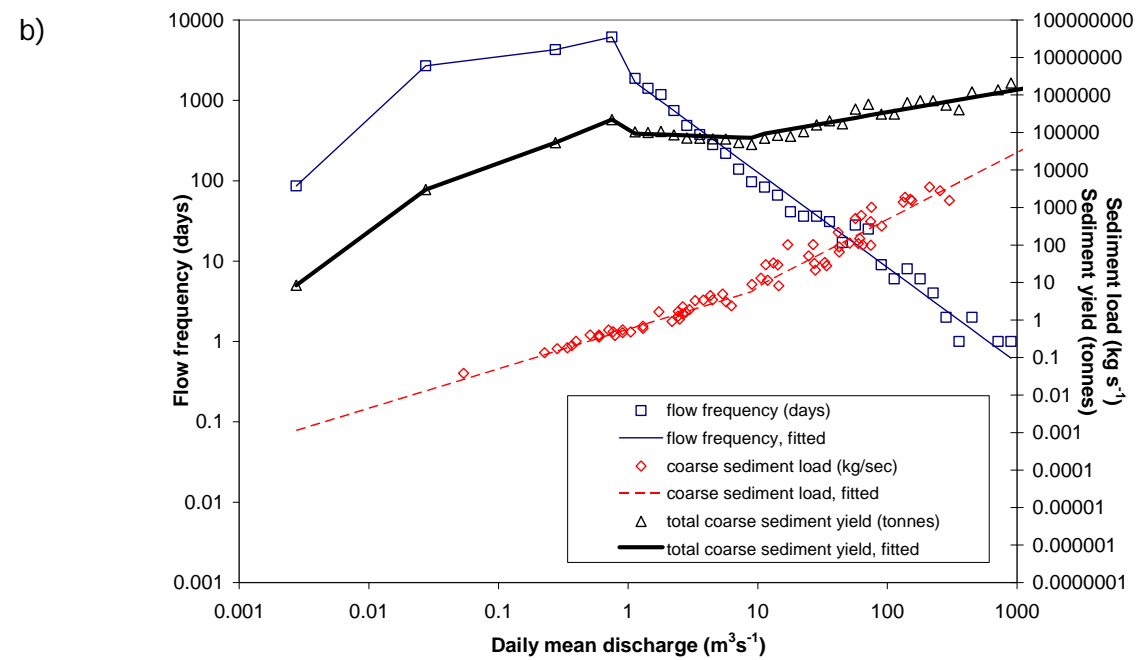
Figure 4-4b. Flow frequency and coarse (>0.0625 mm) sediment load for long-term daily mean flow record for USCR at the County line (USGS 1118500 and 11109000). Unlike classic alluvial rivers, the variation of sediment yield with flow does not exhibit a peak at “intermediate” discharges (as defined by the range of flows seen over the last century), but increases with increasing flood frequency without (heretofore observed) bounds.

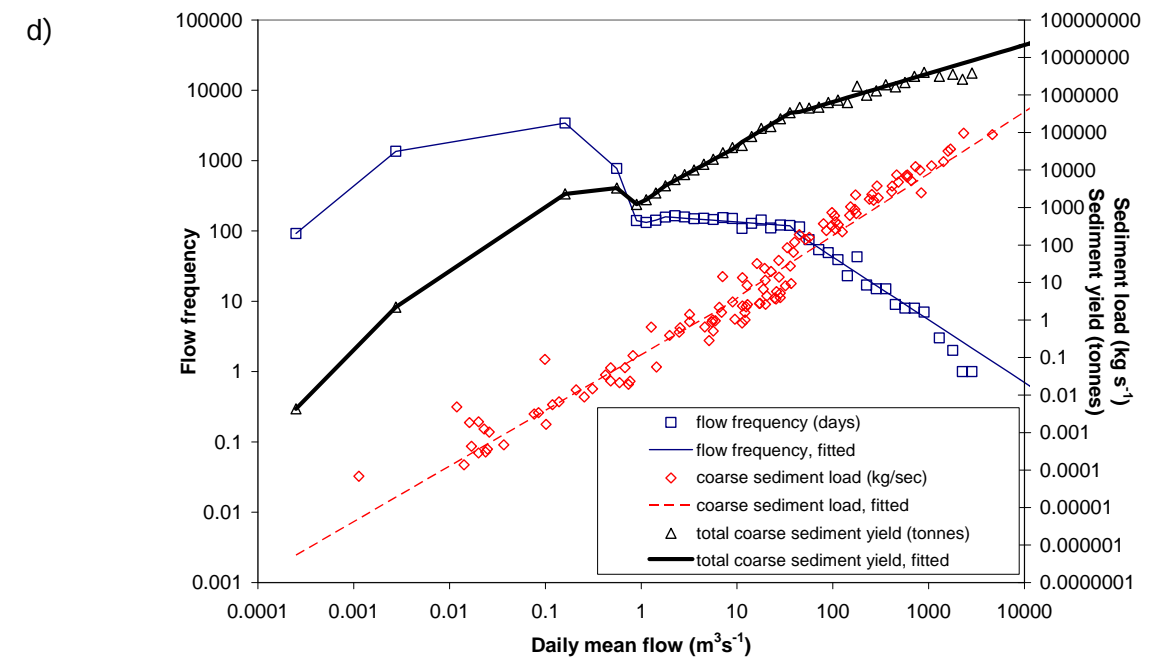
Figure 4-4d. Flow frequency and coarse (>0.0625 mm) sediment load for long-term daily mean flow record for LSCR at Montalvo (USGS 11114000). Unlike classic alluvial rivers, the variation of sediment yield with flow does not exhibit a peak at “intermediate” discharges (as defined by the range of flows seen over the last century).

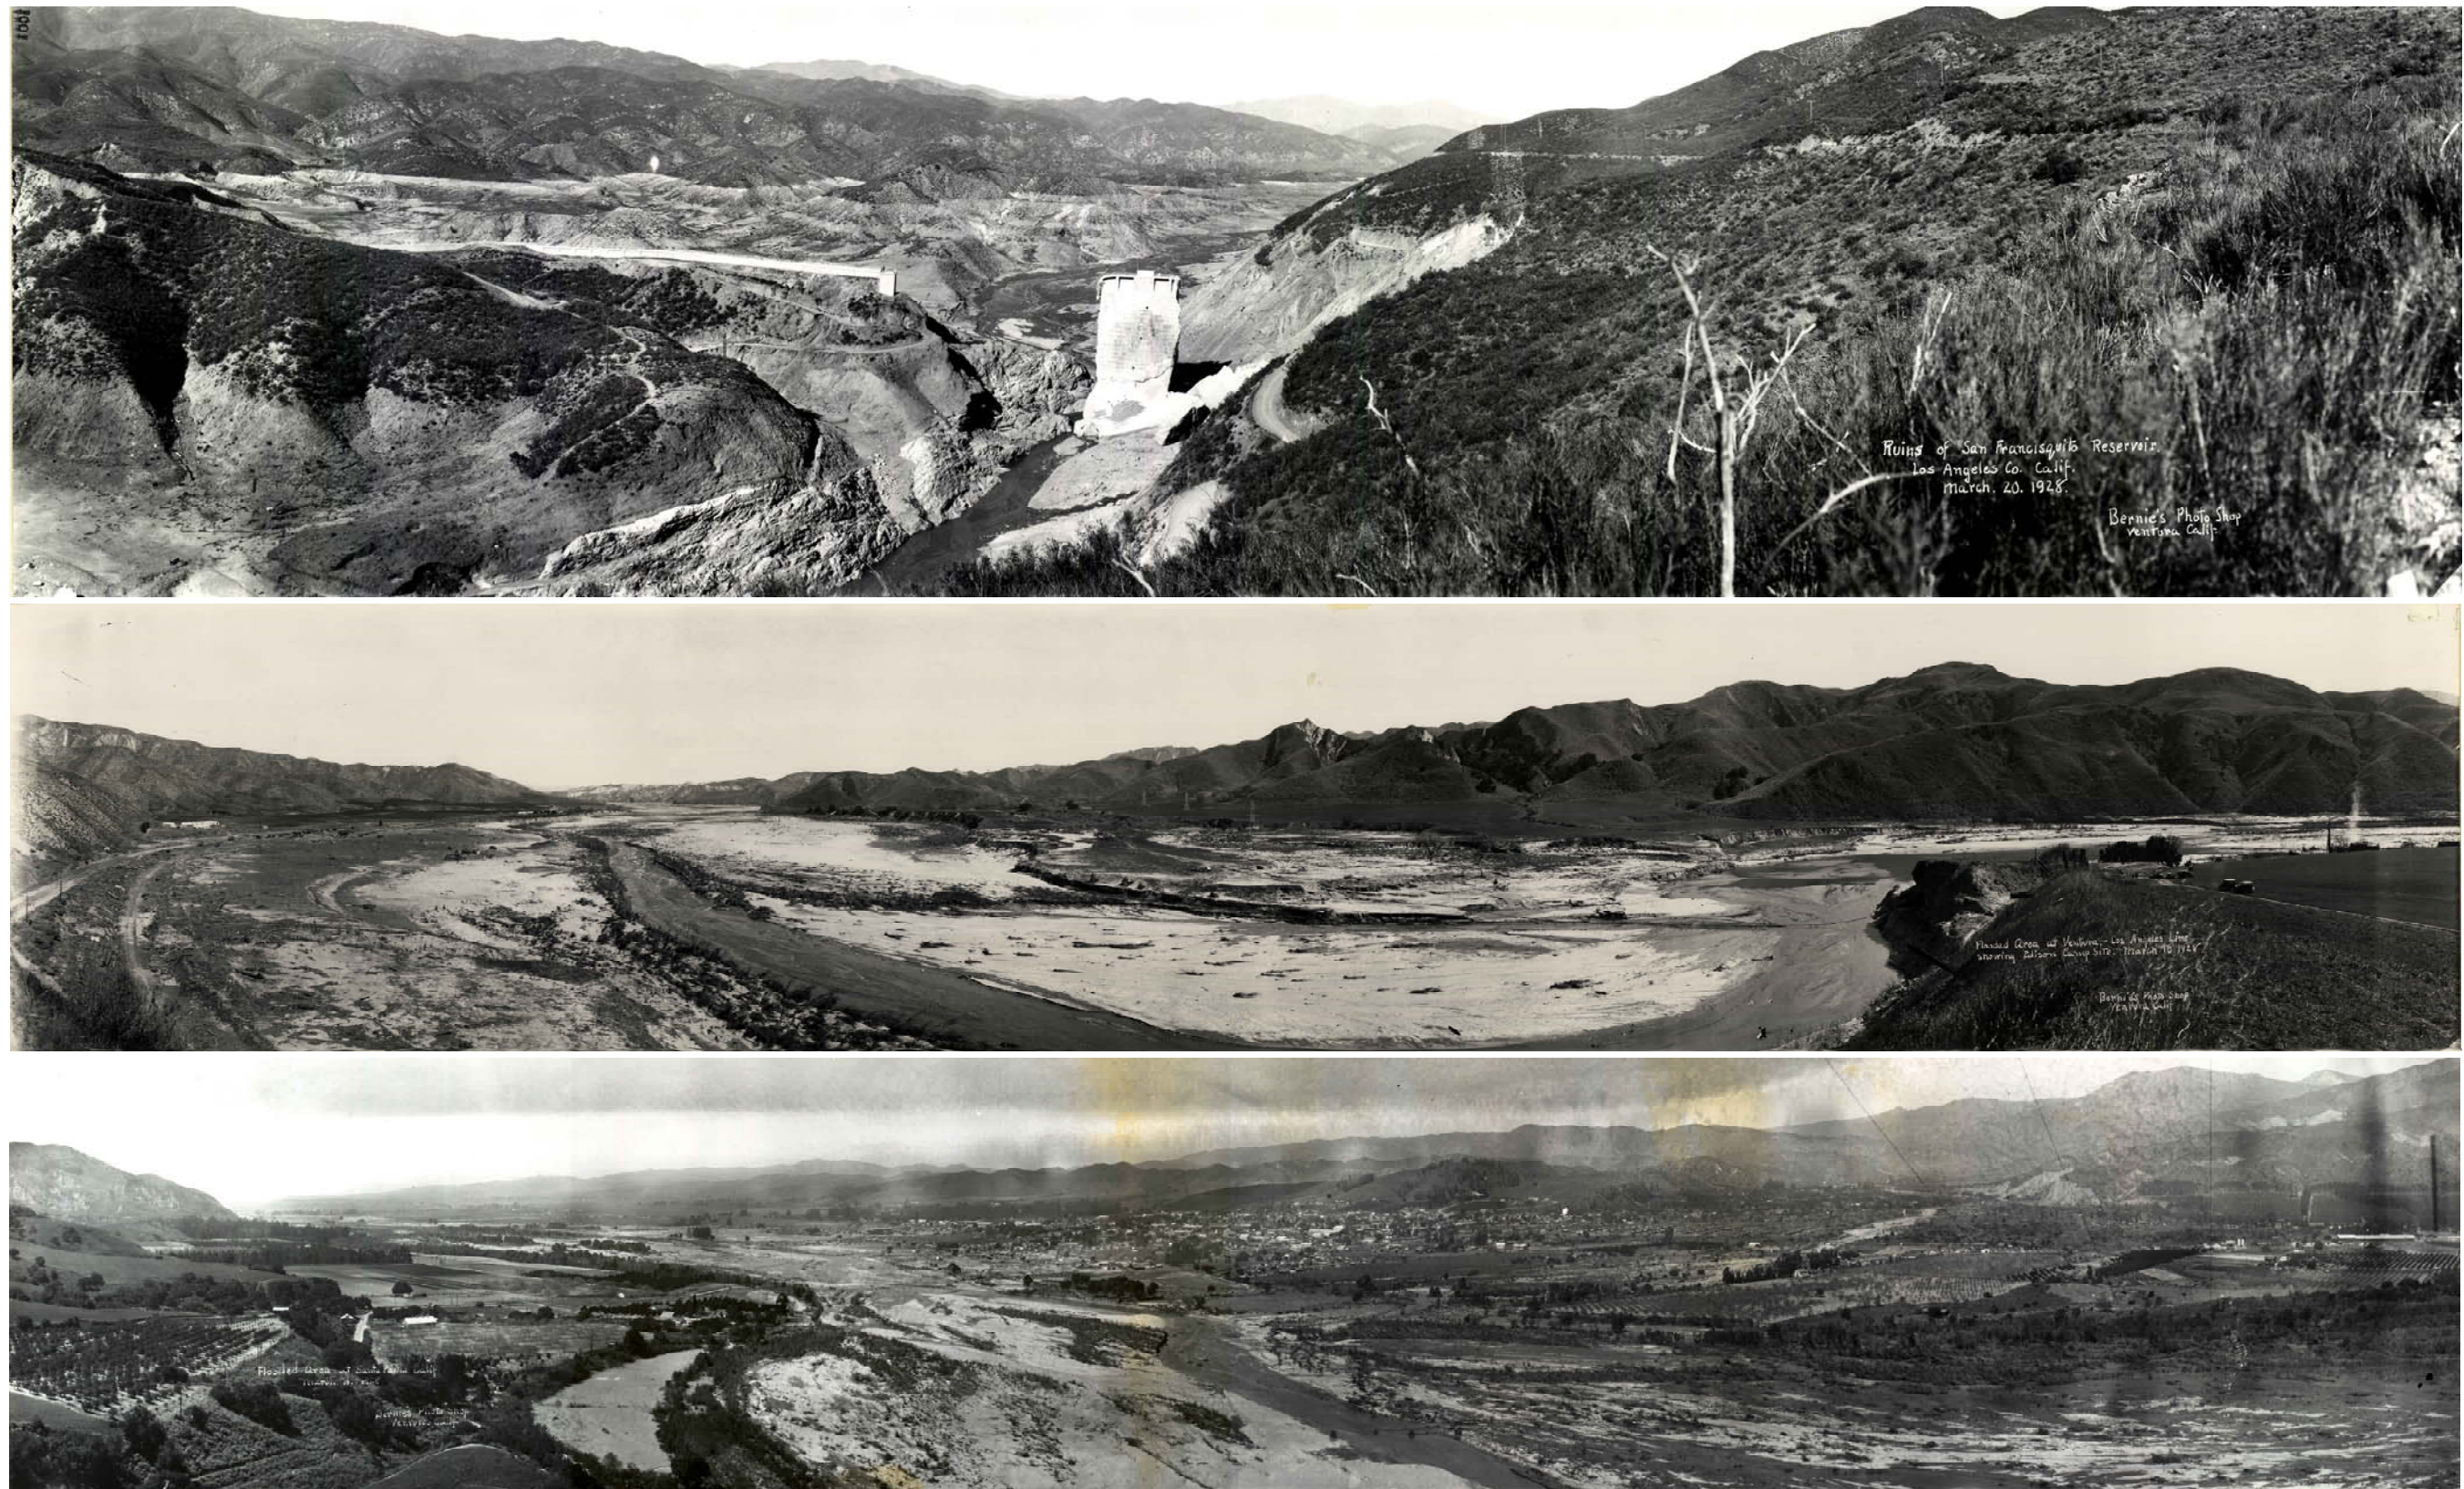
Figure 4-7. The remains of the St. Francis Dam after collapsing just before midnight on March 12, 1928, in the San Francisquito Canyon subwatershed (top). Middle, a downstream view of the mainstem Santa Clara River near the County line, five days after the dam break flood. Below, a downstream view of the mainstem SCR near Santa Paula Creek, the day after the dam break flood. Photos courtesy of the VCWPD.

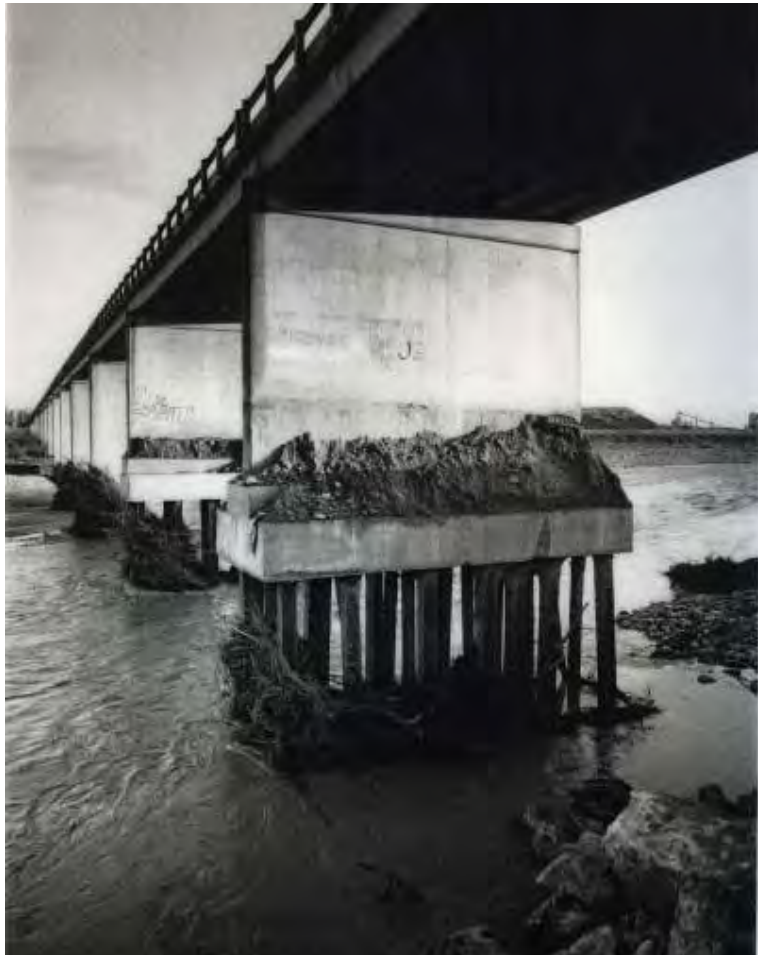
Figure 4-9. Undercutting of the Highway 118 bridge over the SCR as a result of incision following the 1969 floods. (Photo courtesy of the VCWPD.)

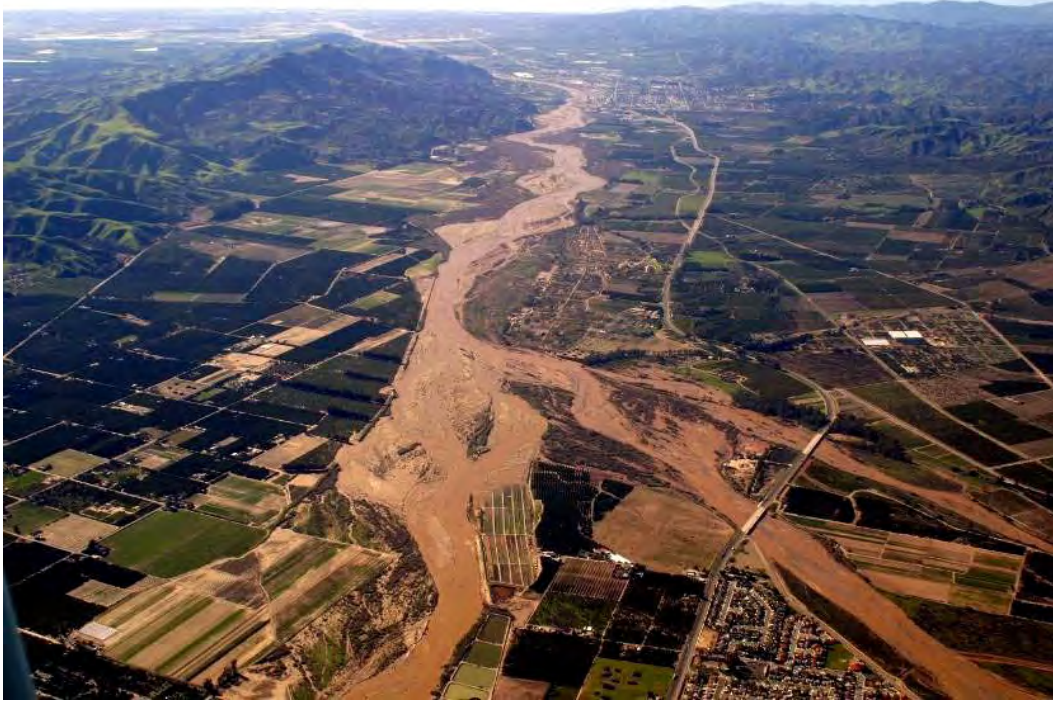
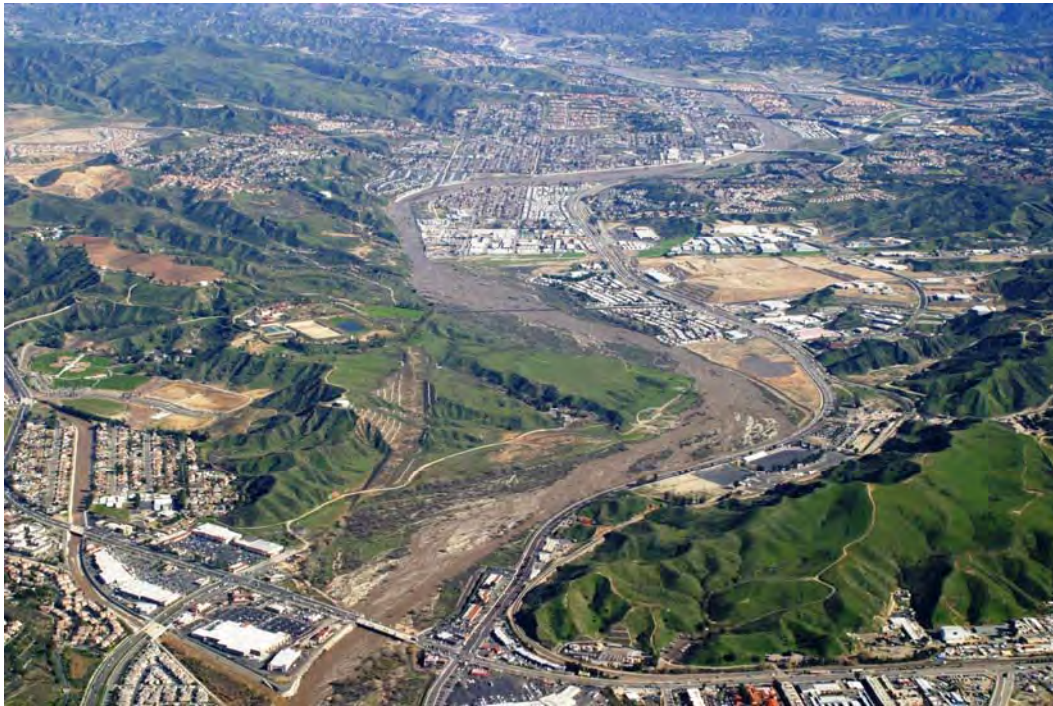
Figure 4-13. View of the SCR during the January 2005 flood, with a westward, downstream view of the LSCR near the Sespe Creek confluence (two channels entering from right) (a), and an eastward, upstream view of the USCR through the Santa Clarita Basin near the Bouquet Canyon confluence (channelized downstream extent entering from left) (courtesy of the California State Coastal Conservancy).

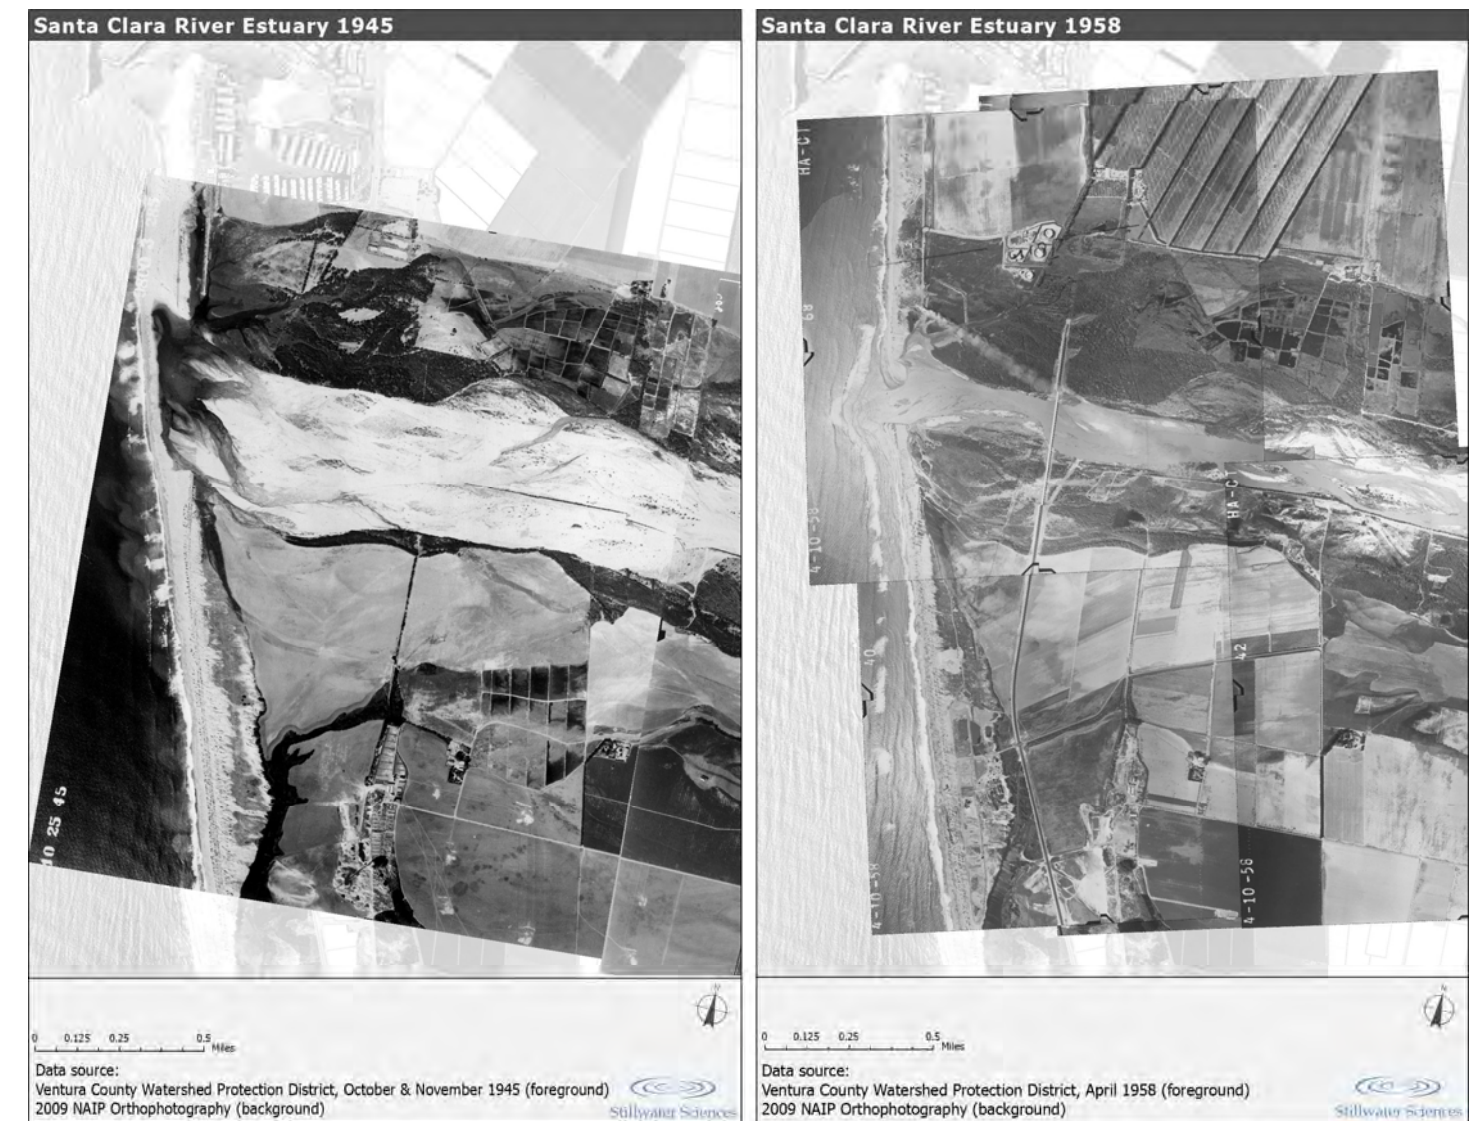
Figure 5-9. SCRE and surrounding floodplain (1945 and 1958).

1945 The shoreline and river mouth shown in the October 1945 photograph advanced to the north and remained relatively stable to the south in comparison with the 1927 position (Figure 5-9). The sediment deposited from the St. Francis Dam failure (1928) and following 1938 floods (approximate 50-year event) is evident in the 1945 photograph. Vegetation within the main channel was still absent, presumably from scour associated with the 1938 flood event. The distributary channel network at the southern extent appears in-filled due to agricultural encroachment. Although the mouth/estuary complex

- appears to have expanded with shoreline advance, the area to the north appears to have been filled in more relative to the 1927 photograph.
- 1958** The shoreline and river mouth shown in the April 1958 photograph eroded landward at both the north and south ends in comparison with the 1947 photograph (Figure 5-9). A decade without a major discharge event from the SCR (i.e., instantaneous discharge was less than $1,416 \text{ m}^3 \text{ s}^{-1}$ [50,000 cfs] between 1947 and 1958) led to considerable vegetation development within the active channel. Riparian forest development at the southern portion of the active channel extent within the mouth/estuary complex led to a quasi-stable channel exiting to the north.

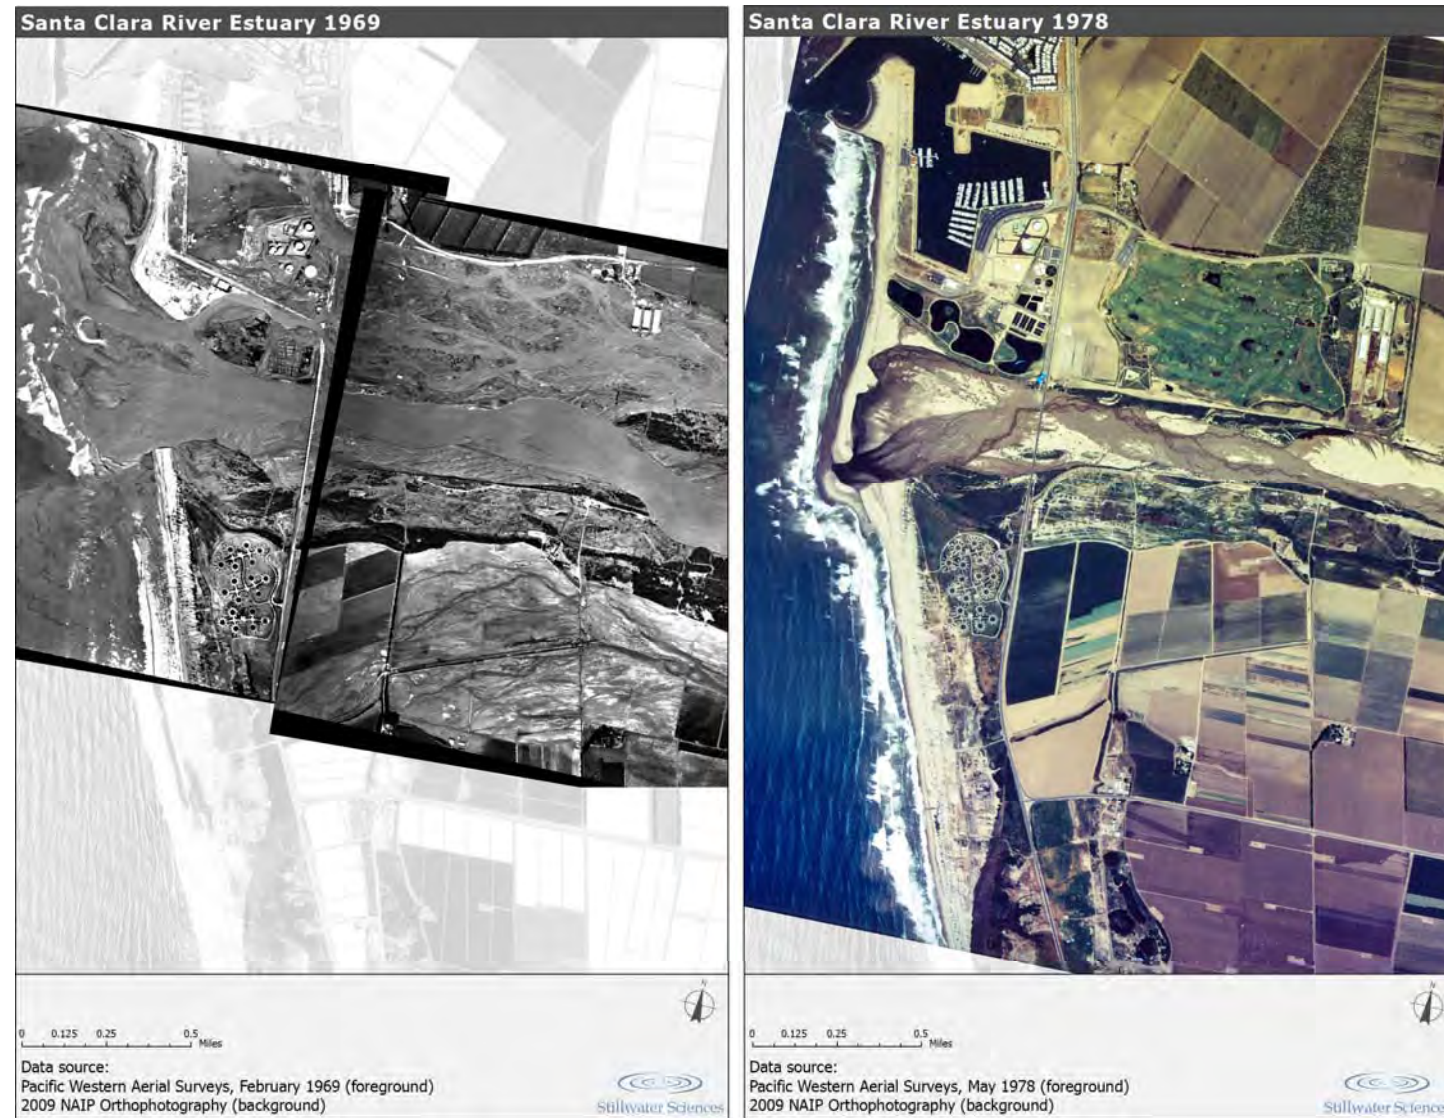
Figure 5-10. SCRE and surrounding floodplain (1969 and 1978).

- 1969** The shoreline and river mouth shown in the February 1969 photograph appear relatively unchanged when compared with the 1958 photograph (Figure 5-10). Levees on both banks established upstream of the Harbor Boulevard bridge had been established by 1969. The effects of the January and February 1969 floods within and around the SCR mouth are apparent in the photograph: a scoured channel network evident is evident on north side of the channel (upstream of Harbor Boulevard bridge) where the flow overtopped the levee; the impact of levee overtopping on the destruction of Ventura Marina is evident; and considerable deposition of sediment on the south side of channel upstream of Harbor Boulevard is apparent. The location of the channel within the mouth/estuary complex was still to the north, but bank erosion induced by the 1969 flood is evident on riparian forest terrace to the south.

- 1978** The shoreline and river mouth shown in the May 1978 photograph migrated landward compared to the 1969 photograph (Figure 5-10). The March 1978 storm event caused the main channel through the SCRE to move south towards its current location and resulted in the establishment of depositional bars with side channels along the main SCRE channel downstream of Harbor Boulevard and in the mainstem channel upstream of Harbor Boulevard. There is very little in-channel and tidal vegetation shown in the photograph, which is presumably caused by scour during March 1978 storm event.

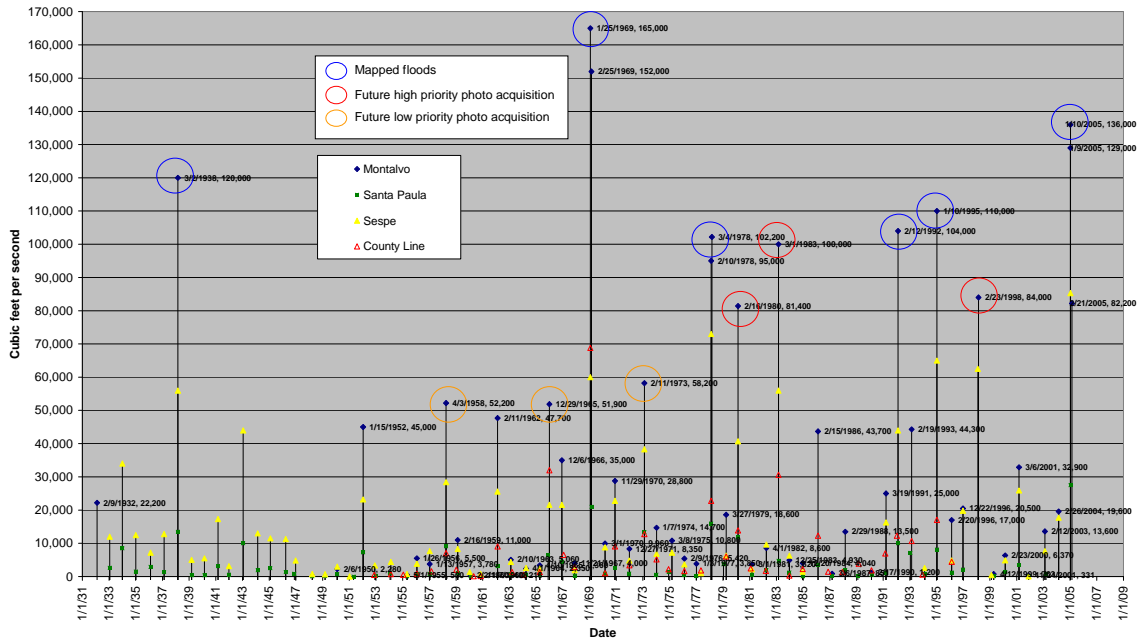
Figure C-1. Historical peak flows at stream gauges on LSCR shown in comparison to known air photo imagery acquisition dates.

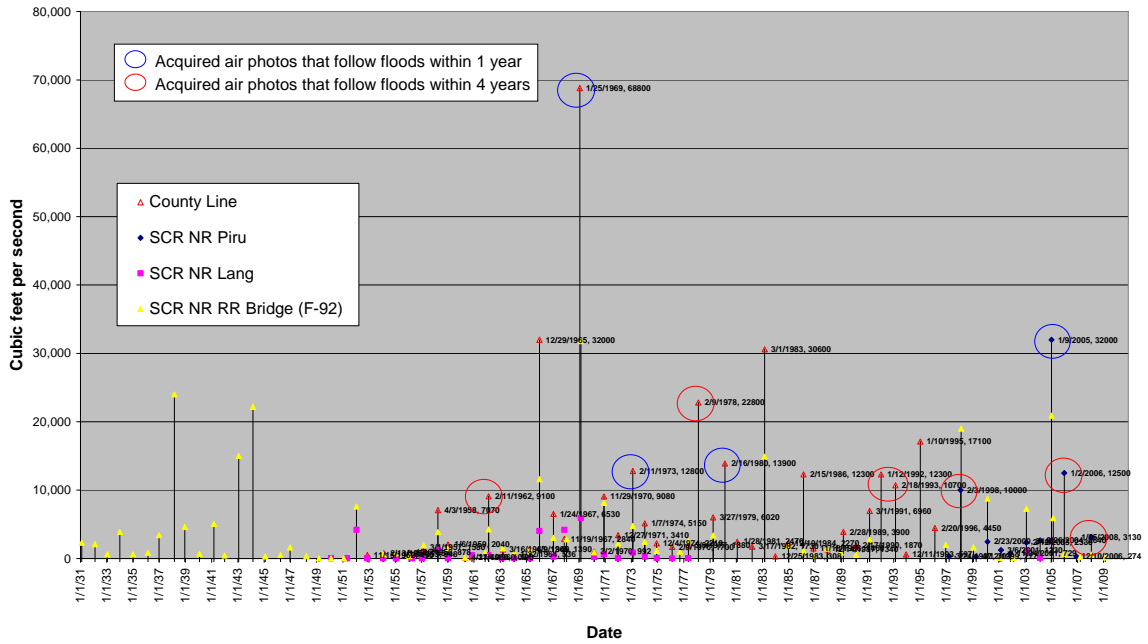
Figure C-2. Historical peak flows at stream gauges on USCR shown in comparison to known air photo imagery acquisition dates.
